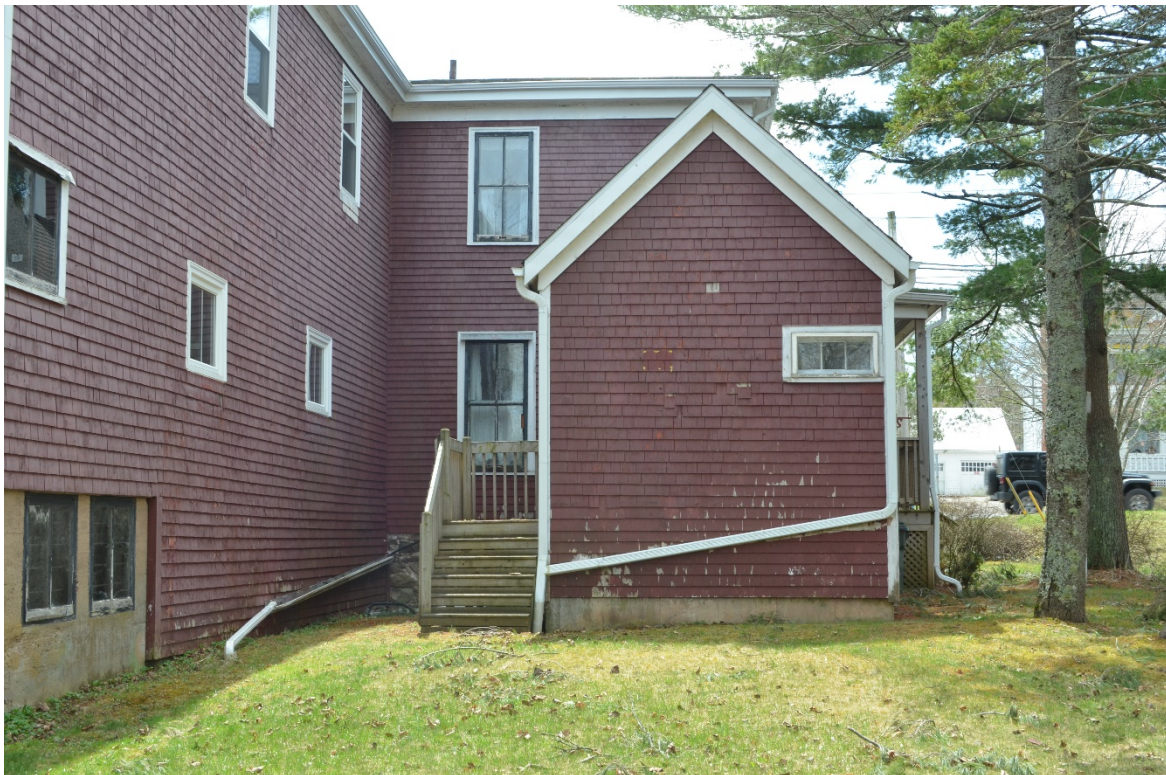
*Figure 8: Rear View, Centre Section. Note that eavestrough on narrow section has custom joint and that eavestrough carries sump pump hose. It would have to be removed and reinstalled after painting.*

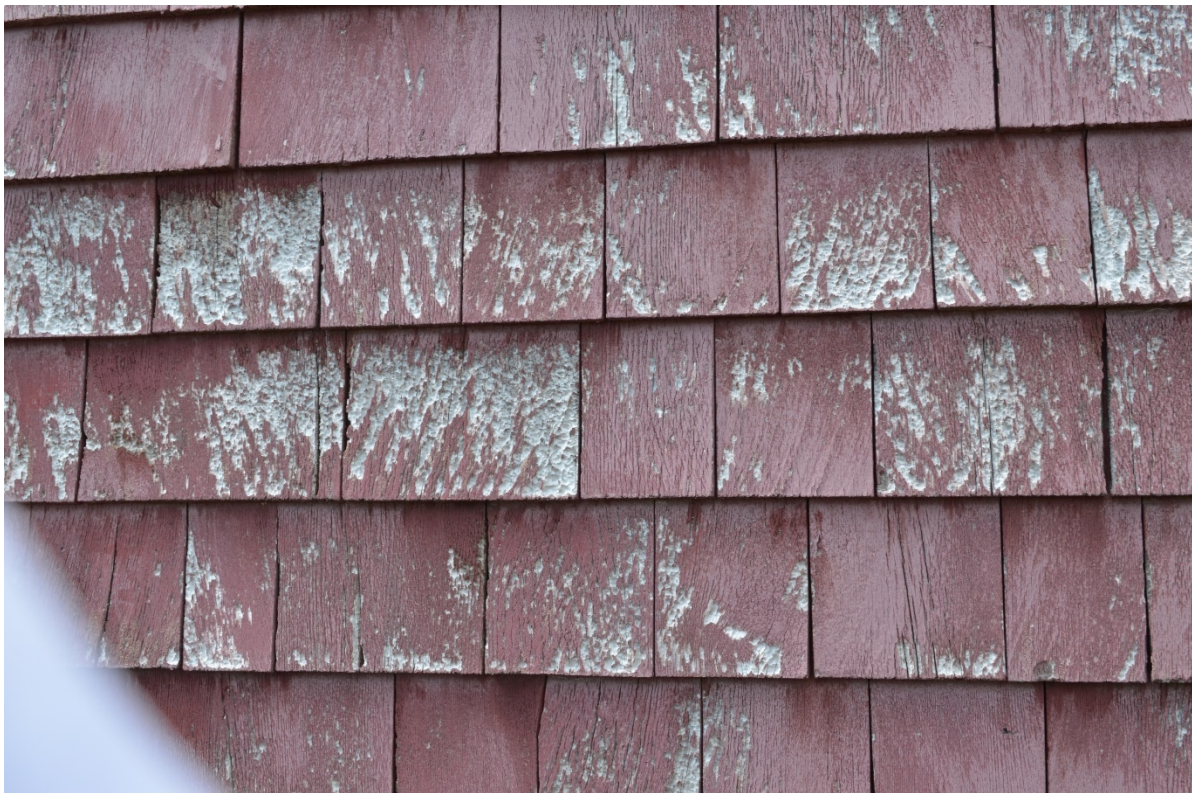
*Figure 14: Close-up of shingle damage, driveway side*

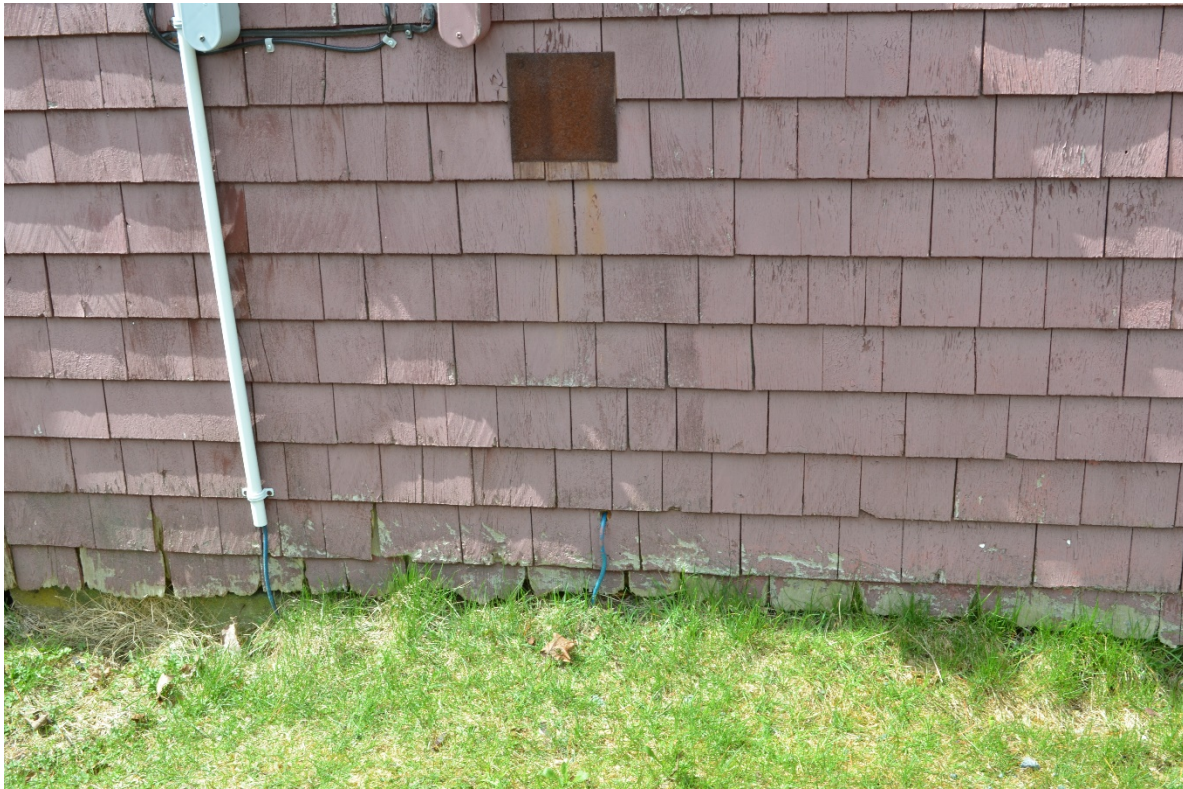
*Figure 15: Example of shingle damage along driveway side and in limited areas of the centre section*

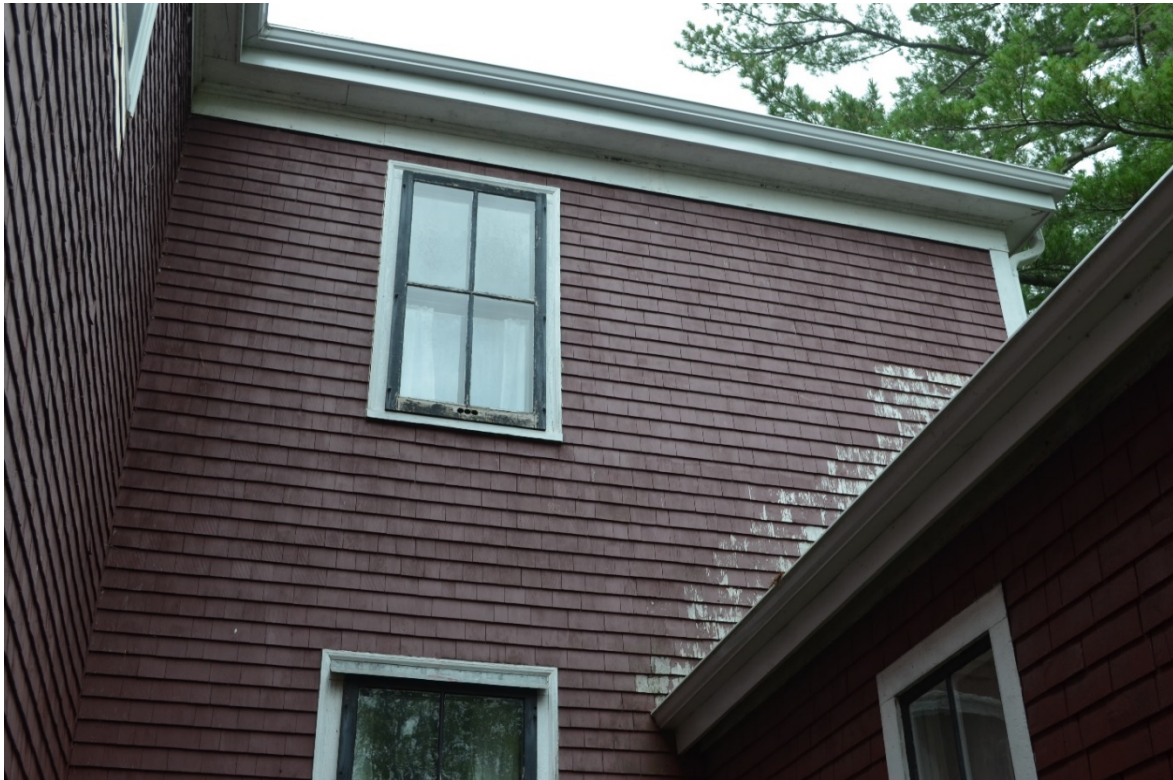
Figure 17: Close-up of bare area on Centre section
