APPENDIX E: PICTURES

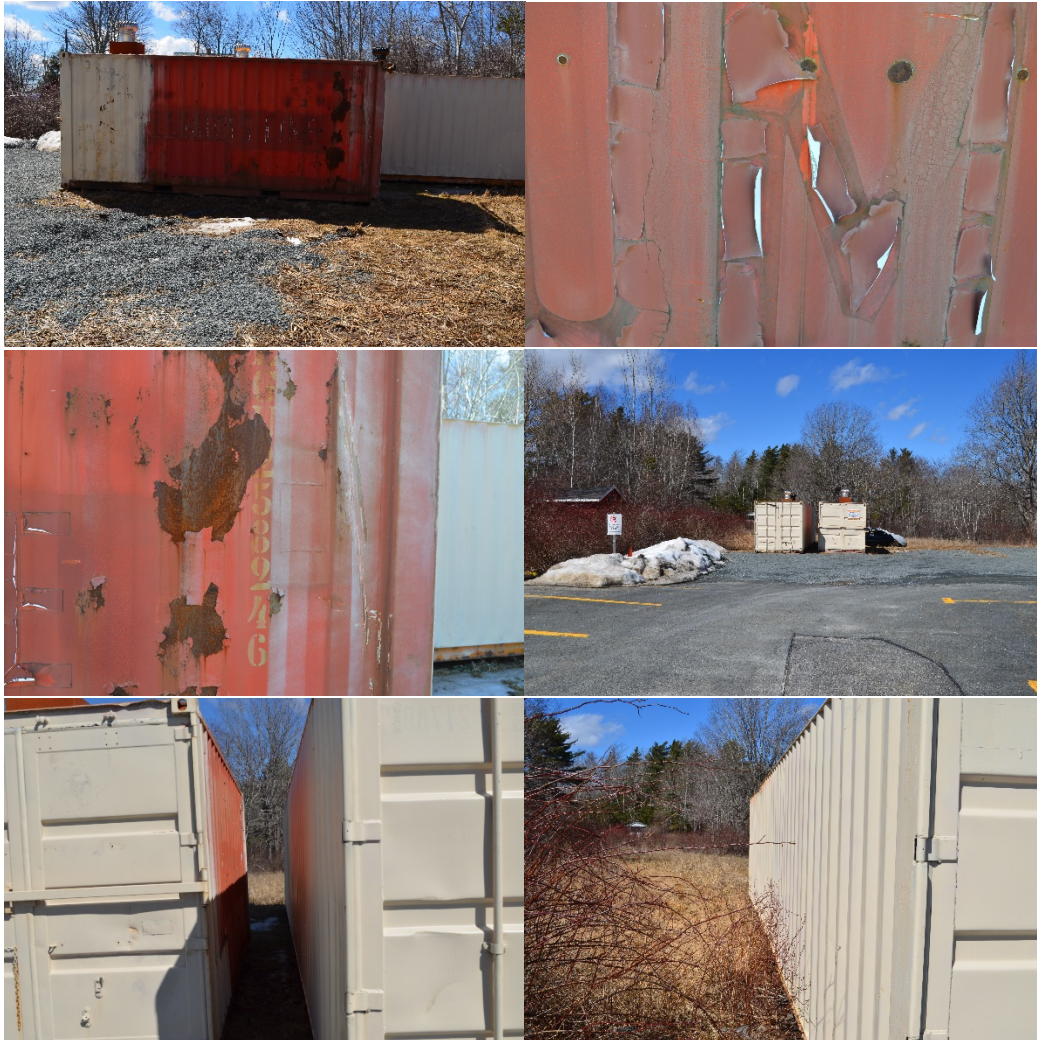
SC 1 & SC 2, First three pictures show SC 1 and the worst of the flaking paint; volunteers can do some scraping to remove the worst of the flaking paint. Last two pictures show the sides of SC 2.

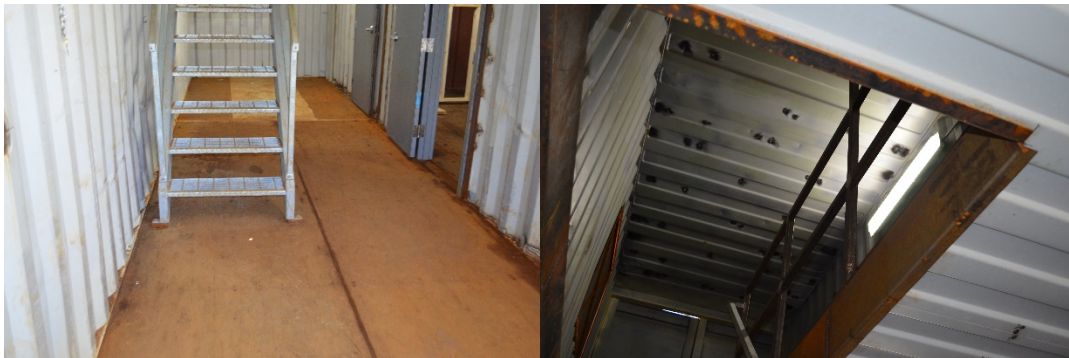
Training Facility: Interior Views

Second picture is view through stairs to second floor, showing railing that must be painted.

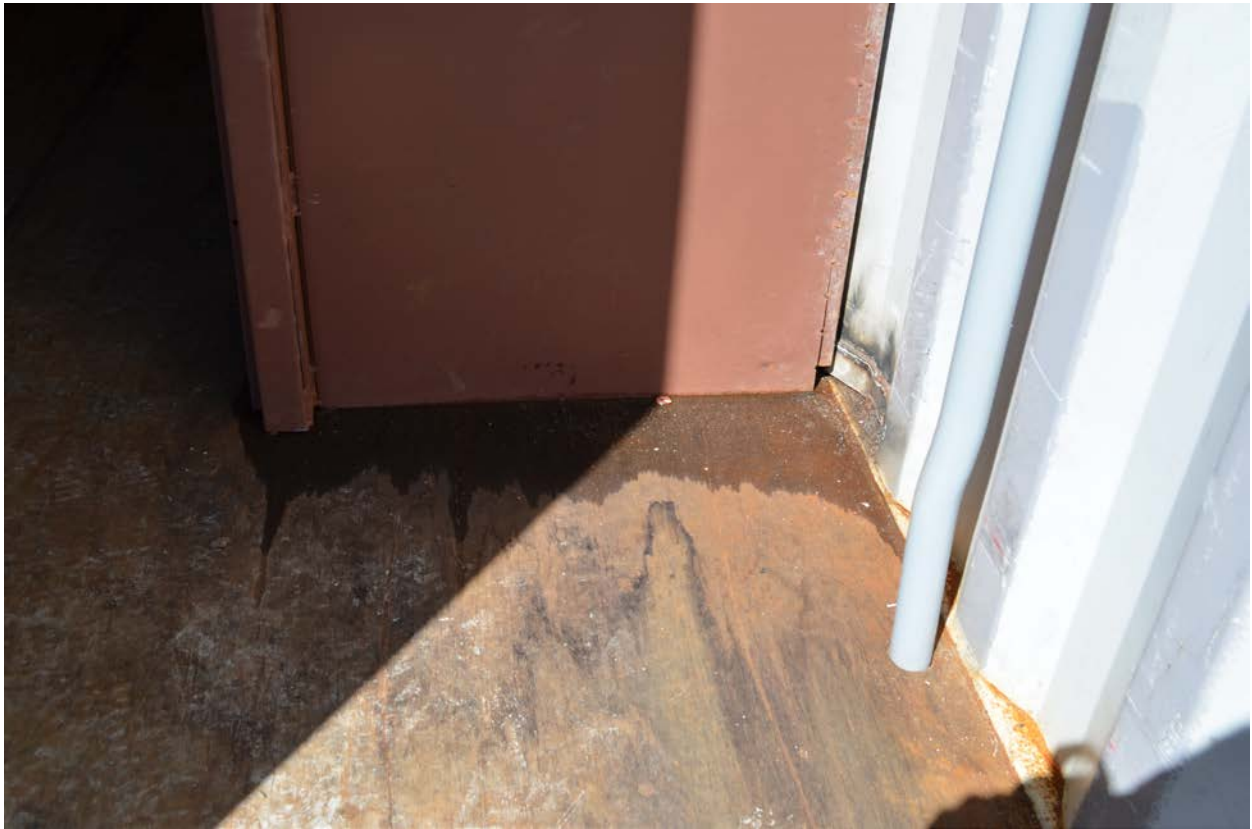
Training Facility: Interior View

Shows the bottom of a bulkhead containing a door which is typical at two locations on the ground floor. The bulkheads create the vestibules shown in Sketch 1.
