EAST HANTS MUNICIPALITY

EAST HANTS MUNICIPAL SWIMMING POOL

AUDIT AND LIFE CYCLE PLAN

FINAL REPORT

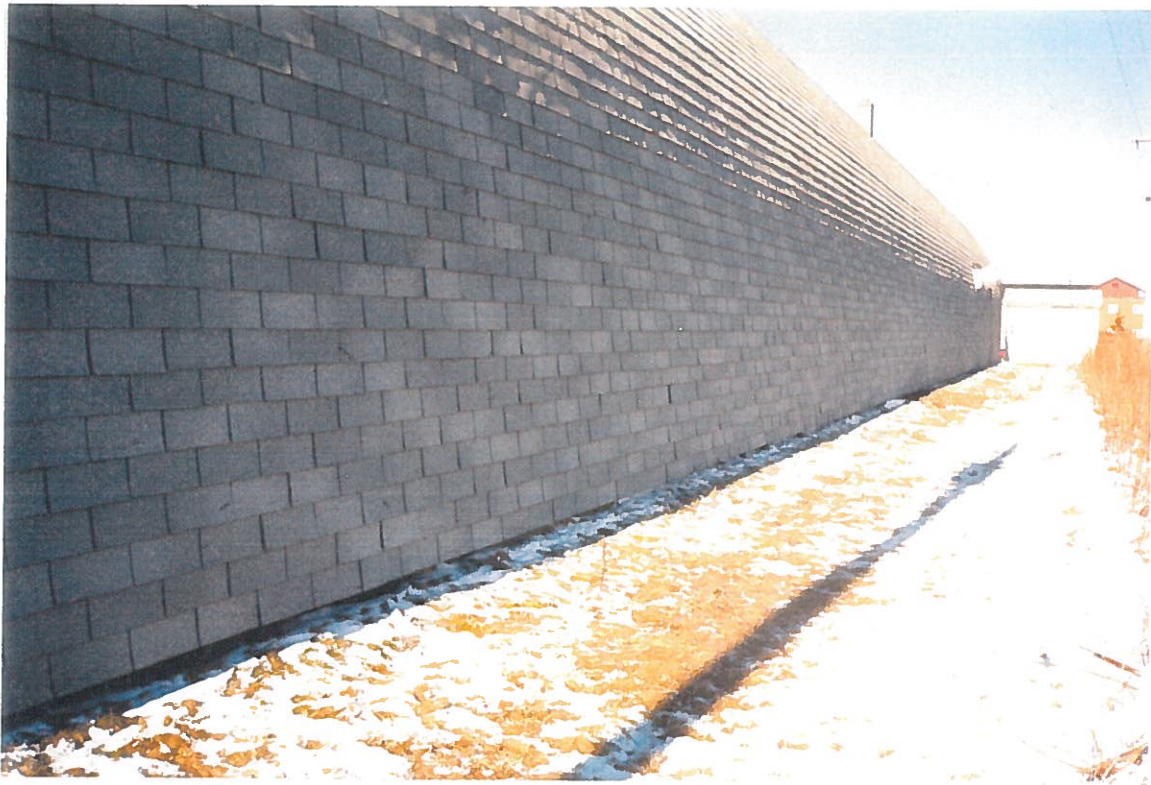
East side of pool with sloped grass area adjacent to the structure.
Ref. Section 2.1.1

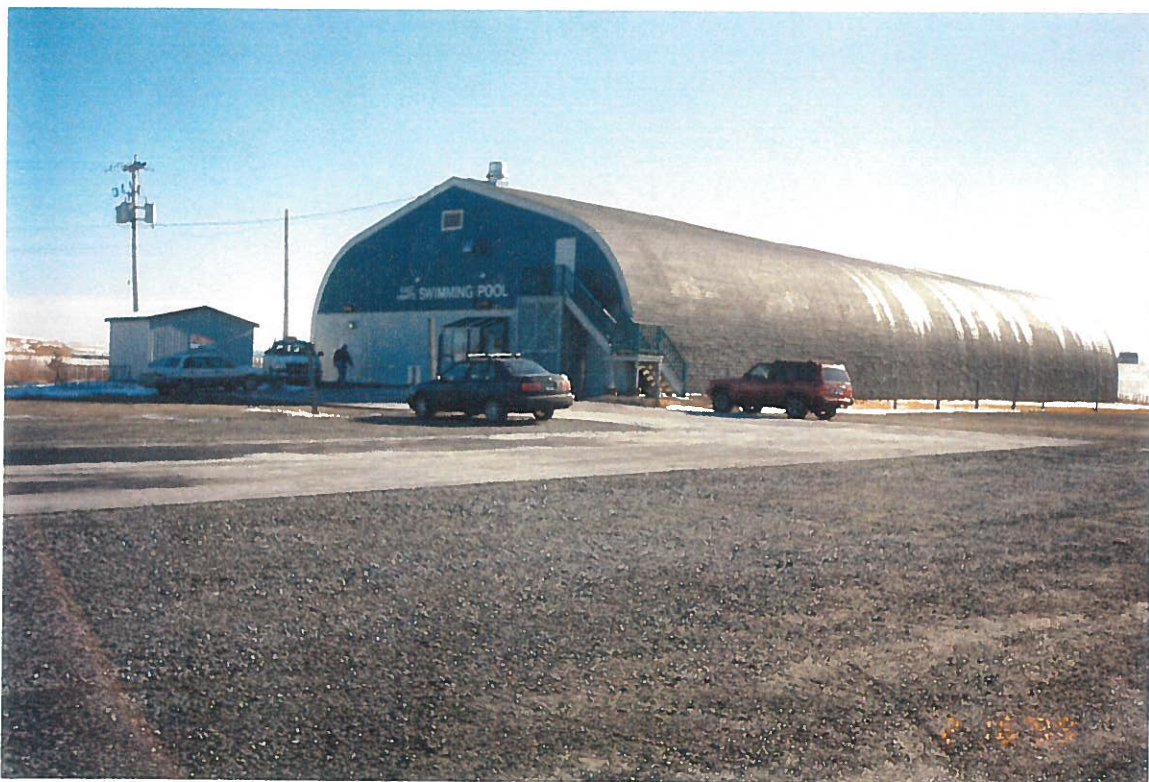
The asphalt paved driveway and the small paved area in front of the pool are in good condition and appear to be well maintained. The gravel parking areas are free from potholes and are also well maintained.

Paved driveway and gravel parking areas.
Ref. Section 2.1.2

- annual.
- .1 Yearly gravel grading to eliminate potholes and to create a smooth transition from the gravel to asphalt surfaces should be carried out as needed. An allowance for yearly maintenance of the asphalt surface would allow repair of potholes or cracks which occur in the asphalt. An annual allowance of \$1,000 is recommended for this work.

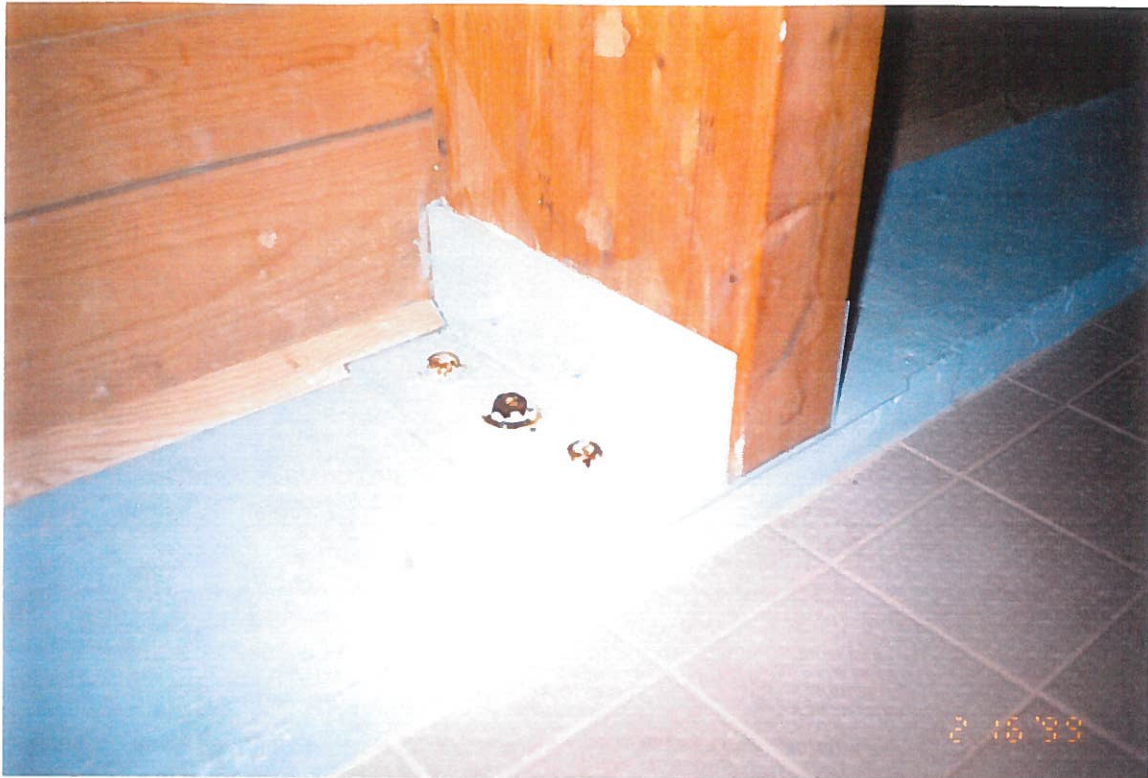
The anchor bolts located at the glulam base plates are showing signs of surface corrosion in several locations. Refer to the photograph in Appendix B.

Glulam arch base plate. Note surface corrosion on anchor bolts.
Ref. Section 2.2.4

- 2000
- .2 The anchor bolts, which are showing signs of corrosion, should be cleaned to bare metal and painted with a three coat painting system suitable for high humidity areas. This is considered a Priority 2 recommendation with a cost estimate of **\$1,000**.

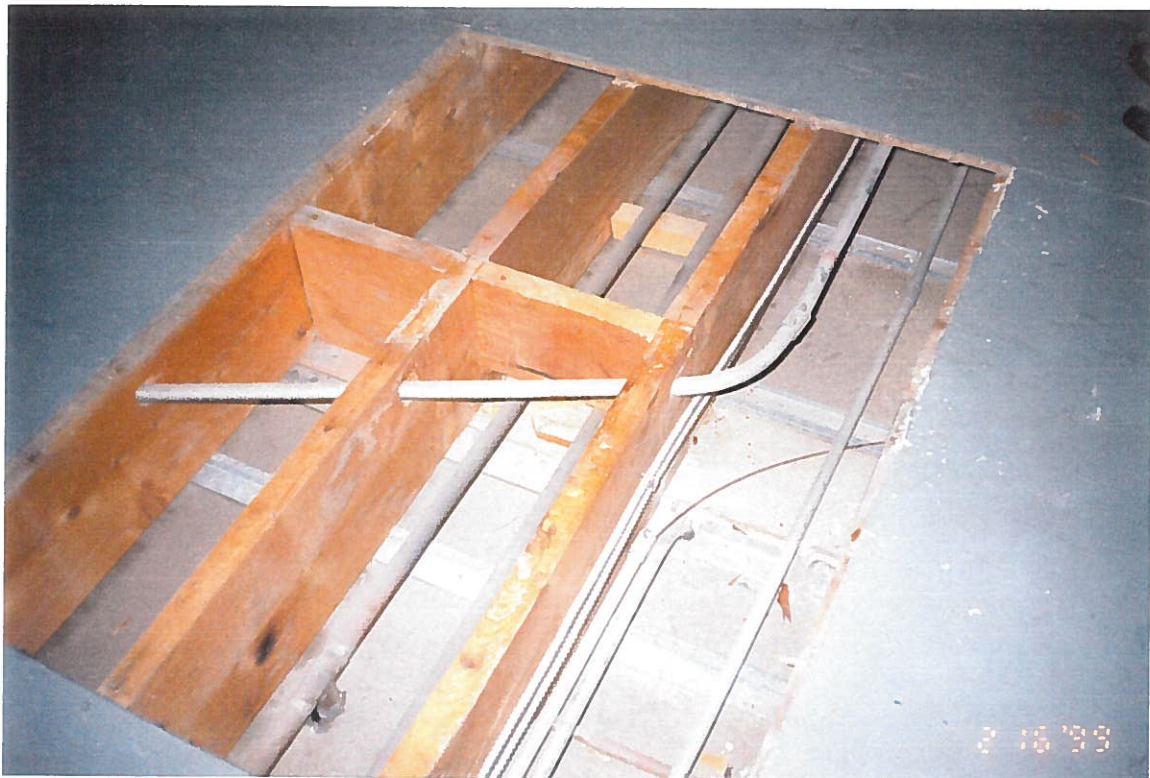
Plywood removed from mezzanine floor to view the framing for the mezzanine.
Ref. Section 2.2.4

- 2008
- .4 The mezzanine could be used as an exercise area providing additional steel framing is installed to support the wood joists where the spans exceed 12' - 0". The steel framing would be installed between the concrete block walls perpendicular to the spans of the wood joists. This is a Priority 3 recommendation with a cost estimate in the order of **\$10,000 to \$20,000**.

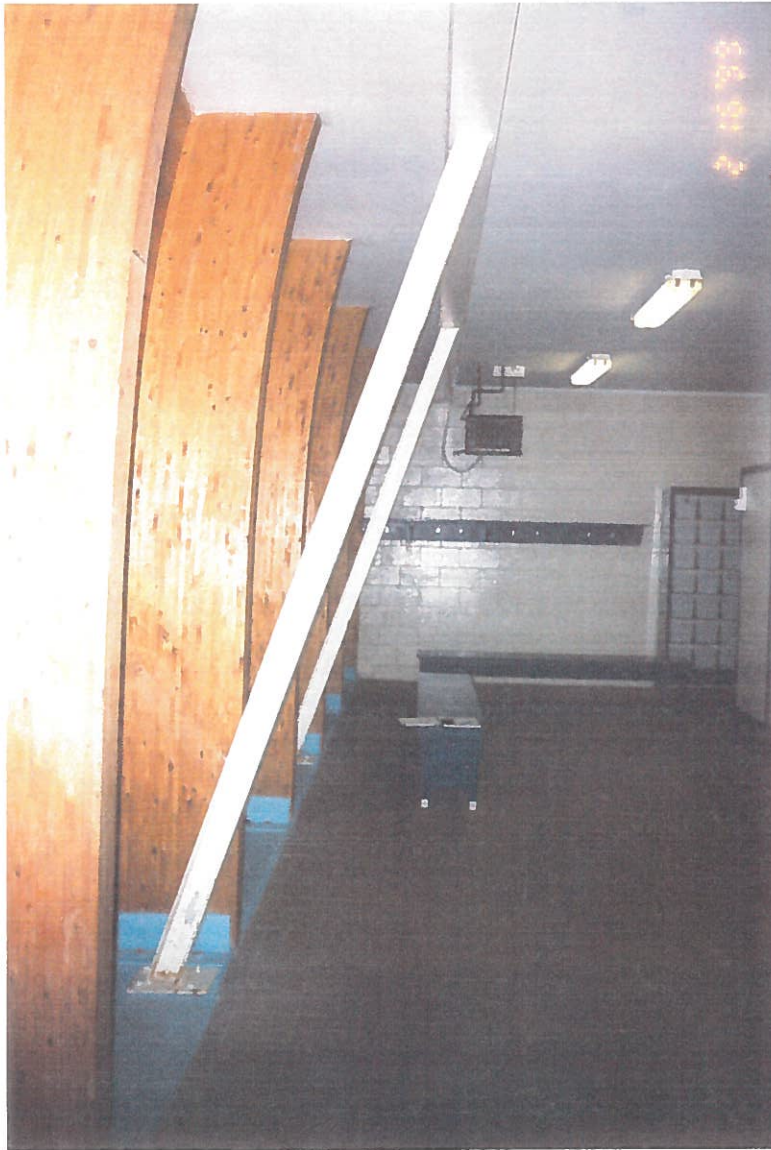
Steel columns under steel beam at the east and west sides of the mezzanine.
Ref. Section 2.2.4

- repair
1999
additional
2006
- .3 The steel columns at the east and west sides of the mezzanine do not provide adequate support for the steel beam. Additional steel framing should be installed which frames between the first interior block wall and the glulam arches. This is a Priority 1 recommendation with a cost estimate of **\$8,500**.

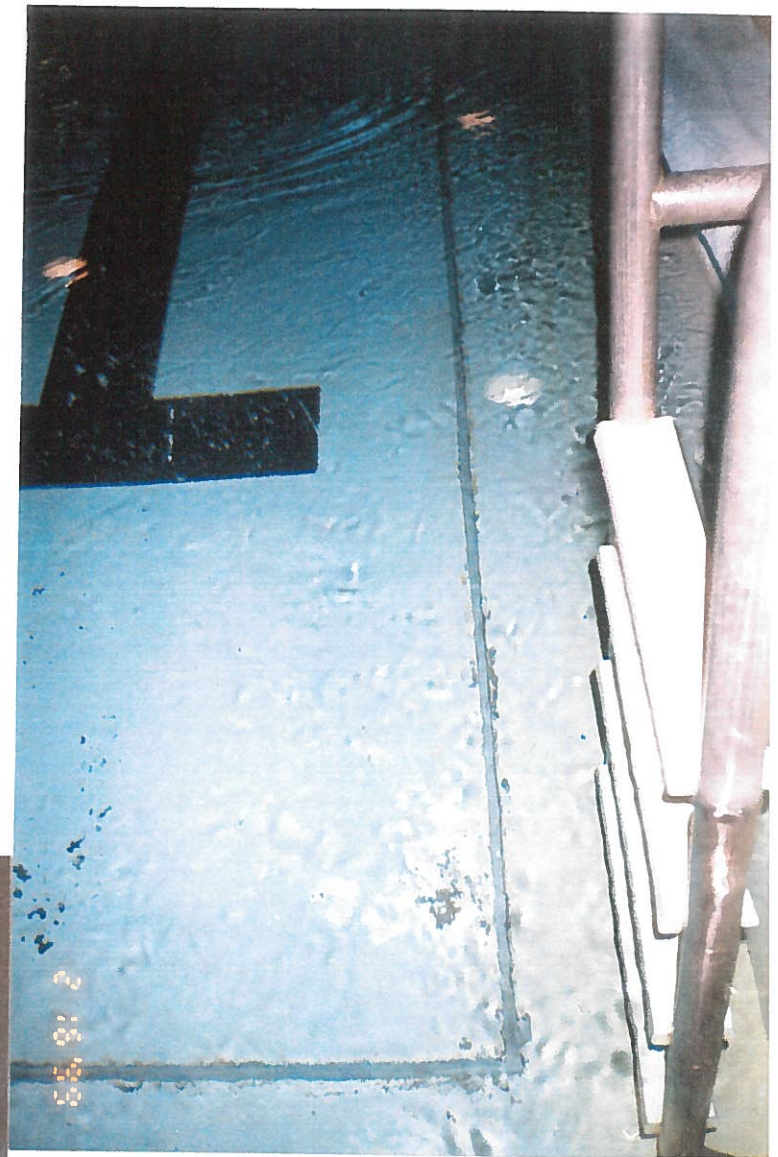
The pool was full of water during this building audit. As reported by the maintenance manager for the pool the construction joints in the pool were recently sealed over the few weeks prior to the audit. At that time only selected areas were sealed. Prior to sealing the joints, water was leaking from the pool reportedly at a rate of approximately 2,000 gallons per day. Since the joints were sealed there has been still considerable water lost from the pool in the order of 1,000 to 2,000 gallons per day.

Pool construction joint
in shallow end.
Ref. Section 2.3.

- 2001
- .1 To prevent the leaking of the large volume of water from the pool on a daily basis the pool should be drained and all cracks and the construction joints repaired. The concrete cracks should be routed and an epoxy paste installed to permanently seal the cracks. The existing sealant should be removed from the construction joints and the joints filled with a properly installed two component sealant. This is considered a Priority 2 recommendation with a cost estimate of **\$15,000** and will have a maintenance cost of approximately \$5,000 every ten (10) years.

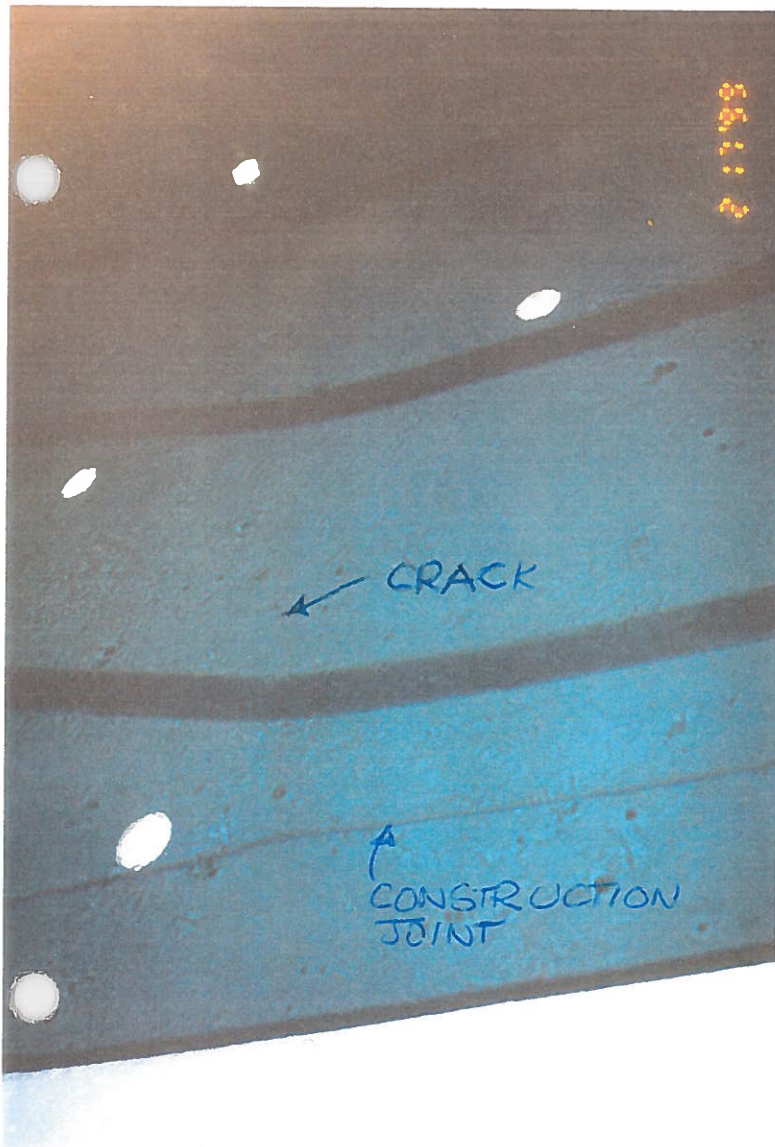
The crack in the bottom concrete slab located in the deep end and as indicated in the photograph included in Appendix B as well as the construction joint in the bottom slab of the pool, are most likely the main sources of the leaks in the pool. From the volume of water lost per day there does not appear to be a waterstop installed in the construction joint between the two adjacent concrete surfaces, therefore the sealant is the main means of

retaining water in the pool. Sealant may deteriorate over time in a submerged condition and should not be used as the only means of retaining water in the pool.

Although there is no evidence of any detrimental effects from this loss of water on a daily basis the leaks in the pool should be repaired. The soils report prepared in 1991 by Jacques Whitford and Associates indicated the site was built up with a sandy silt fill which could be very susceptible to erosion by this volume of water leaking from the pool.

Pool construction joint in deep end.
Note crack in the deep end of the pool.
Ref. Section 2.3

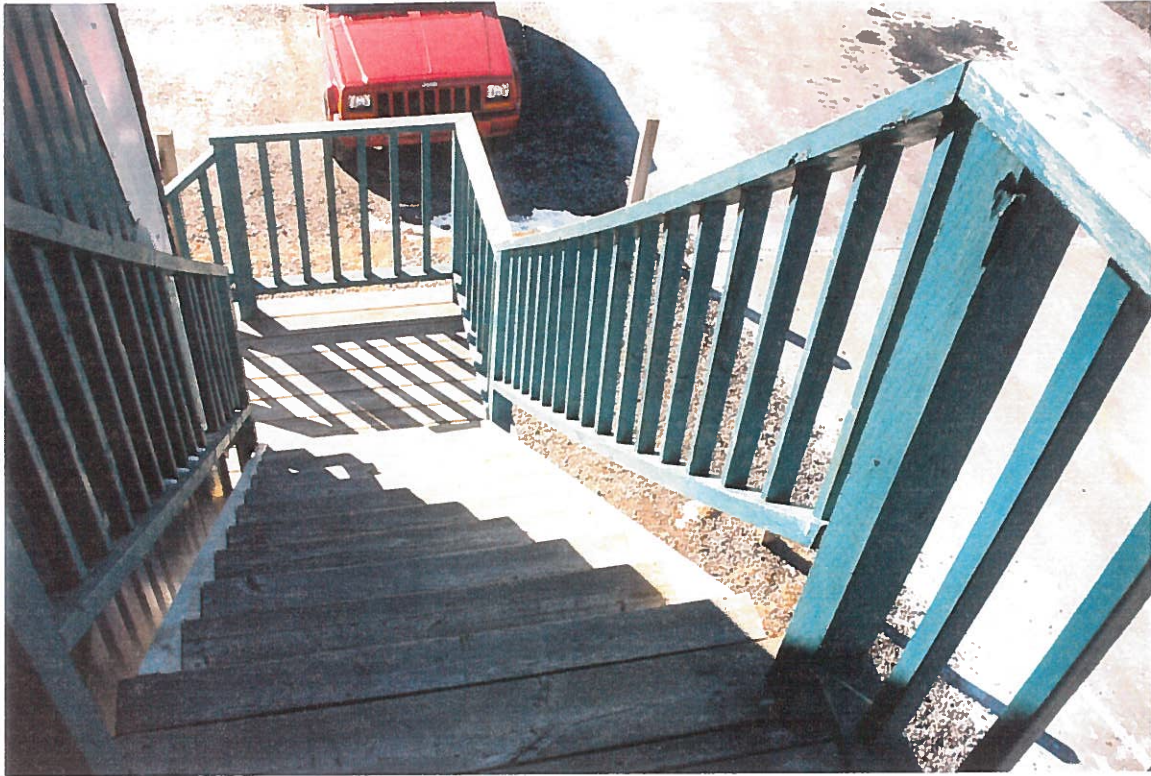
The mezzanine emergency exit stairs have openings in excess of 100 mm in balustrades, and between the stair treads. Upgrading of existing facilities which were presumably installed prior to this requirement for openings not to exceed 100 mm is not obligatory, but is advisable in public facilities. There is also some concern for the structural adequacy of the upper stair railing, which are presently supported only from the top and intermediate landings. These deficiencies could contribute to an accident particularly if unsupervised children were using the stair (Ref. NBCC Sections 3.4.7.6(4)).

Stair and rails with excessively large openings.
Ref. Section 2.3.5

- 1999 .1 Improve stair such that openings in rails, and risers are less than 100 mm, and upper stair rails are better supported. This is a Priority 1 recommendation with a cost estimate of **\$1,000.**

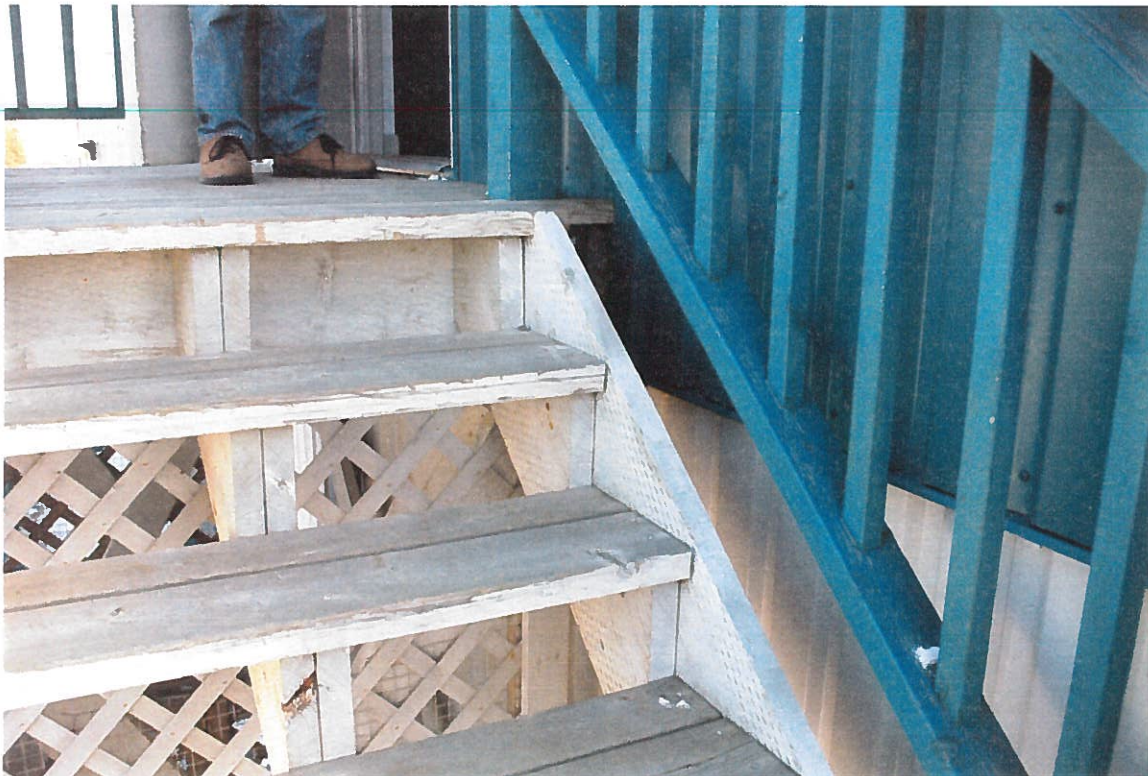
Stair and rails with excessively large openings.
Ref. Section 2.3.5

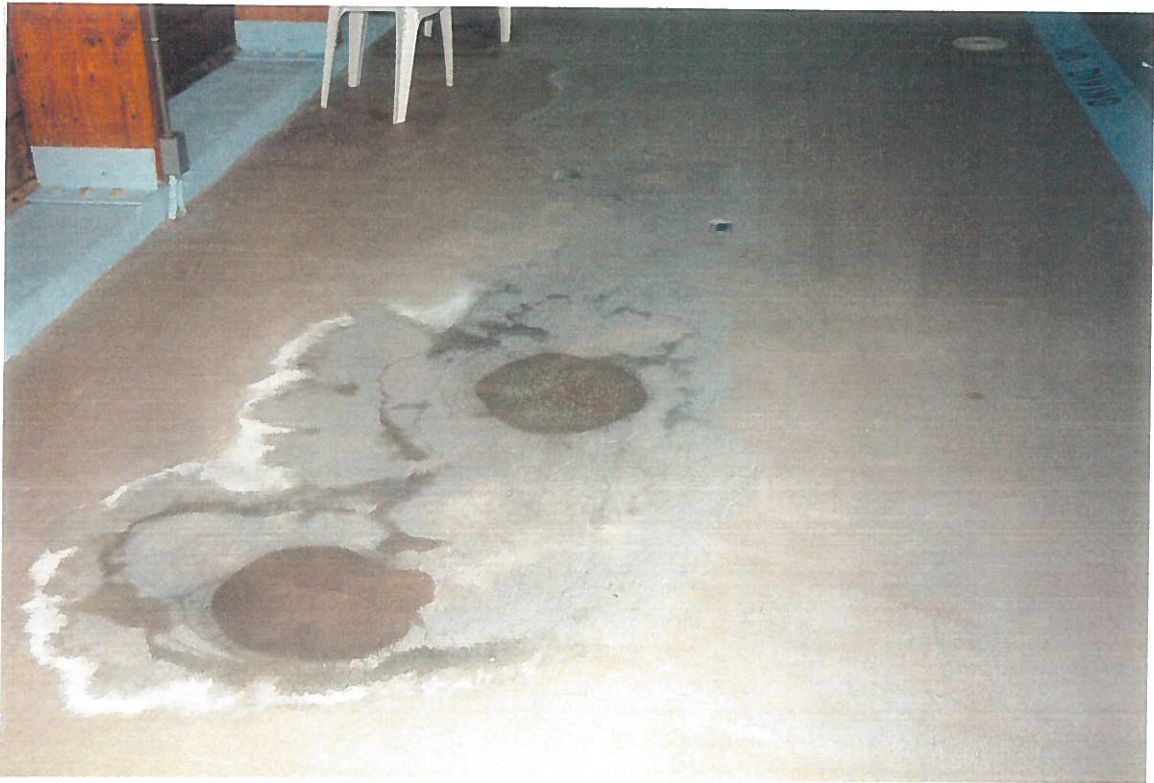
All ceramic tile finishes are in good condition, however, where they have been overcoated with Miradur in shower areas, the coating has discoloured due to constant long term wetting from dripping showerheads, standing water, etc. A replacement non-skid tile should be considered, primarily as a cosmetic improvement.

Miradur floor finish discolouration.
Ref. Section 2.4.1

- ✓ .1 Replace shower area floor tile. This is a Priority 3 recommendation with a cost estimate of \$2,000. 2002
- .2 Improve grading and refinish Miradur pool deck or install ceramic tile on the pool deck. This is a Priority 3 recommendation with a cost estimate of \$10,000 or \$22,000. 2001

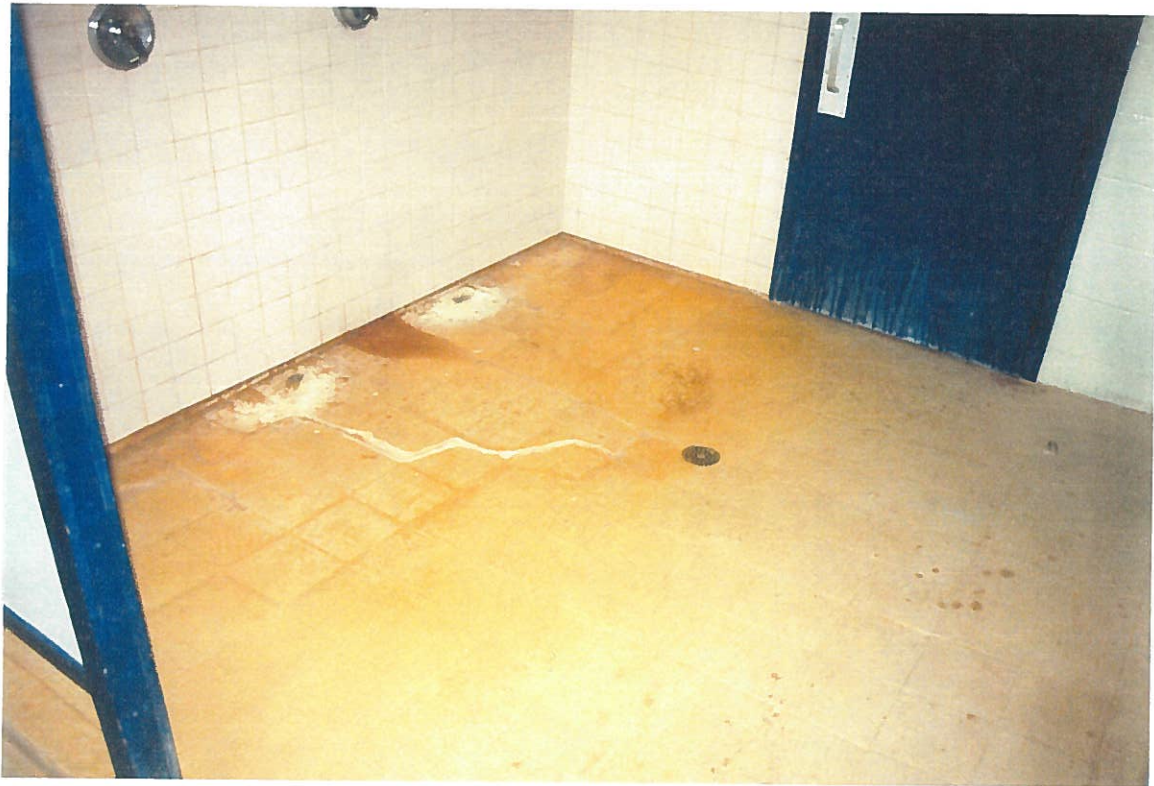
Miradur floor finish discolouration.
Ref. Section 2.4.1

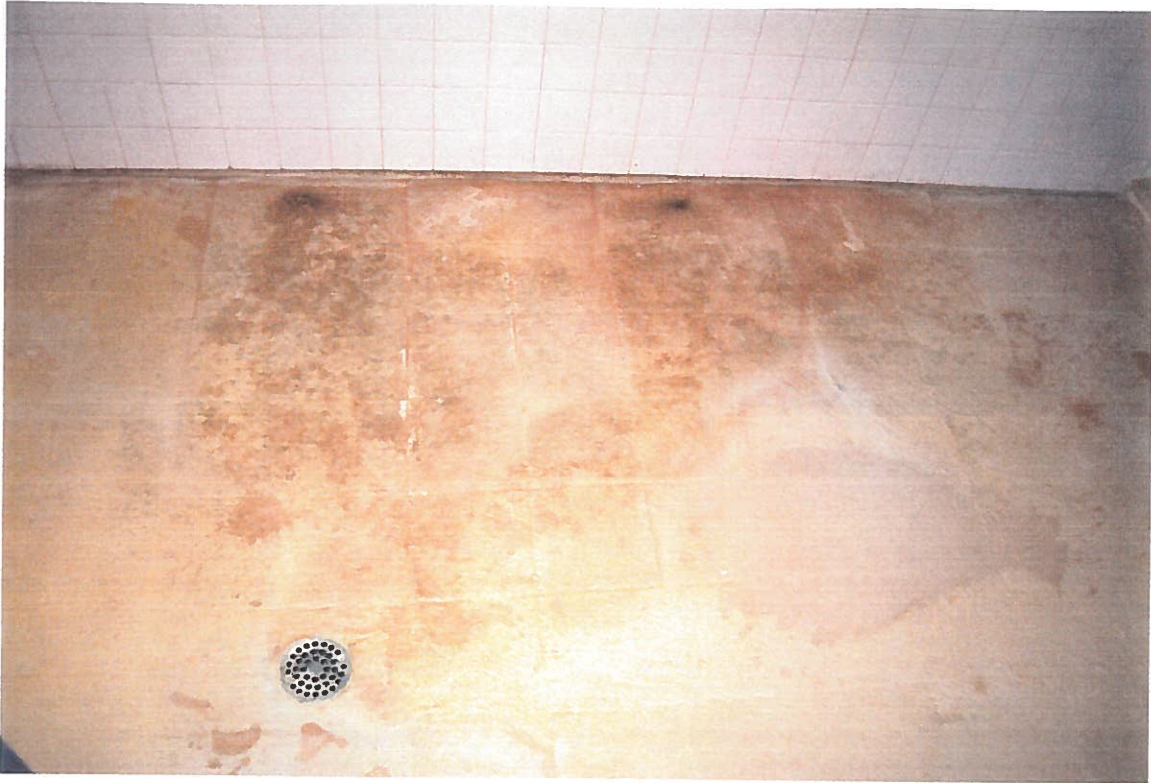
Miradur floor finish discolouration.
Ref. Section 2.4.1

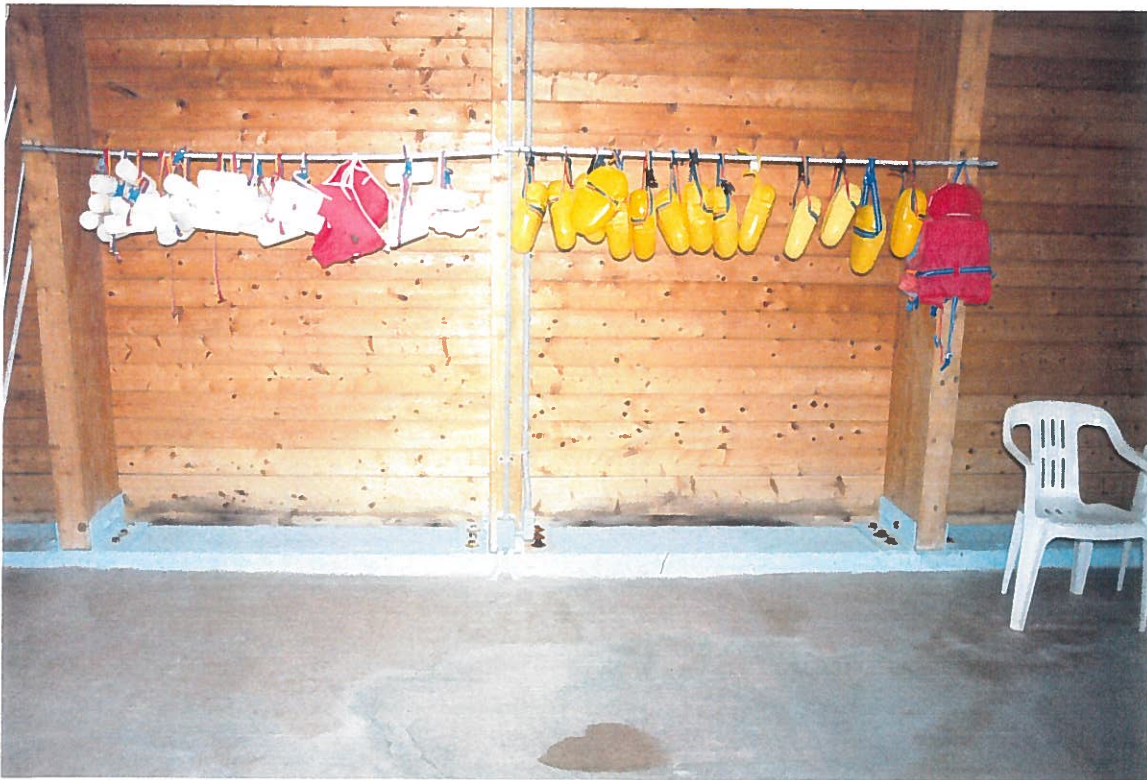
All interior wall surfaces were found to be in good condition (most areas are painted concrete block). The clear finished wood wall surface in the pool pavilion is beginning to show signs of deterioration due to constant wetting along the concrete foundation ledge where the wood finish terminates. This condition should be addressed by refinishing and changing the detail where the wood meets the concrete ledge, so that the water can dissipate without resting against the wood wall cladding.

Wood wall finish deterioration and rust at steel fastenings.
Ref. Section 2.4.2

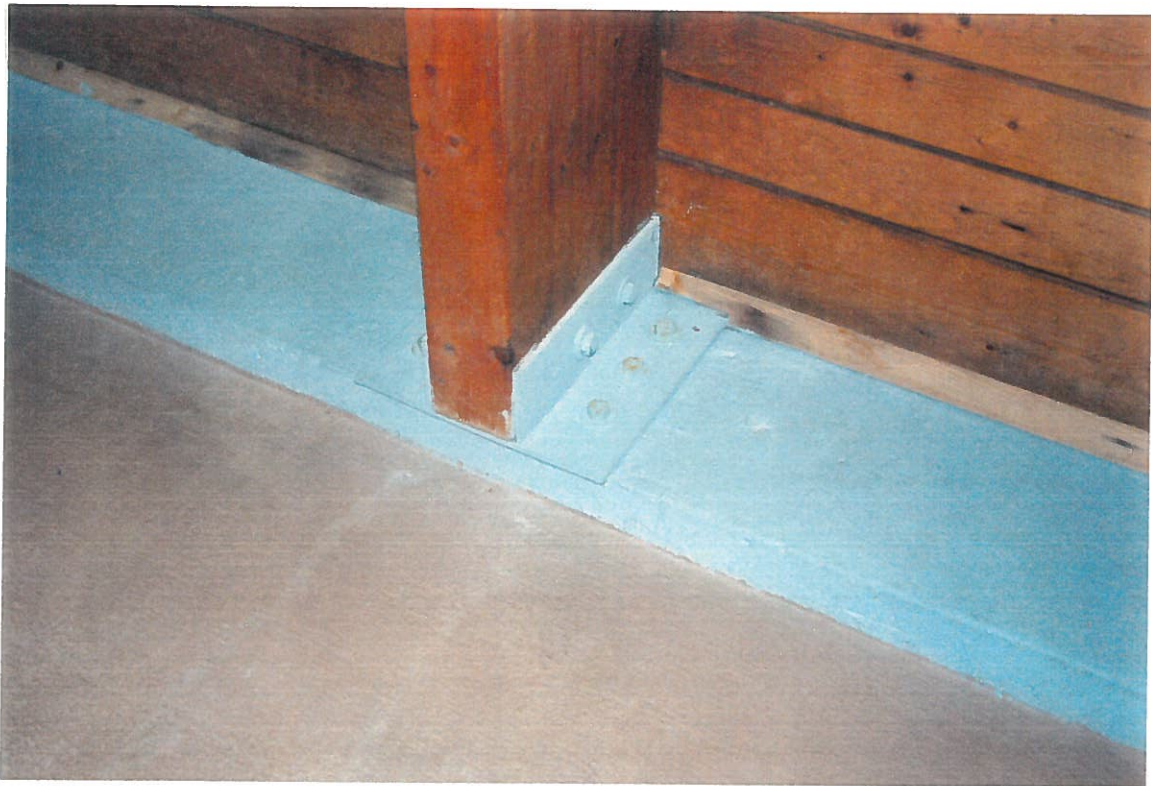
Wood wall finish deterioration and rust at steel fastenings.
Ref. Section 2.4.2

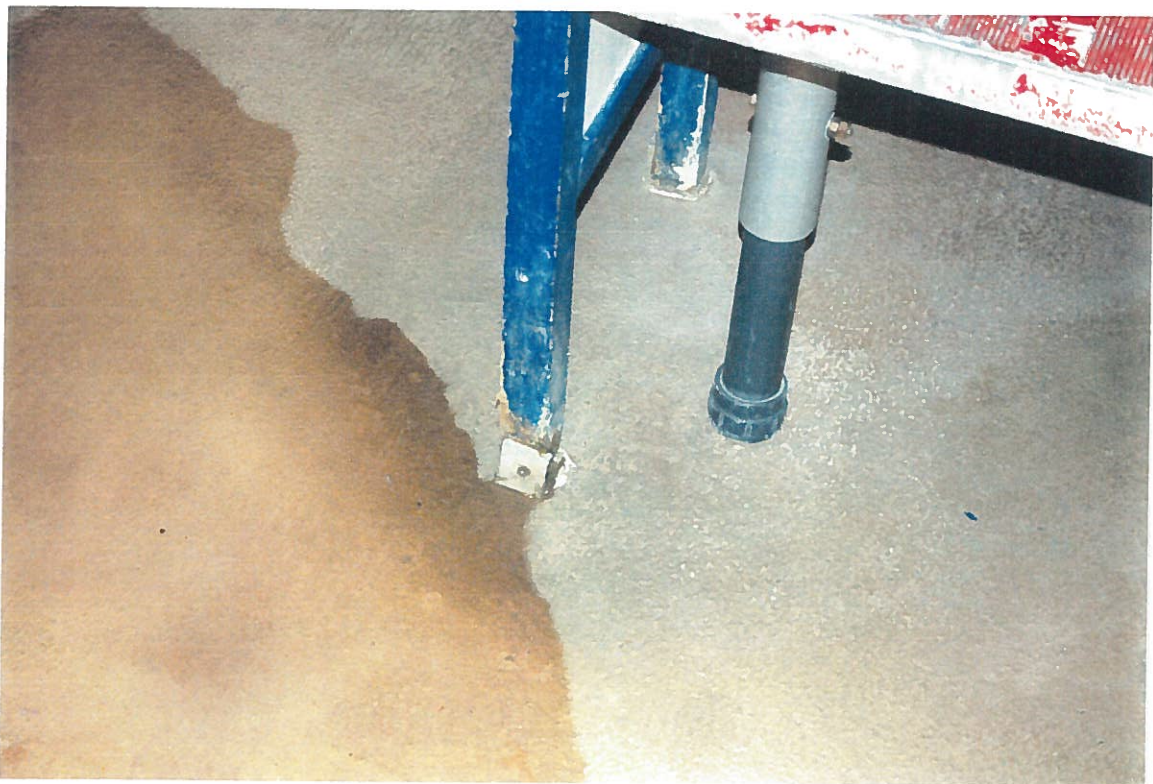
The privacy screens in change rooms and the pool pavilion have begun to deteriorate due to constant contact with the wet floor. They would also benefit by upgrading of hardware (change room/toilet and dressing cubicles).

Deterioration of privacy screen leg due to wet environment.
Ref. Section 2.4.2

- Reserve .1 Establish a reserve fund to cover interior painting of the wall surfaces. This should include an annual maintenance allowance of **\$1,000** per year.
- 2001 .2 Repair and upgrade privacy screens and cubicle dividers. This is a Priority 3 recommendation with a cost estimate of **\$2,000**.
- 2000 .3 Refinish the pool exterior wall and change the detail at the wall and foundation connection. This is a Priority 2 recommendation with a cost estimate of **\$5,000**.
- 2001 .4 Provide tile base in the vestibule. This is a Priority 3 recommendation with a cost estimate of **\$100**.

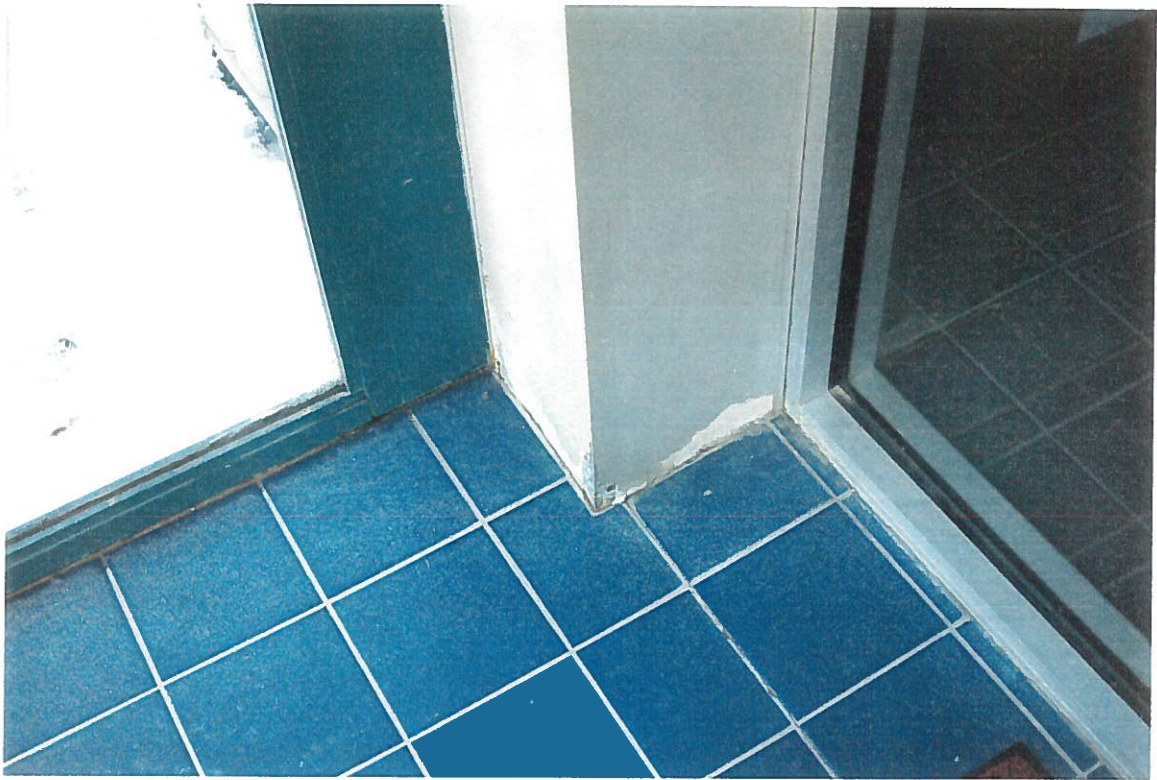
Tile base required.
Ref. Section 2.4.2

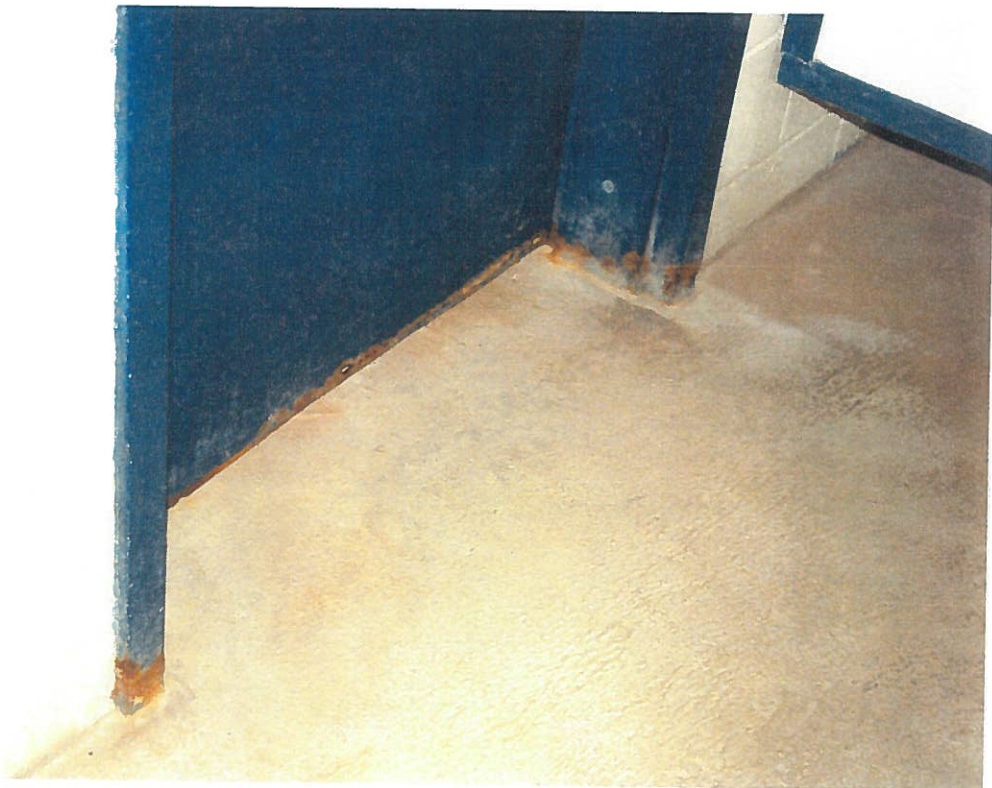
The interior doors are generally in good condition, however, the five doors and frames between the pool and the support spaces, similar to the fire exit at the far end, are showing signs of deterioration due to the constant wetting where the frame meets the floor. These units should be budgeted for replacement on a regular cycle.

Women's change room door and frame.
Ref. Section 2.4.3

- .1 Replace the pool to support space doors, frames and hardware, and all other interior door hardware, first in year two, and then on an eight year cycle. This is a Priority 2 recommendation with a cost estimate of \$7,000 per cycle.
2000
- ✓ .2 Provide a doorstep to the main stair upper door. This is a Priority 2 recommendation with a cost estimate of \$50.
2000

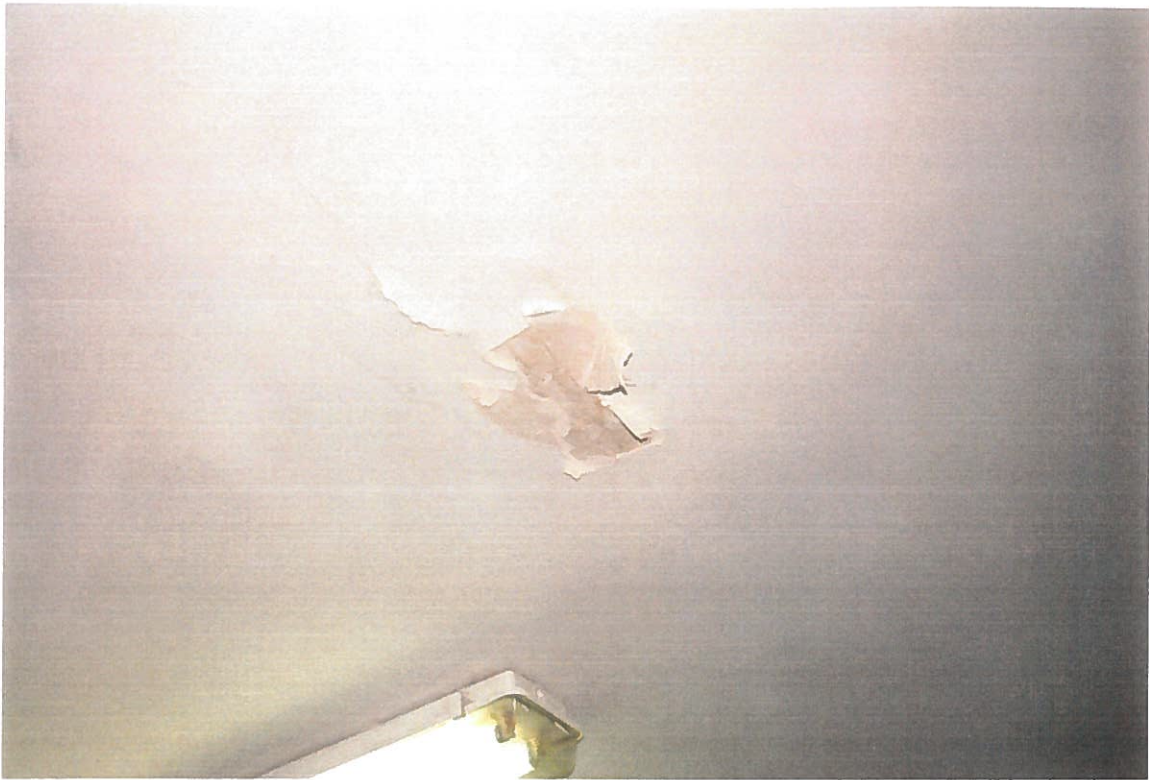
All of the ceilings were in good condition, however, there was one area of water damage in the women's change room, below the location where a servicing mast roof penetration has leaked. Repair of this leak at the roof is noted in the Electrical Section. Two other minor repairs, one in the stairwell and one in the lobby, are also necessary due to previous mechanical equipment leaks.

Water damage to ceiling at women's change room.
Ref. Section 2.4.4

- 2001 .1 Repair the damaged ceilings. This is a Priority 3 recommendation with a cost estimate of \$500.

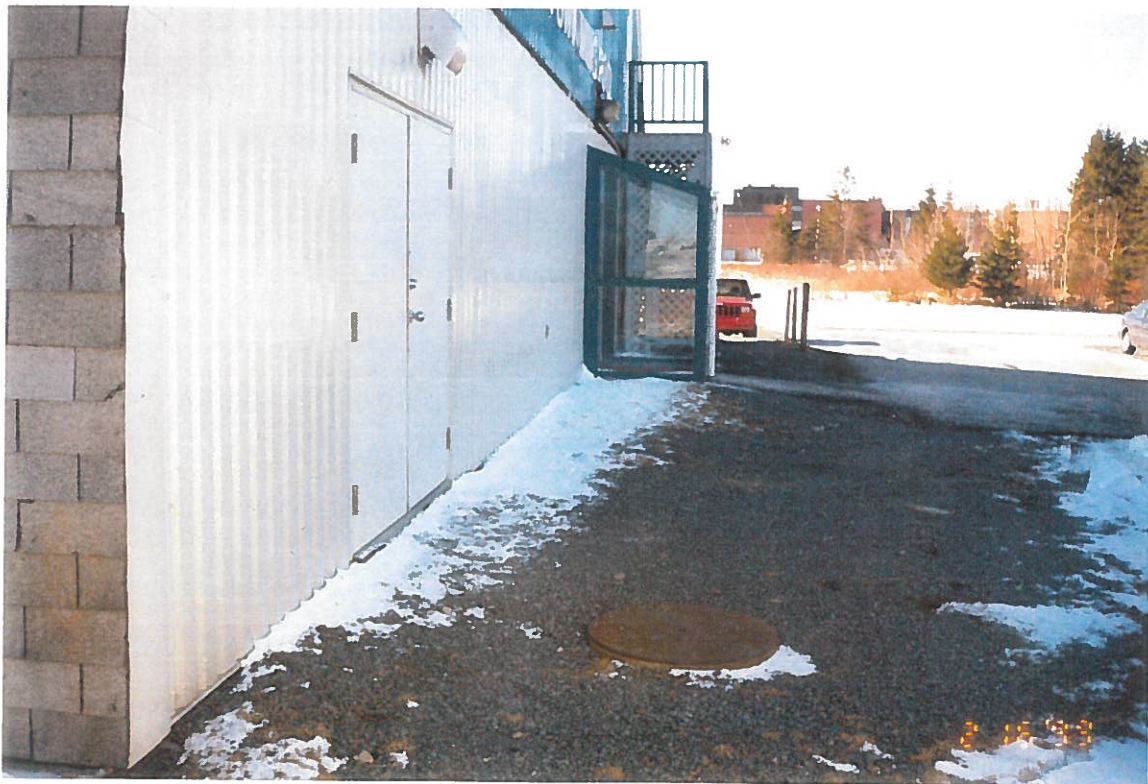
Excessive cross slope on paved area outside vestibule.
Ref. Section 2.5

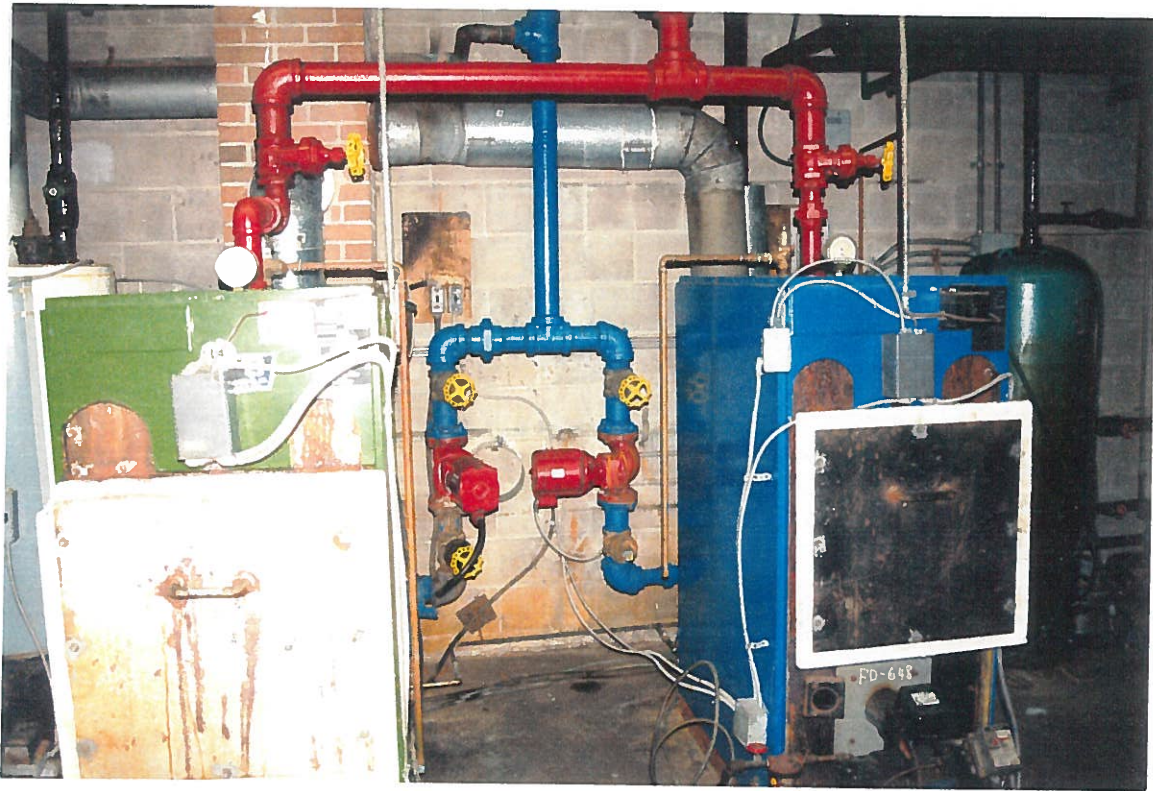
Space heating is provided by hydronic heating appliances supplied by two oil fired hot water boilers. These appliances consist of horizontal unit heaters and duct mounted heating coils. Equipment is in fair condition but the chimney is undersized.

Existing chimney showing three connected appliances.
Ref. Section 2.6.1

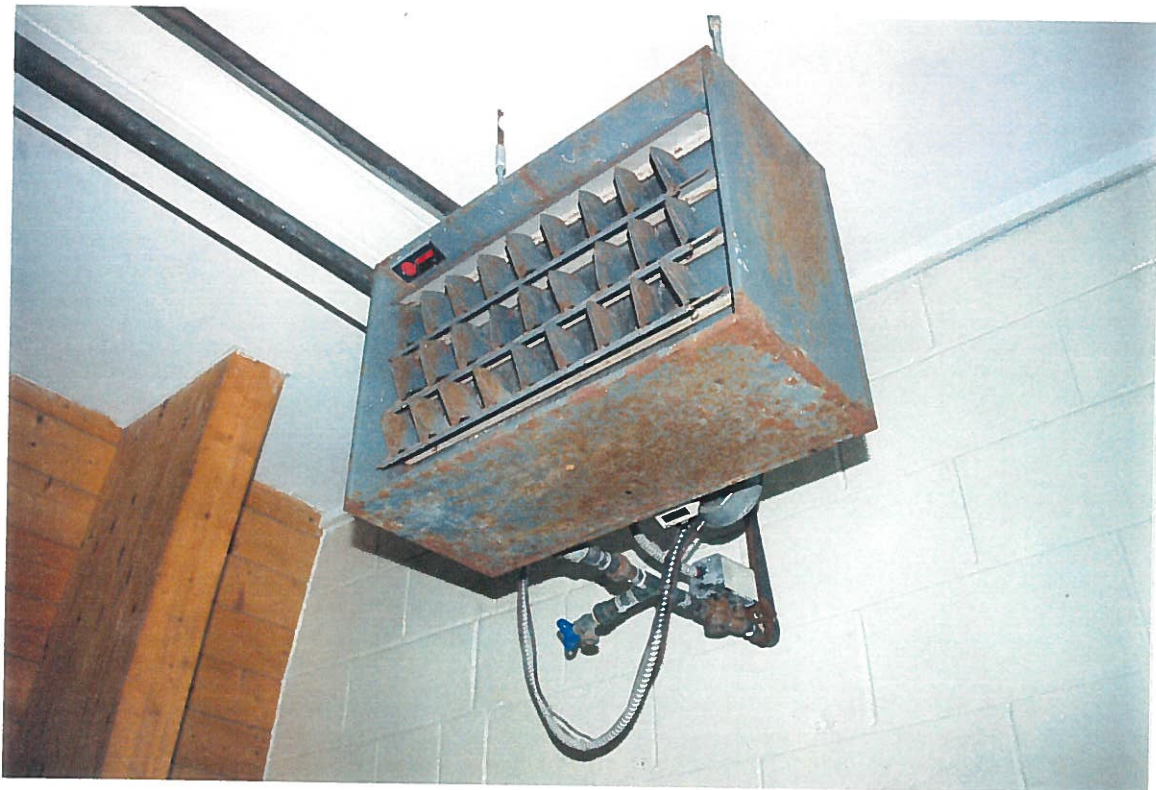
Existing corroded unit heater in locker room..
Ref. Section 2.6.1

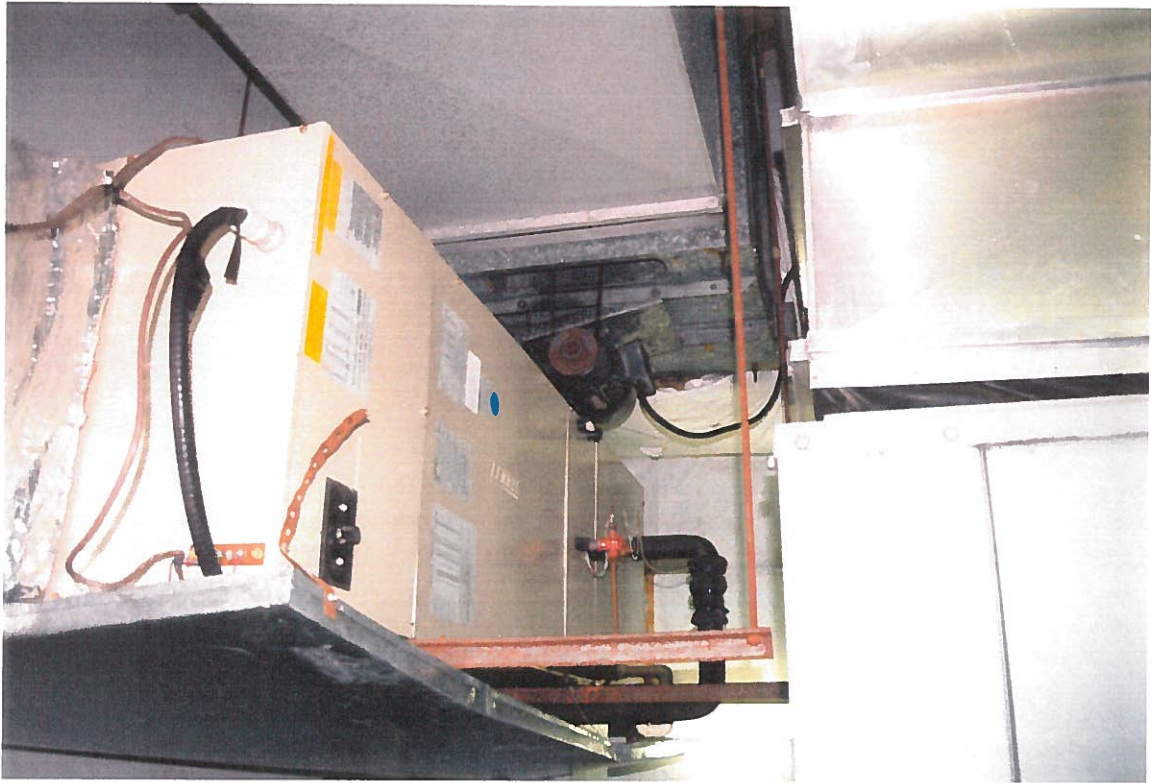
Existing A.C. unit serving mezzanine area. Note drain pan.
Ref. Section 2.6.2
