EAST HANTS MUNICIPALITY

EAST HANTS MUNICIPAL SWIMMING POOL

AUDIT AND LIFE CYCLE PLAN

FINAL REPORT

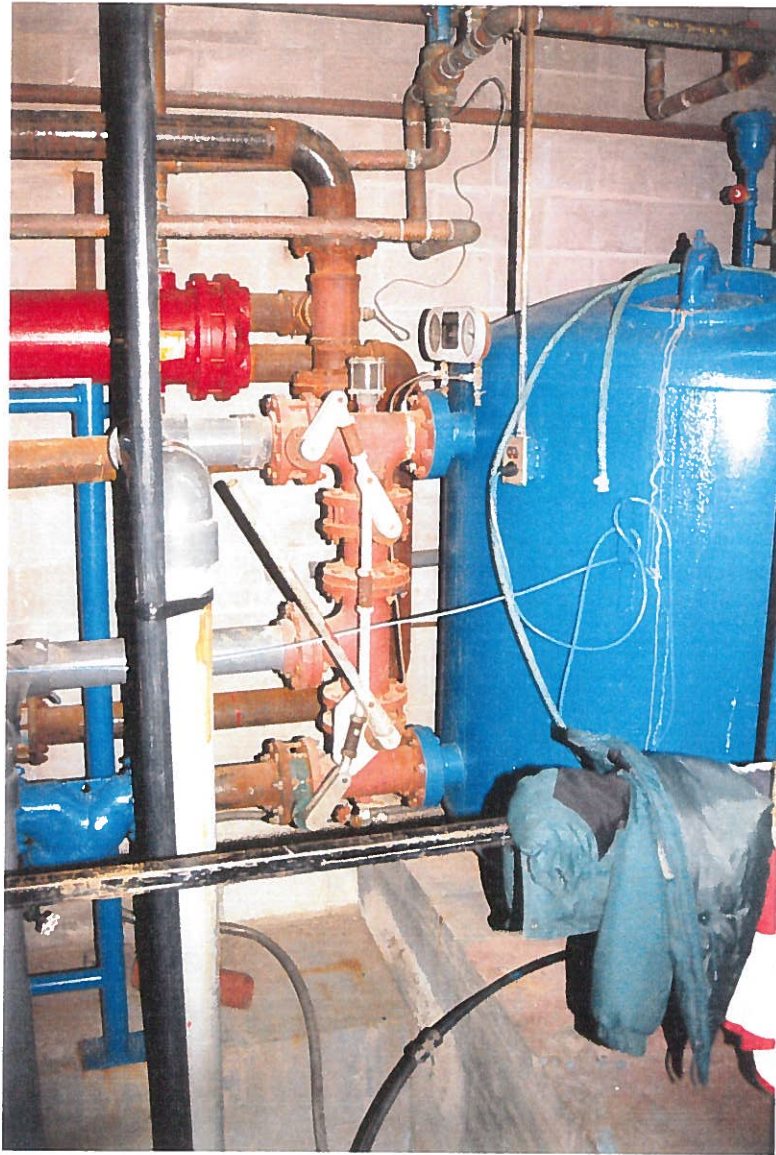
Plumbing equipment and systems are in fair condition. Pool filtration equipment is in fair condition but much of the ferrous piping and fittings may be badly corroded and in need of replacement.

Existing ferrous pool water piping and valves.
Ref. Section 2.6.4

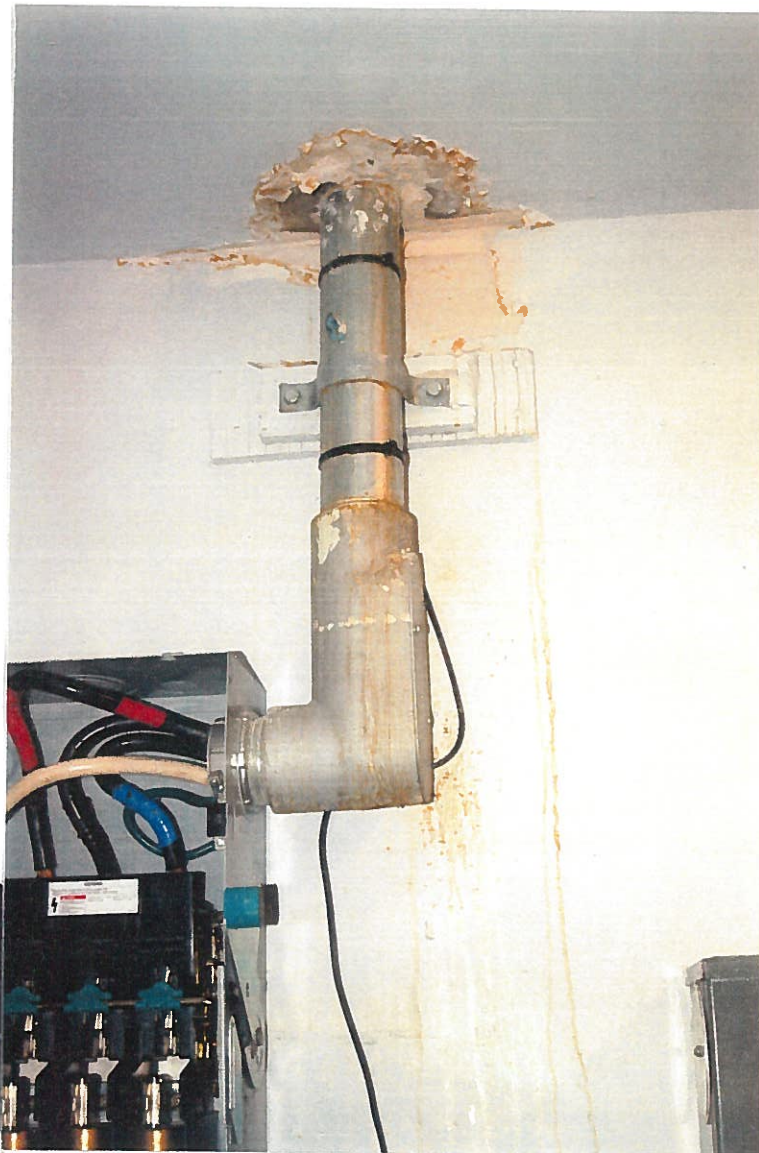
Water damage/main electrical.
Ref. Section 2.7.1

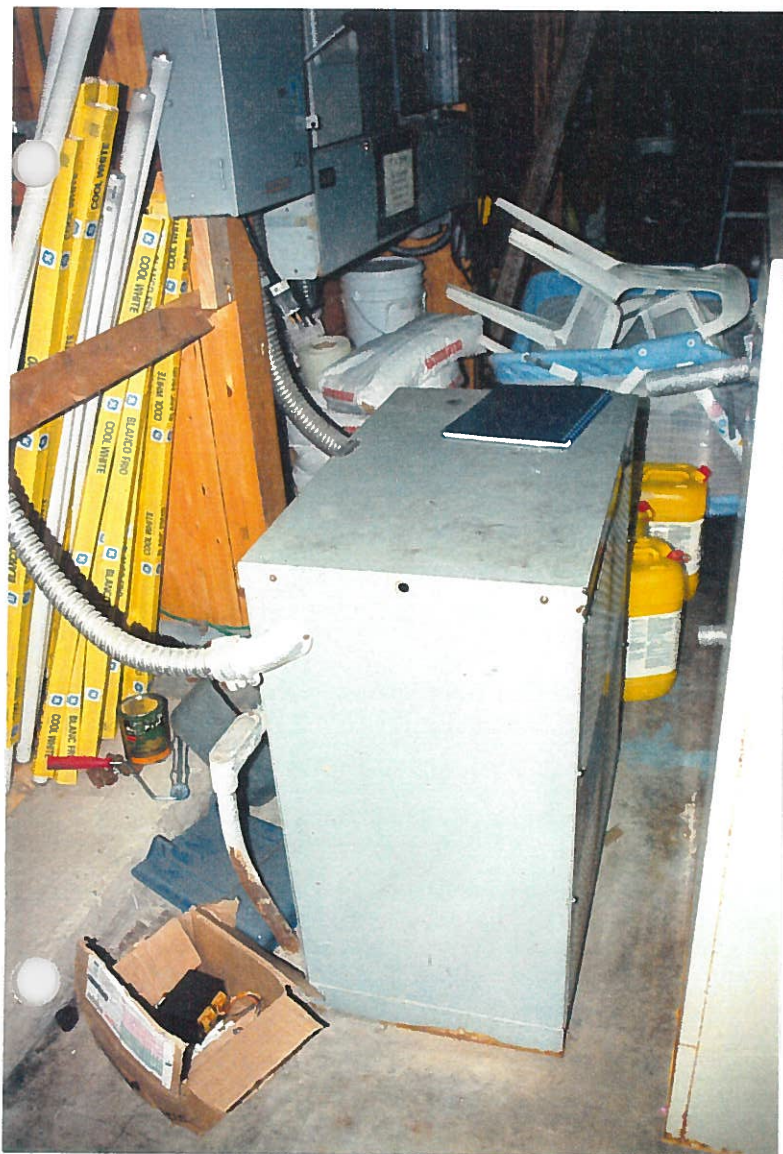
Lower mechanical room
electrical equipment.
Ref. Section 2.7.2

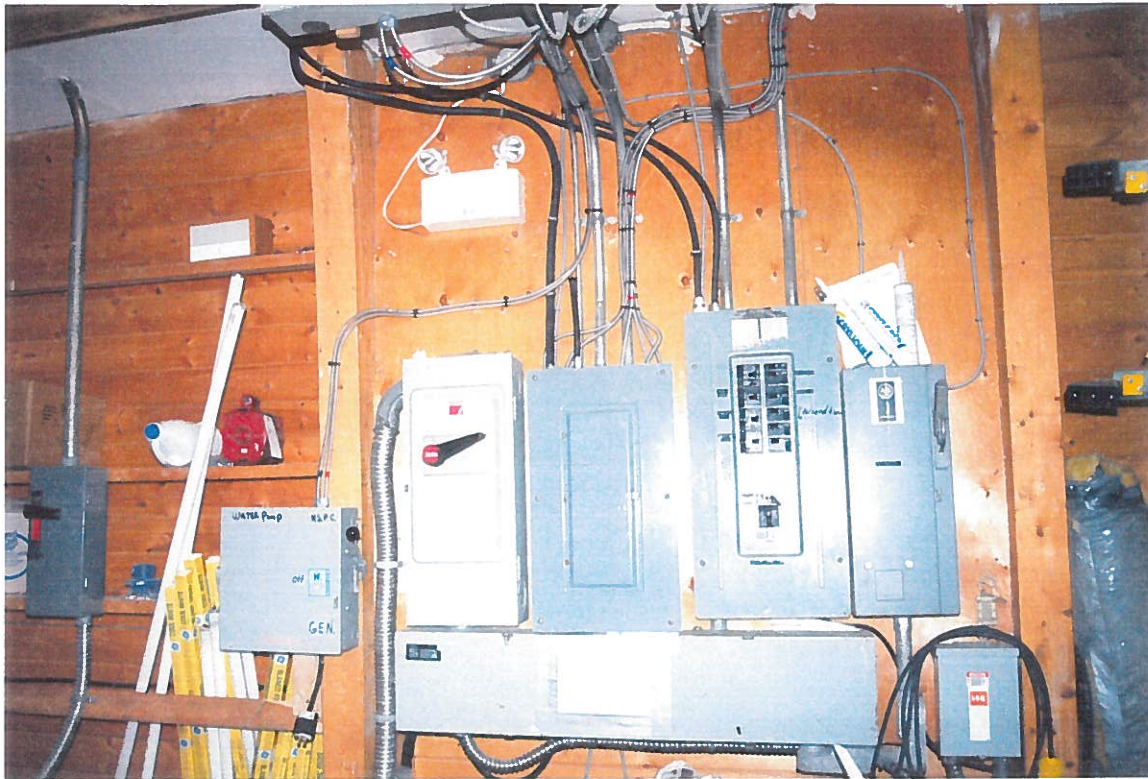
Unmarked electrical equipment in lower mechanical room.
Ref. Section 2.7.2

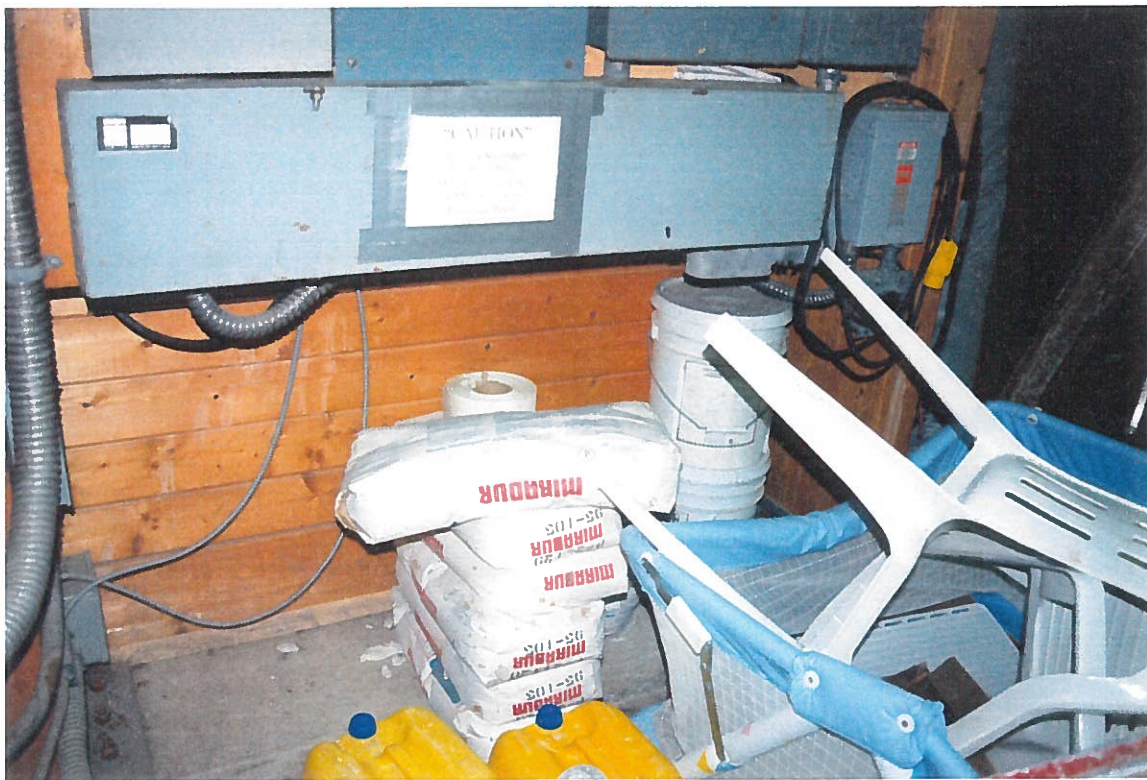
Lower mechanical room storage area.
Ref. Section 2.7.2
