**Roof Inspection Report  
East Hants Swimming Pool  
Milford, N.S.**

# Roof Inspection Report

Roof 1 Consultant: Roger Prime RRO  
Client: Municipality of East Hants  
Roof 1 Project No.: A14441  
Purpose: Condition Inspection  
General Contractor: N/A  
Roofing Contractor: N/A

Date of Report: October 16, 2014

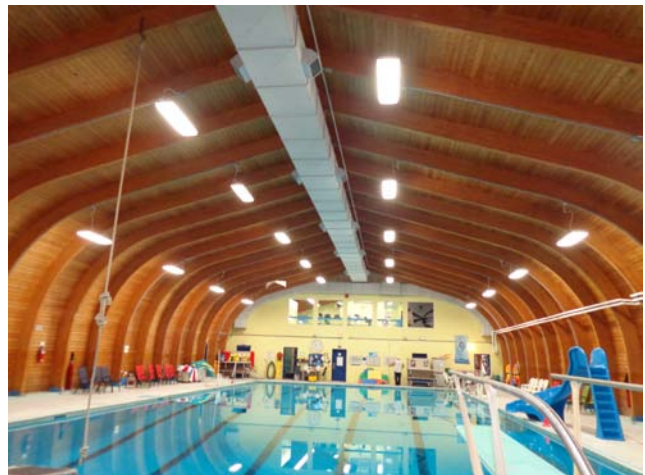
Photo 5

Interior view showing glue-lam beams and tongue and groove decking. The decking appears to be in good condition from the underside.

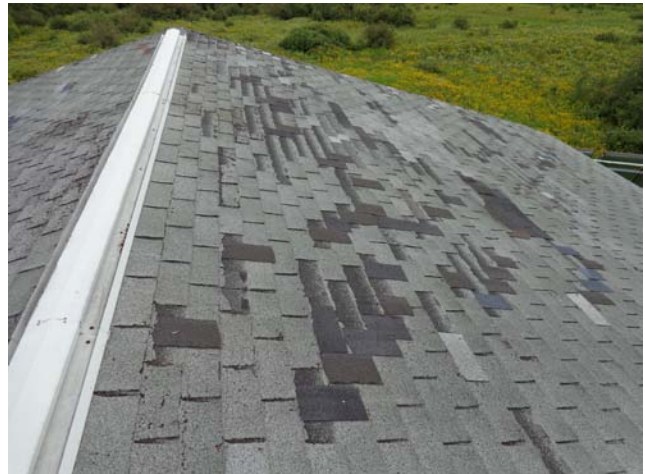
Photo 6

24 ft. x 24 ft. area at right rear where the sheathing is soft and appears to be deteriorated.

The asphalt shingle roof system on this building is in generally poor condition. In particular an area approximately 48 ft. wide x 24 ft. long at the rear appears to have some deteriorated plywood sheathing and possibly damaged insulation and wood strapping.

- 1) Completely replace the approximately 48 ft. x 24 ft. and 10 ft. x 10 ft. areas where the plywood sheathing appears to be deteriorated. This may include replacement of plywood sheathing, wood strapping, insulation and vapour retarder.
- 2) On the balance of the roof replace all missing, split or otherwise deteriorated shingles.
- 3) Replace any other deteriorated plywood sheathing including underlying components that may be encountered while replacing the shingles on the balance of the roof.
- 4) Repair the crack in the chimney cap.
- 5) Re-seal the roof flashing at the electrical mast.
- 6) Keep the intake vent at the bottom of the slope open to facilitate proper ventilation of the roof assembly.
- 7) Closely monitor the roof and replace any shingles that may blow off in the future as soon as practically feasible.

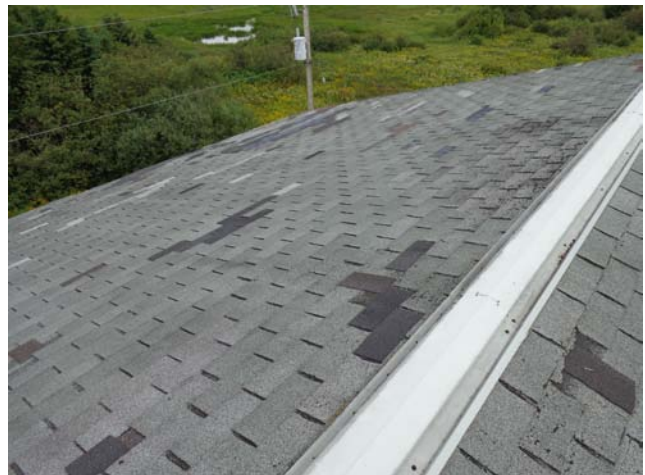
Photo 7

24 ft. x 24 ft. area at left rear where the sheathing is soft and appears to be deteriorated although not as bad as the right side.

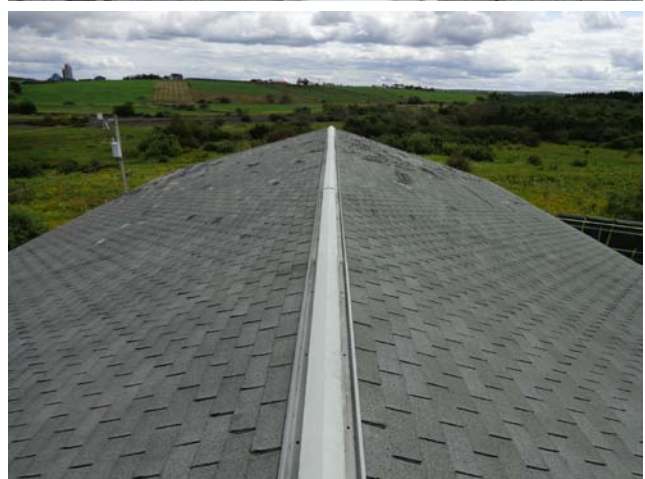
Photo 8

Overview of areas shown in Photos 6 and 7.

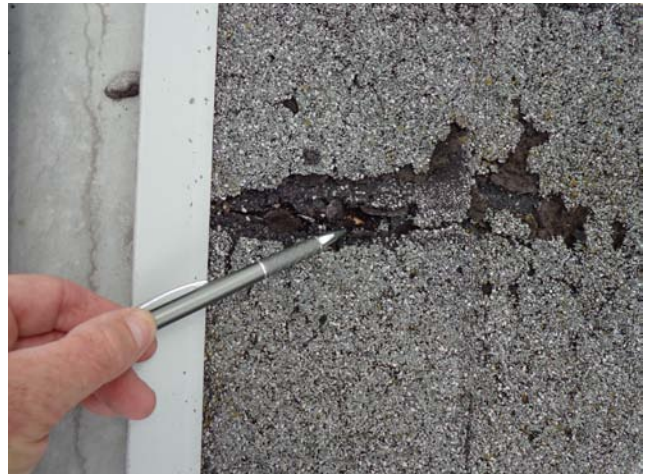
Photo 9

Typical shingle deterioration.  
The plywood sheathing is exposed at this location.

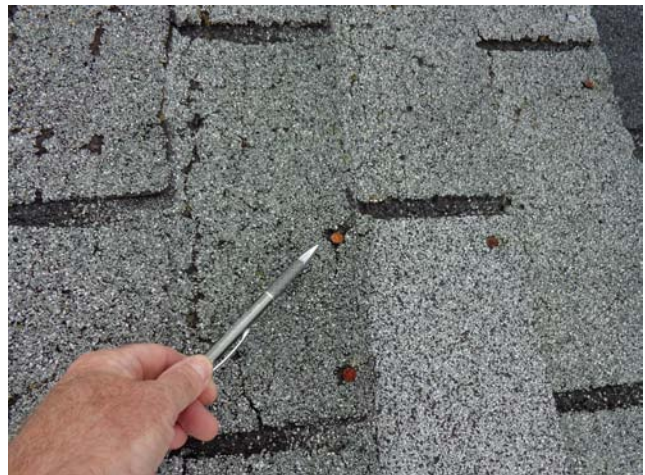
Photo 10

Typical shingle deterioration.  
Nails are protruding at this location.

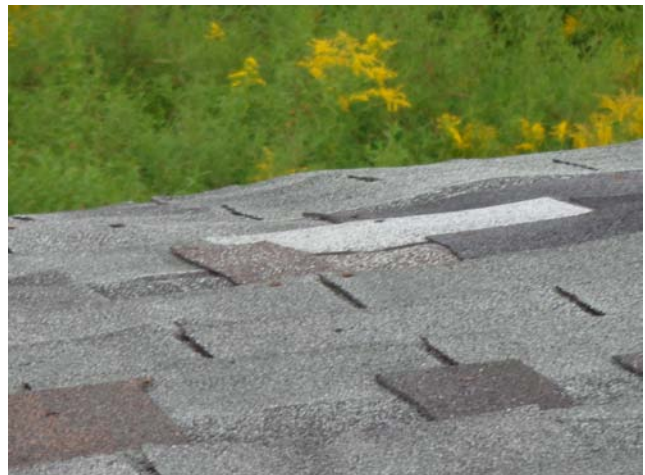
Photo 11

View of typical warped sheathing at distressed locations.

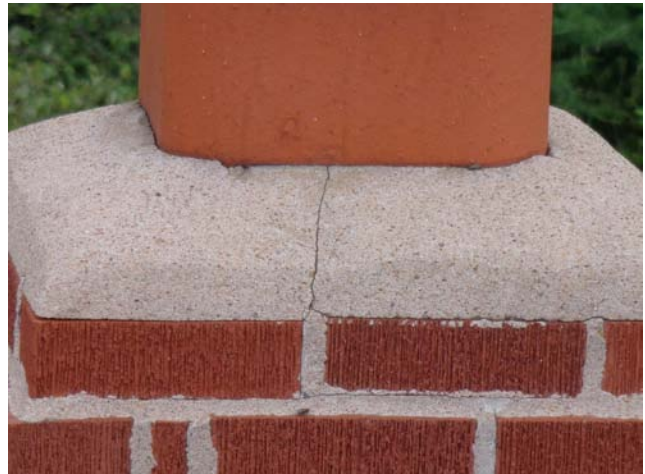
Photo 12

Crack observed in the chimney cap.

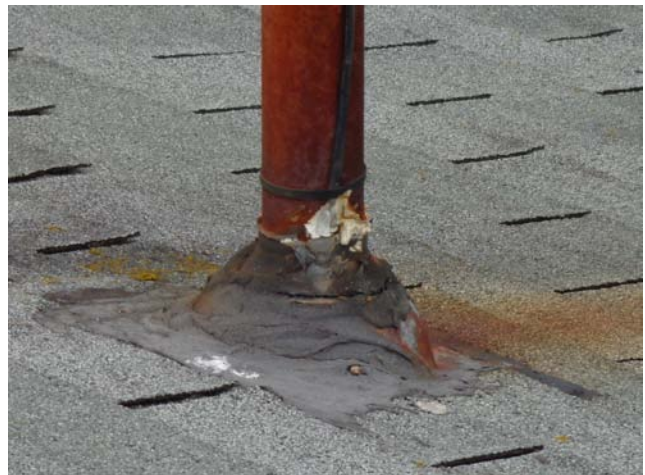
Photo 13

Sealant has dried out and split at the electrical mast roof flashing.

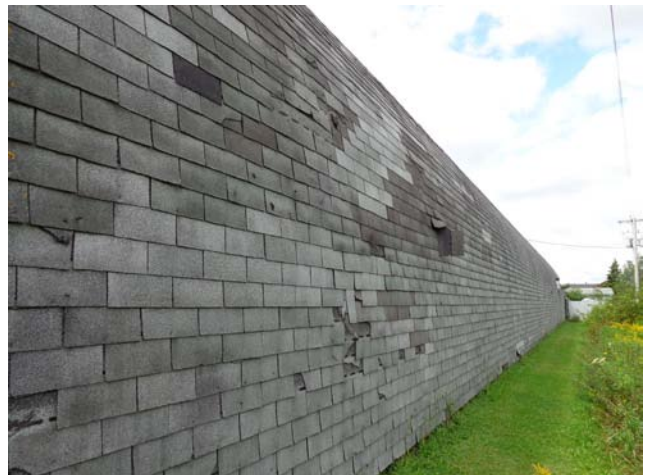
Photo 14

View of missing and damaged shingles on the left side of the building.

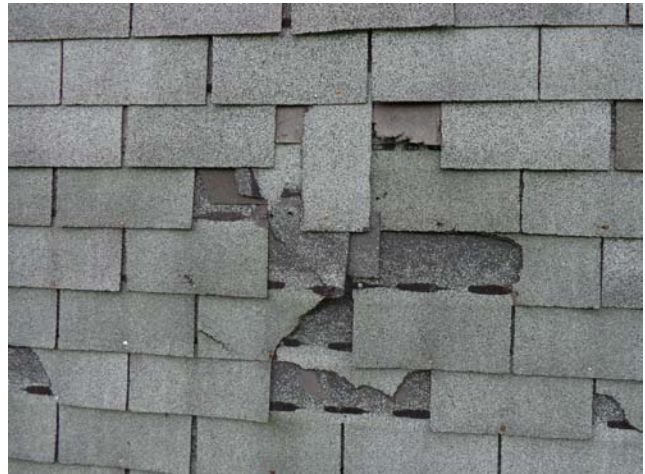
Photo 15

Location where bees were seen going under the shingles.

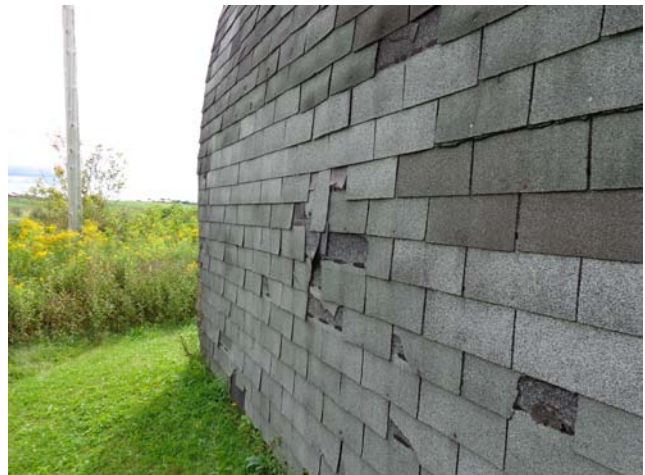
Photo 16

Overview of location where bees were seen going under the shingles.

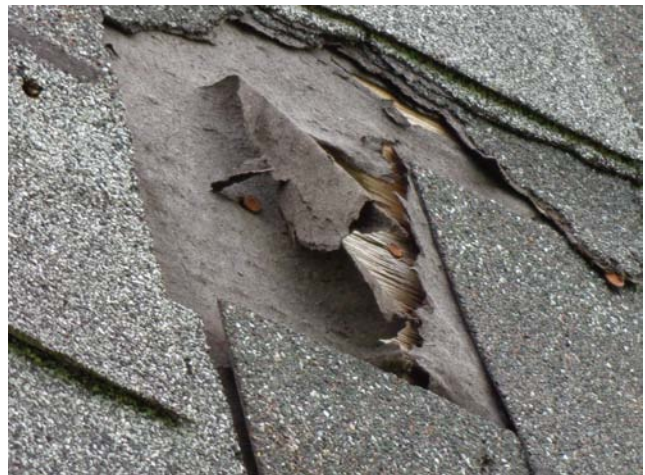
Photo 17

Typical shingle deterioration exposing the plywood sheathing to water intrusion.

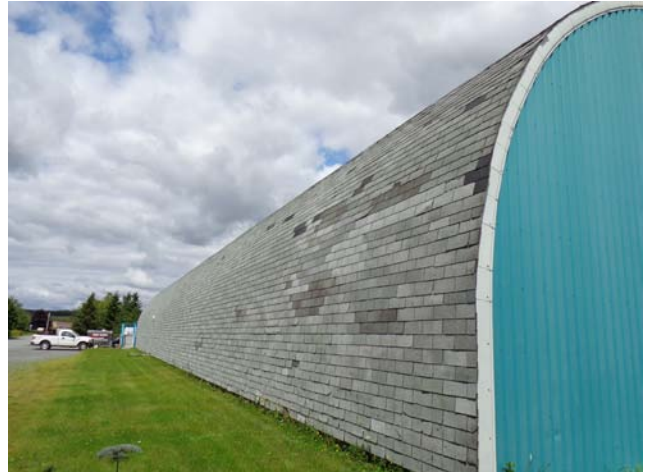
Photo 18

View of missing and damaged shingles on the right side of the building.

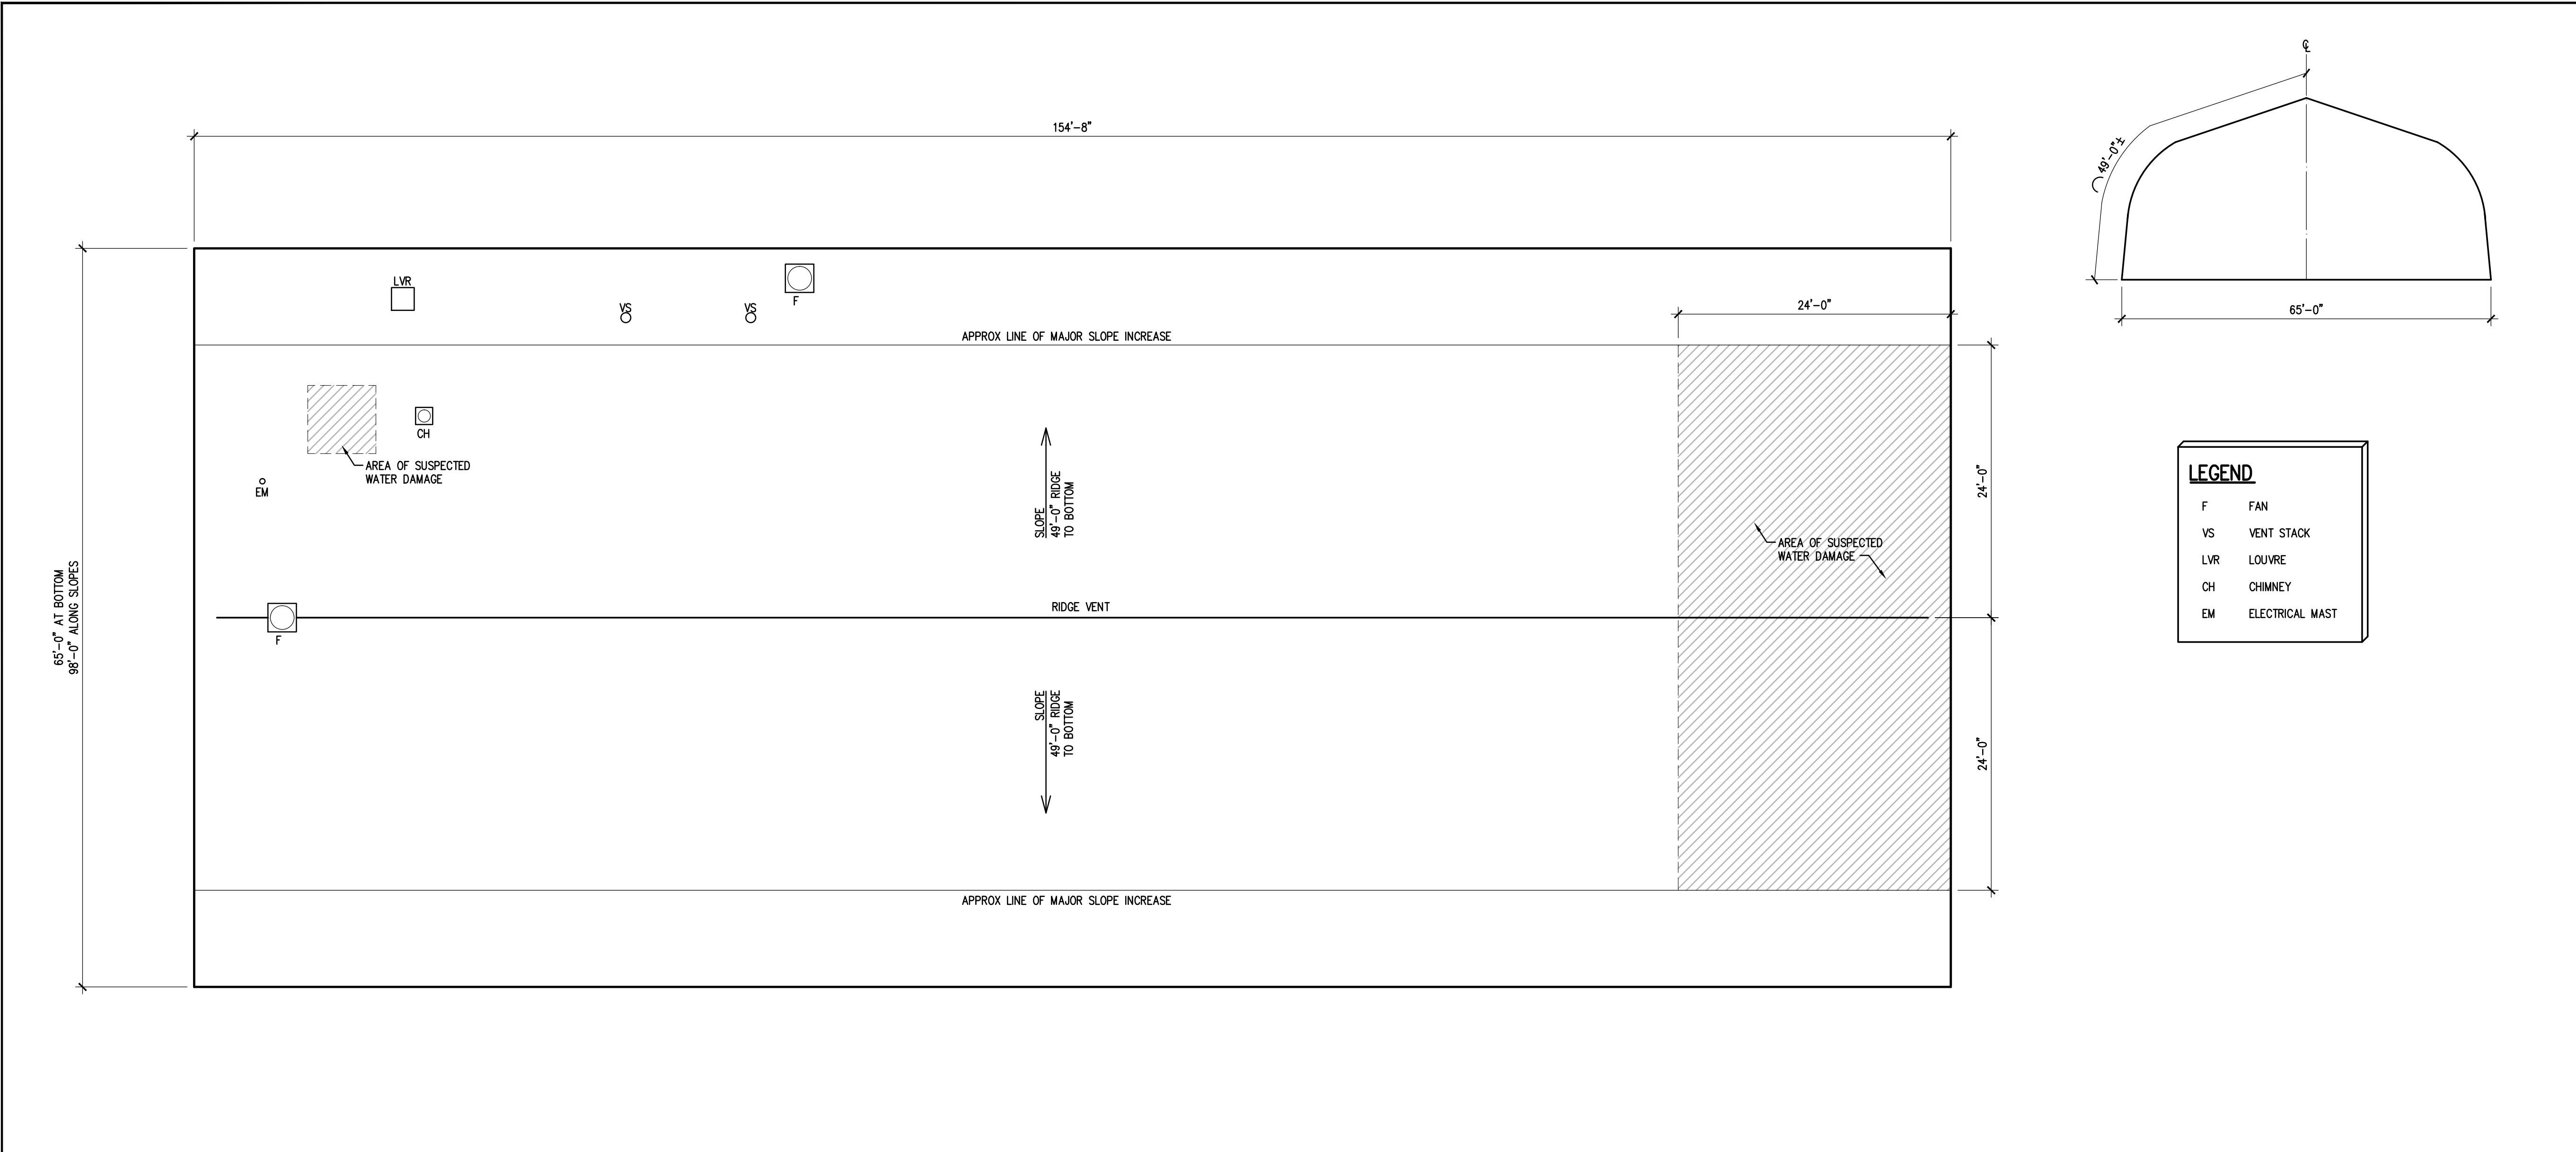
2) An area of approximately 48 ft. x 24 ft. at the rear and 10 ft. x 10 ft. at the front appears to have some rotted plywood sheathing (see Drawing A1 attached).
