Title: Shubenacadie Leak Detection and Condition Assessment

Client: Municipality of East Hants

Report Classification: Final

Date: March 17, 2016

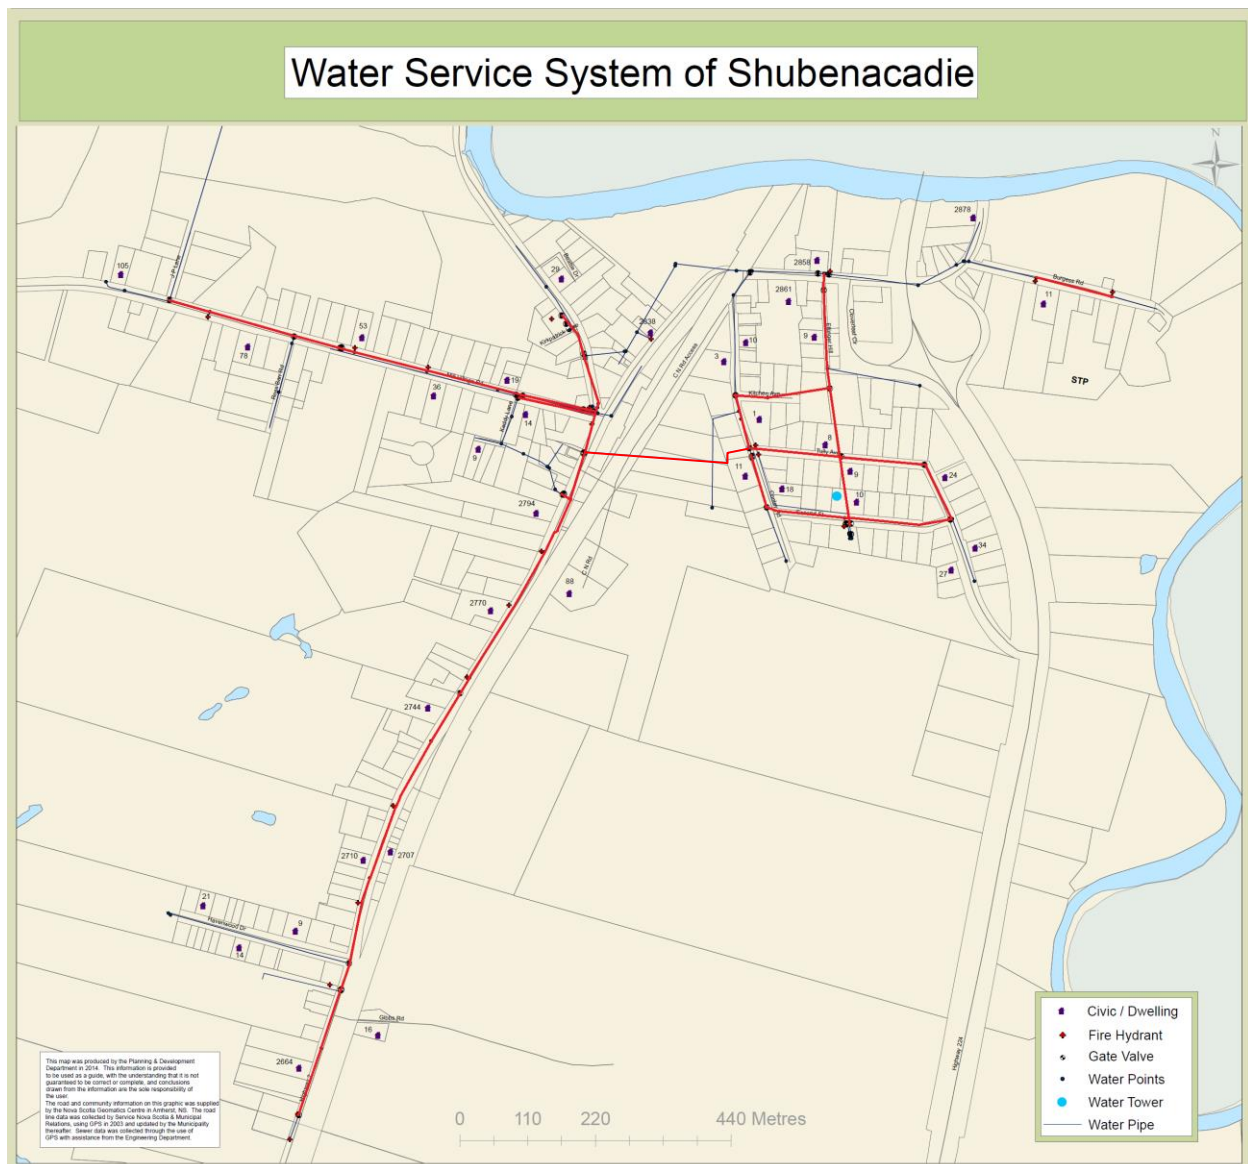
Once site testing commenced it was found that the items outlined as water points in Figure 1 did not provide access to the water mains as originally anticipated. As a result some segments were too long or complex to provide a successful correlation or the purposes of a condition assessment and this project.

Figure 1: System Overview and Site Locations – Segments tested are coloured red

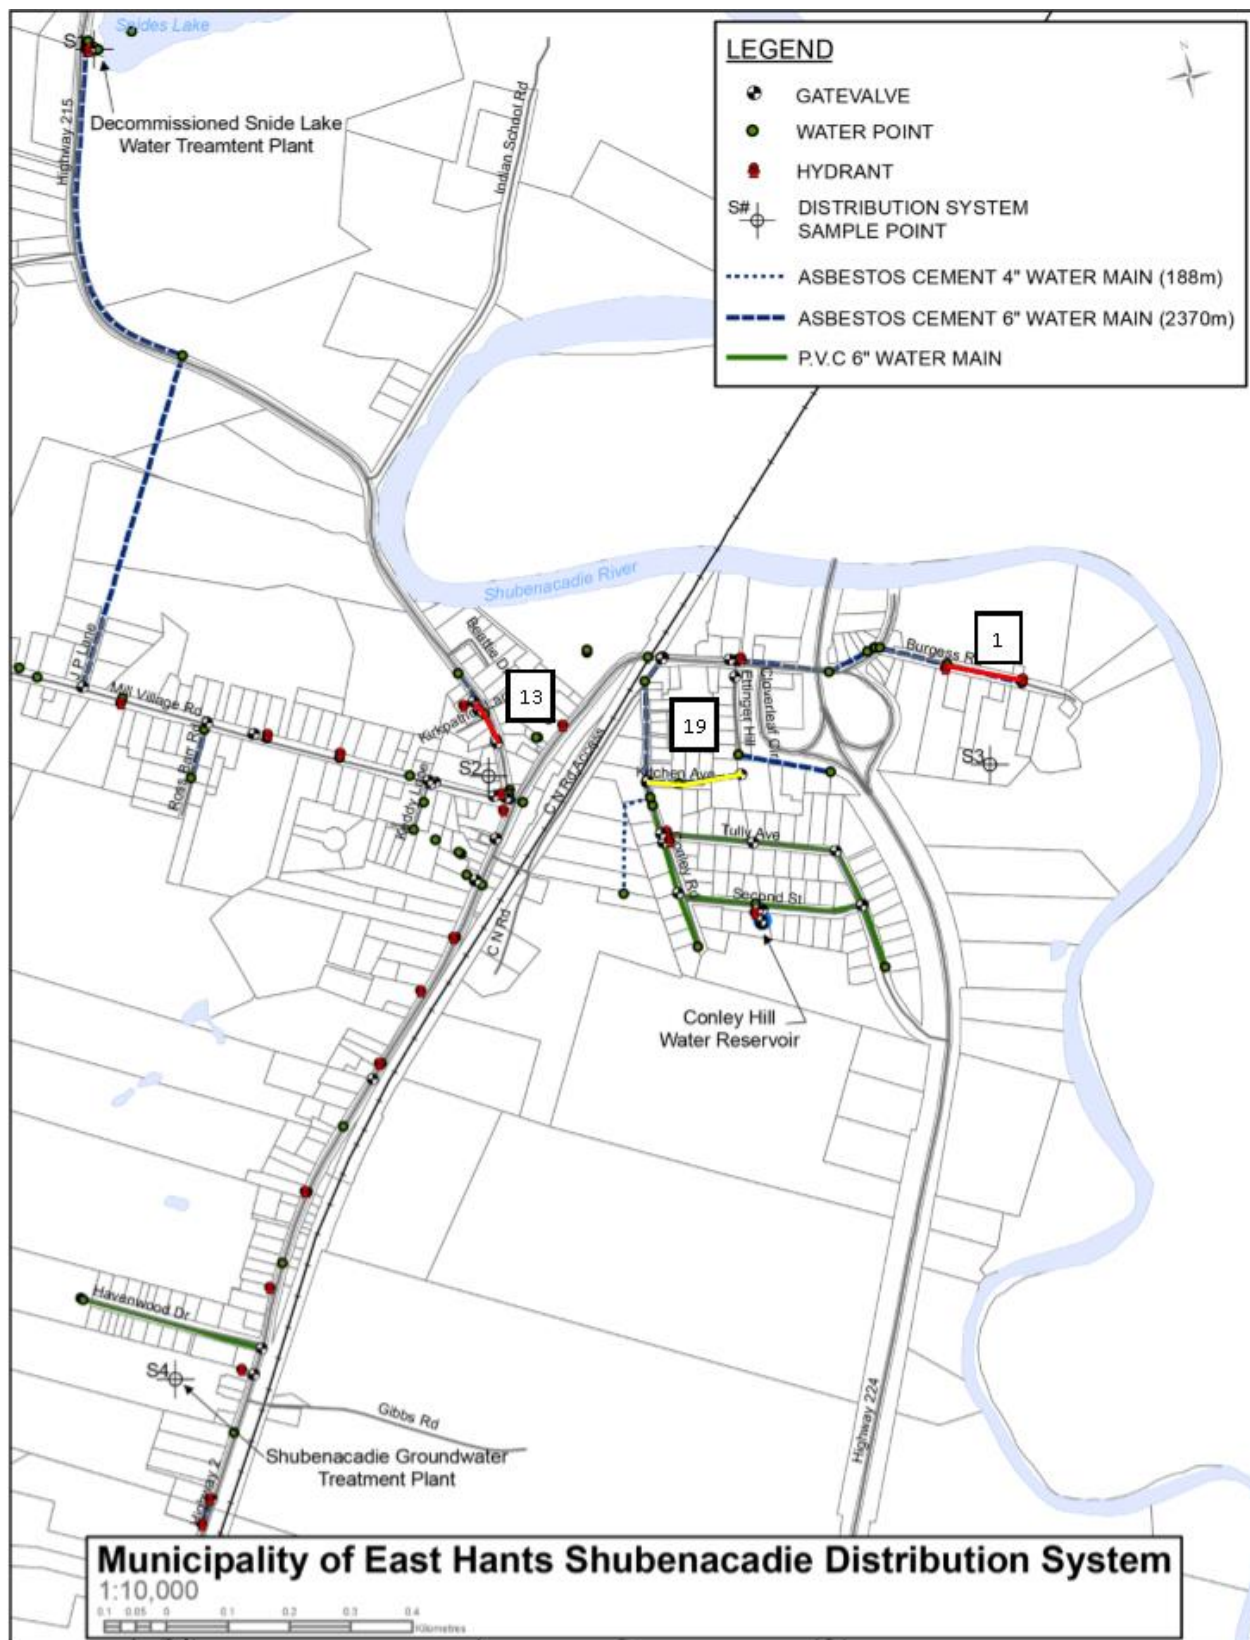
The majority of the pipes inspected showed high levels of degradation (greater than 30%) with some areas showing moderate levels of degradation (between 10 and 30% loss) Given that the mains are all asbestos cement pipe with similar installation age, it is not unusual for them to all exhibit a similar condition.

Only one section of pipe on Burgess Road has sufficient access points in order to correlate successfully. The section that was tested proved to be in poor condition based on the pipe specifications used. Please note that a change of pipe class will not affect the remaining wall thickness and is just used as a base for a percentage loss calculation.

Figure A.1-1: 150mm Diameter Asbestos Cement Pipe

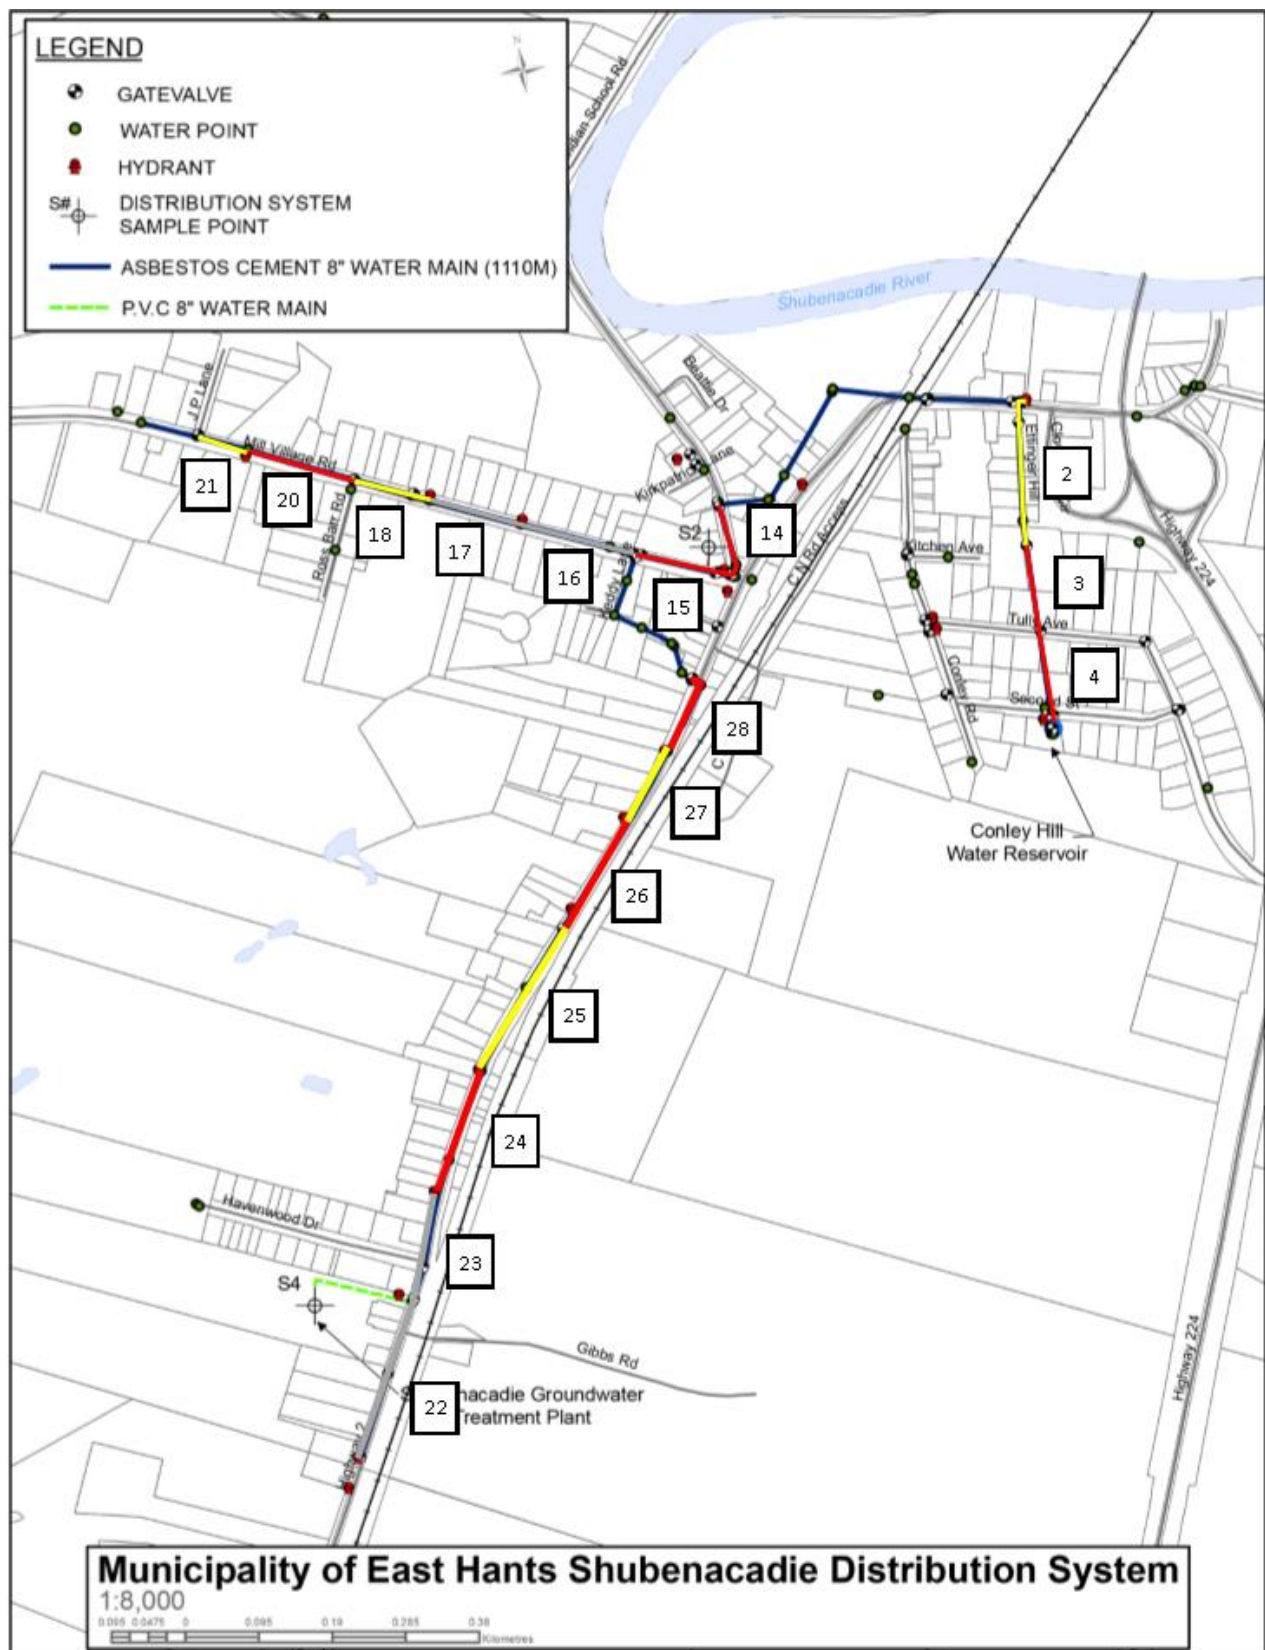
Segment 19 on Kitchen Avenue was measured using a GPS device on site. Typically distances are physically measured with a measuring wheel on site. This measurement was not possible for segment 19 as the main runs underneath a wooded area. If a more reliable distance can be attained for this length of main the new value can be used to recalculate the result if needed.

Sound propagation issues were encountered at the farthest south reaches of the Shubenacadie water system. This issue was highly likely to be due to the presence of PVC leads similar to Mill Village Road or due to some dirt in the valve box that caused an improper sensor connection.

Figure A.1-1: 200mm Diameter Asbestos Cement Pipe

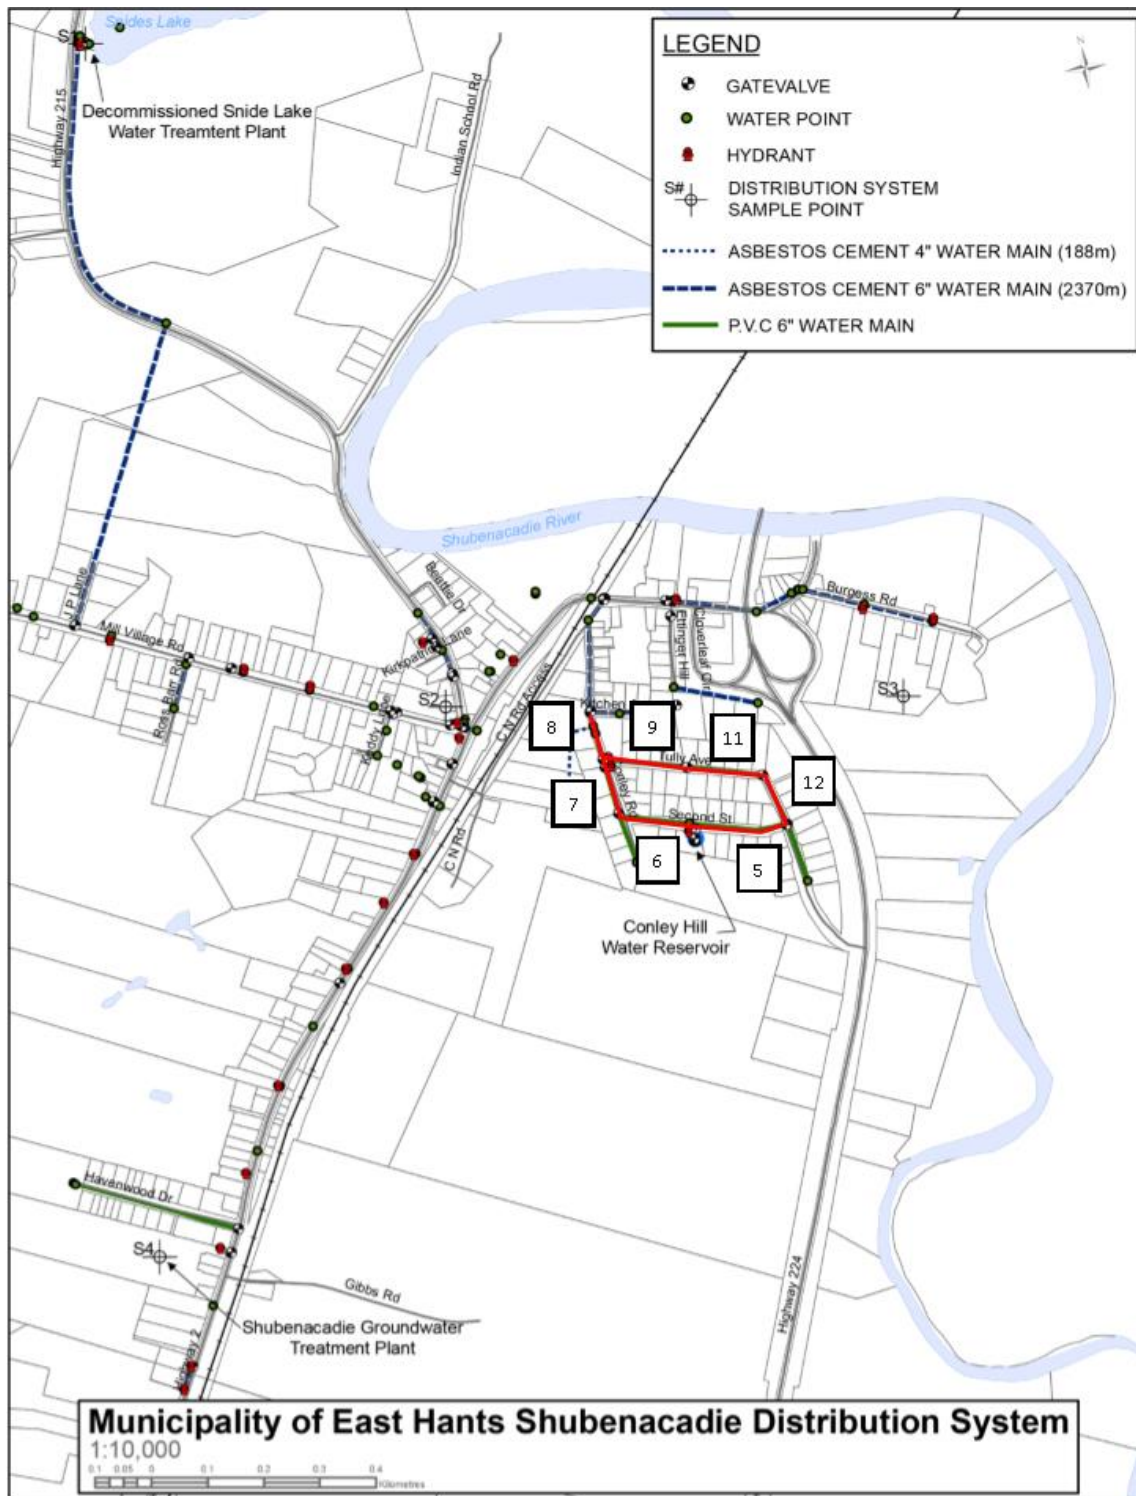
No leaks were detected in Shubenacadie during the time of the survey.

Figure A.2-1: 150mm Diameter PVC Pipe

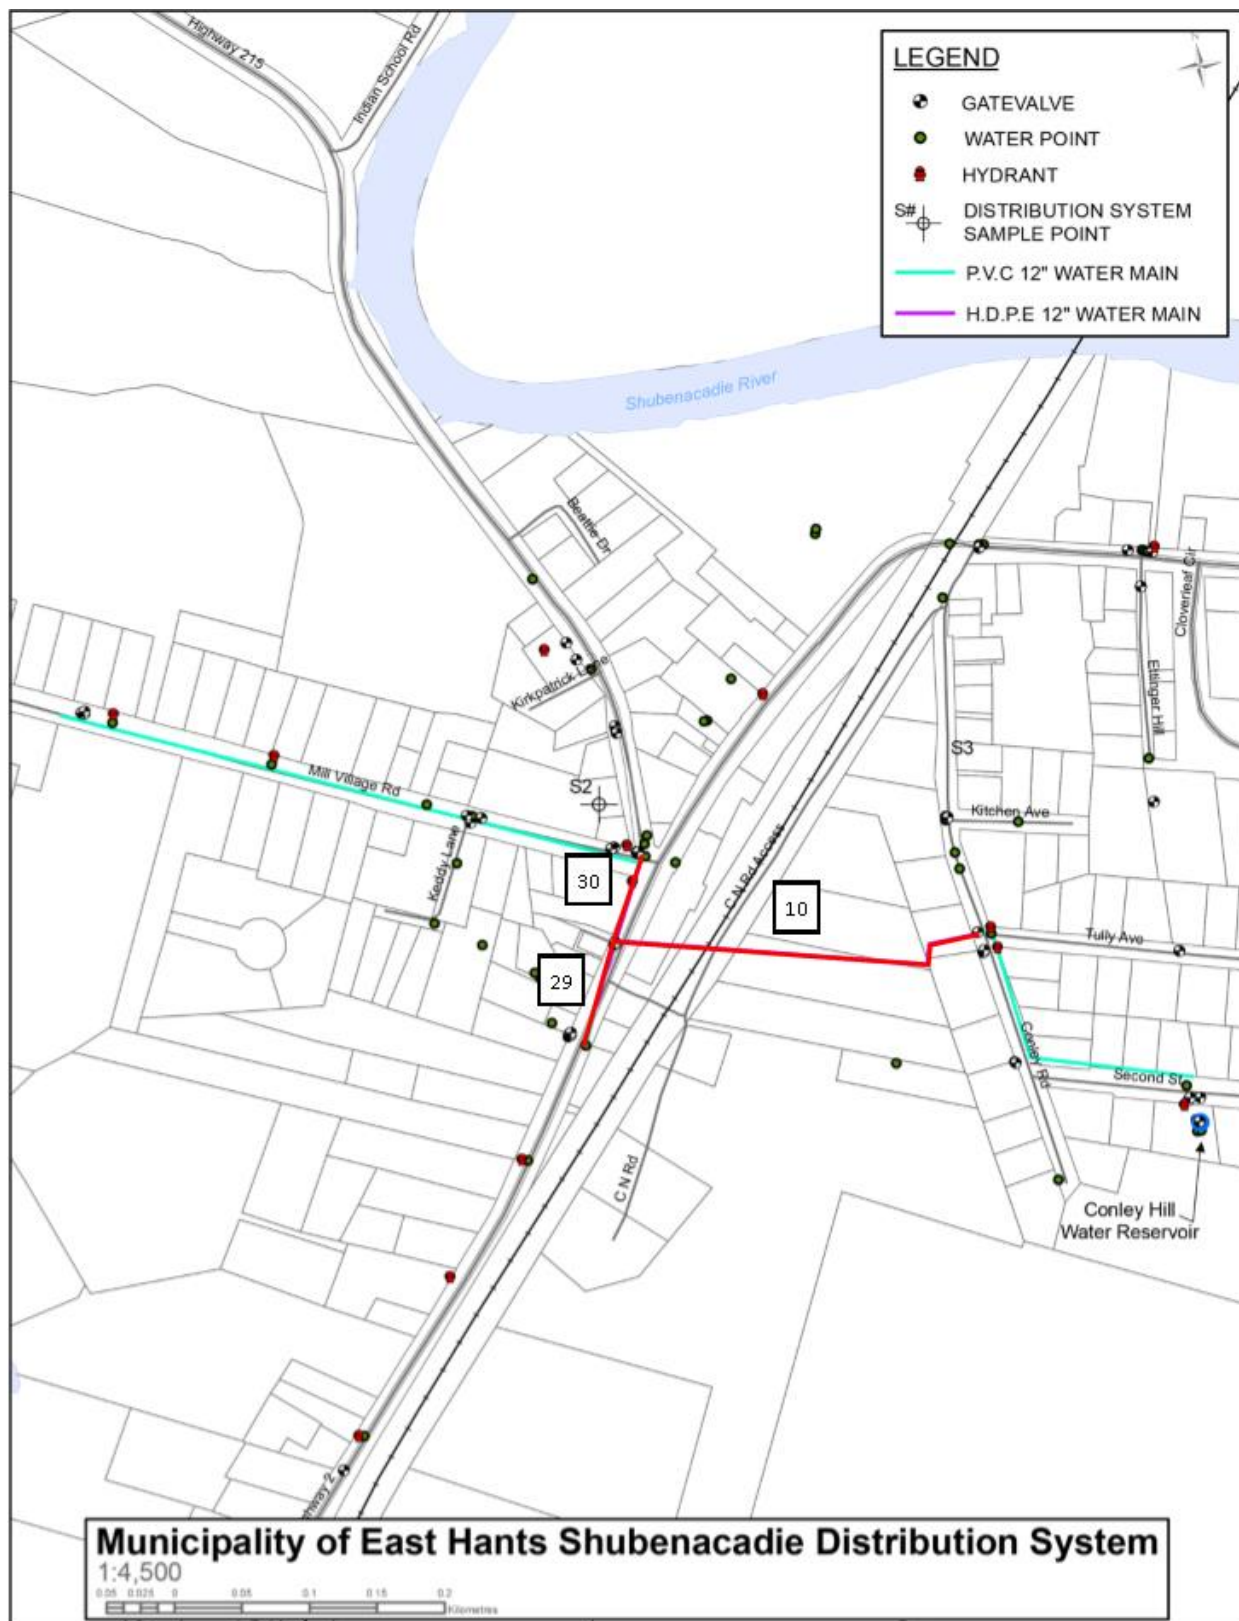
Segment 10 was the only segment that was attempted that provided inconclusive results. Segment 10 involved testing an approximately 300 metre length of main that was 12 inches in diameter, made of HDPE and also crossed under a busy rail line. Plastic pipe has an increased difficulty associated with correlation testing due to the attenuation of noise in plastic pipes. Due to this, shorter segments are tested to help mitigate the dampening effect and ensure that leak noises are able to propagate all the way to the sensor. Segment 10 was attempted on a “best-efforts” basis after informing East Hants that sensitivity would likely be significantly reduced.

Figure A.2-1: 300mm Diameter PVC and HDPE Pipe

The maximum length recommended between Echologics surface mounted sensors in order to deliver reliable results on is 100 metres. It is recommended that future testing be performed with vacuum excavation holes dug at intermediate locations in order to increase the chances of finding a leak.

A measurement of the rail road crossing pipeline was attempted to determine the location of and confirm an apparent loss of water when the line was in service. Due to the length of the segment and the material, correlation was not successful. It is recommended that some intermediate vacuum truck excavation holes be dug in order to break up the distance into smaller sections for correlation with a higher chance of success.
