Asbestos Management Plan (AMP) Chignecto-Central Adult High School (CCAHS Elmsdale), 224 Highway 214, Elmsdale, NS

Final Report

181255.01 • Asbestos Management Plan • October 2019

181255.00 • Hazardous Building Materials Survey Final Report • October 2019

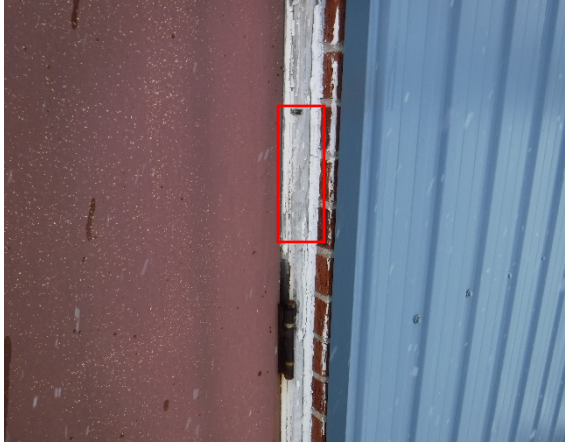
Photo 119: Photo of sample EXT-AS-06, Building Exterior, Wall – Caulking Around Door, 1.2% Chrysotile Asbestos.

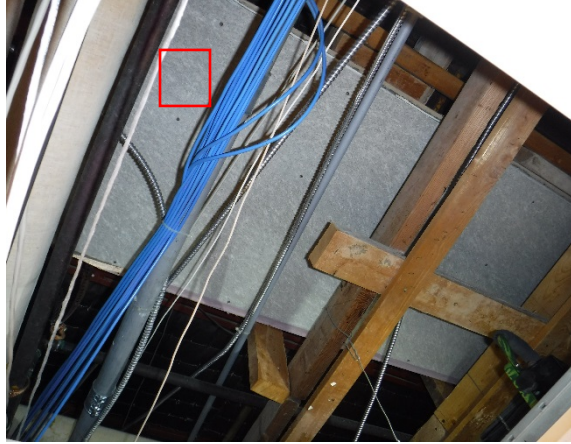
Photo 20: Photo of transite panel found in Hallway (SW), Ceiling Cavity – Visually similar to EXT-AS-01, 13.6% Chrysotile Asbestos.

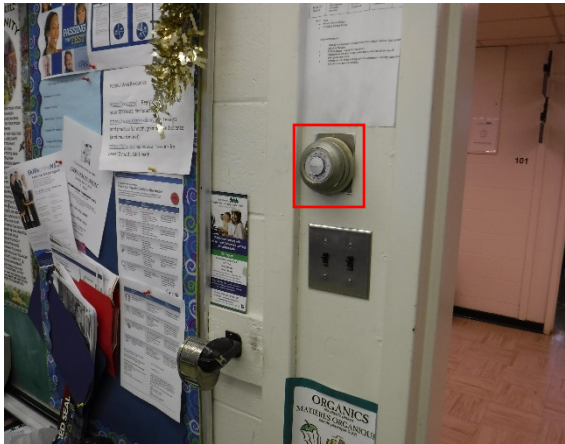
Photo 45: Example Photo of Mercury Thermostats observed throughout building.

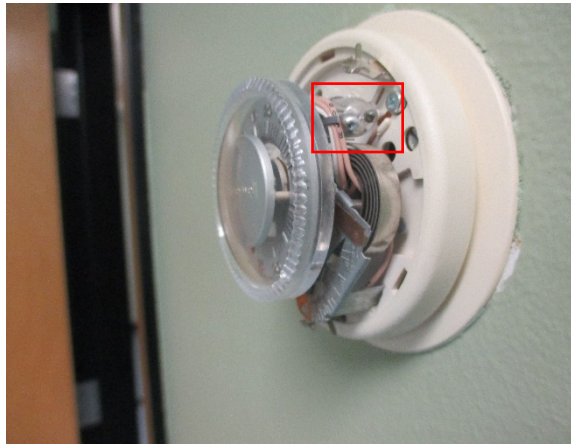
Photo 46: Example Photo of Mercury vial in older style thermostats observed throughout building.
