Hazardous Building Materials Survey Draft Report

Chignecto-Central Adult High School (CCAHS Elmsdale),
224 Highway 214, Elmsdale, NS

181255.00 • Hazardous Building Materials Survey Report • February 2019

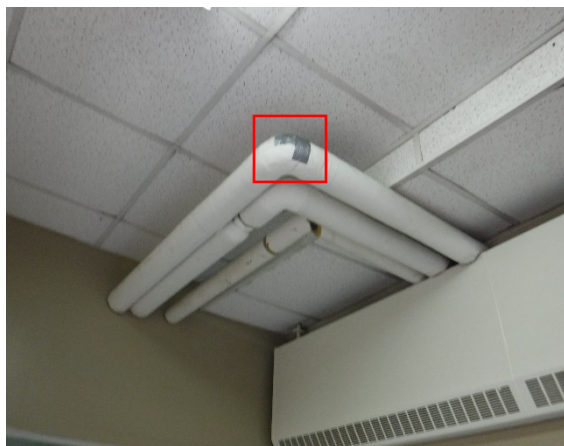
- Approximately 110 pipe elbows with grey parging cement identified as ACM (Samples AS-08, AS-09 and AS-26) associated with piping were noted in the subject building, all pipe elbows that are not fiberglass should be assumed asbestos containing. It should be noted that, solid walls and ceilings limited observation of pipe insulation in multiple rooms throughout the building during the assessment. Additional asbestos containing pipe insulation may be present in concealed locations in the subject building;

Photo 2: Photo of sample AS-08, Hallway (Main) – Piping Insulation, Fitting, 60% Chrysotile Asbestos.

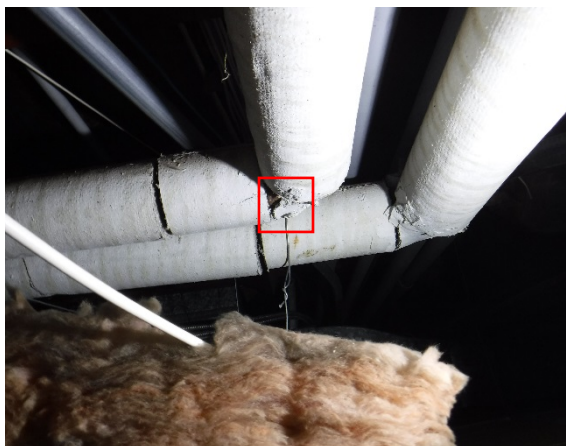
Photo 3: Photo of sample AS-09, Hallway (Main) – Piping Insulation, Fitting, 65% Chrysotile Asbestos.

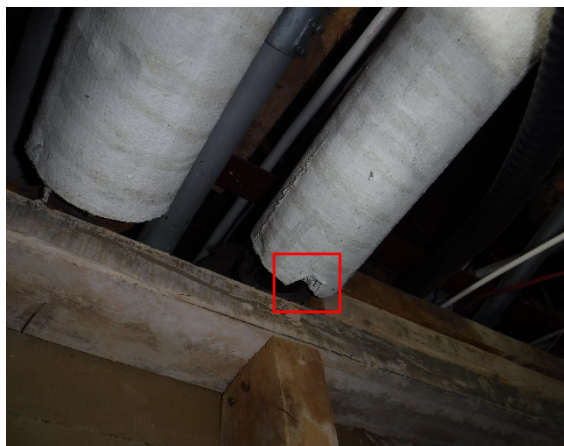
- Approximately 170 linear meters of asbestos containing straight run pipe insulation was noted throughout the building (Samples AS-11, AS-24 and AS-27). It should be noted that, solid walls and ceilings limited observation of pipe insulation in multiple rooms throughout the building during the assessment. Additional asbestos containing pipe insulation may be present in concealed locations in the subject building;

Photo 4: Photo of sample AS-11, Hallway (Main) – Piping Insulation, Straight Run, 60% Chrysotile Asbestos.

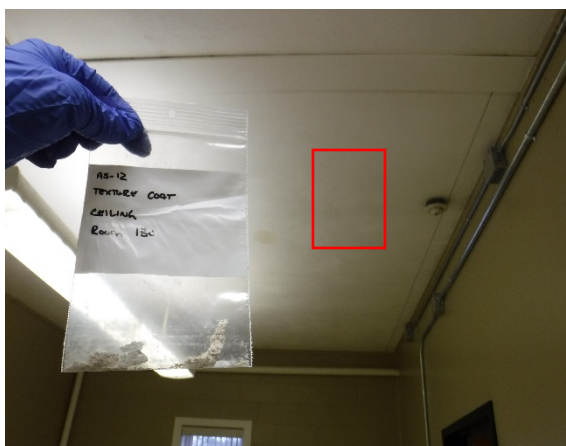
- Approximately 275 m² of texture coating materials identified as ACM were noted in the subject building (samples AS-12, AS-15 and AS-20). It should be noted that based on sampling results, all texture coating material should be treated as an ACM;

Photo 5: Photo of sample AS-12, Room 130, Ceiling – Texture Coating, 2% Chrysotile Asbestos.

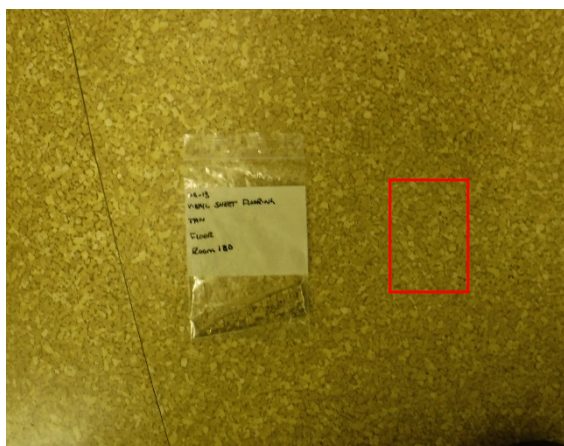
Photo 6: Photo of sample AS-13, Room 130, Floor – Tan Color Vinyl Sheet Flooring, 10.3% Chrysotile Asbestos.

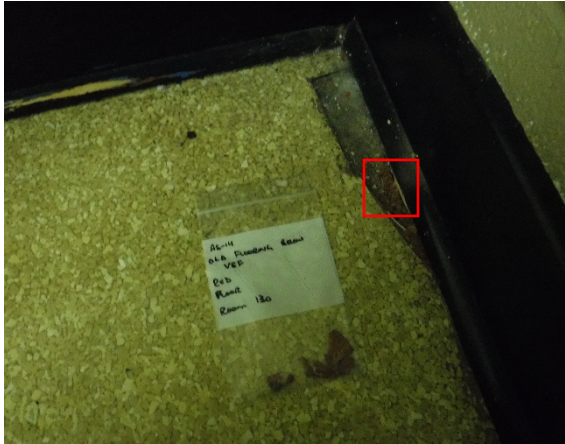
Photo 7: Photo of sample AS-14, Room 130, Floor – Flooring Material below VSF, 6.4% Chrysotile Asbestos.

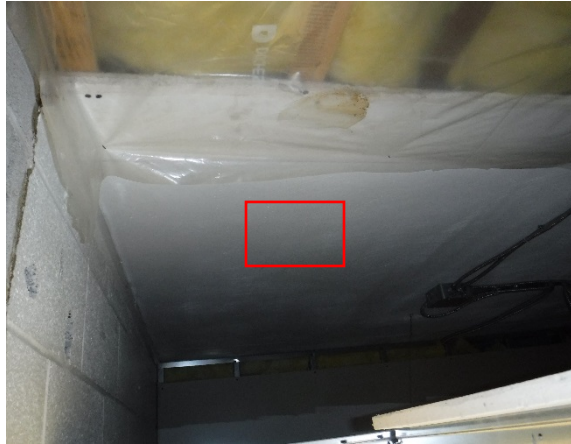
Photo 8: Photo of sample AS-15, Room 127, Ceiling – Texture Coating, 1% Chrysotile Asbestos.

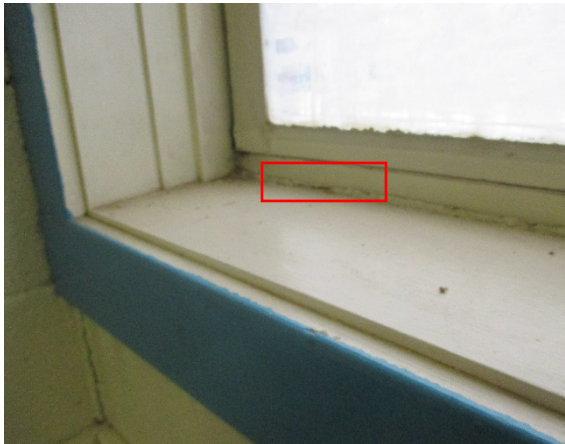
- Window caulking identified as an ACM was noted on the interior of the Men's Washroom window (sample AS-19);
- Cementitious material (transite) identified as containing asbestos was observed on the interior and exterior of the building (Sample EXT-AS-01). One panel was observed within the south-wing Hallway ceiling cavity. All transite material in the subject building should be managed as an ACM. Approximately 2-5 m² was observed in the building interior ceiling cavity. Transite panels were also observed on the building exterior between windows and above doors. Approximately 12-15 m² was observed on the building exterior;

Photo 9: Photo of sample AS-19, Men's Washroom, Window – Caulking Material, 2% Chrysotile Asbestos.

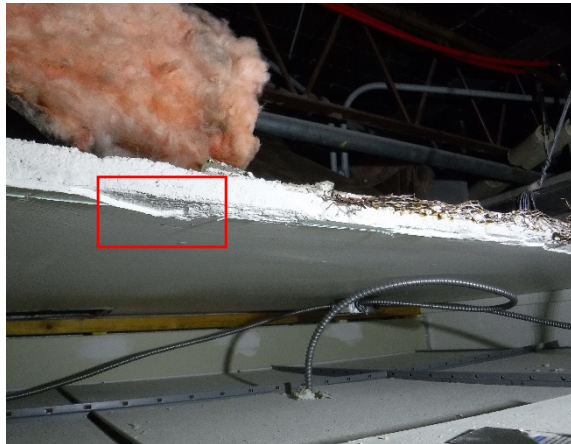
Photo 20: Photo of sample AS-20, Staff Washroom, Ceiling – Texture Coating, 2% Chrysotile Asbestos.

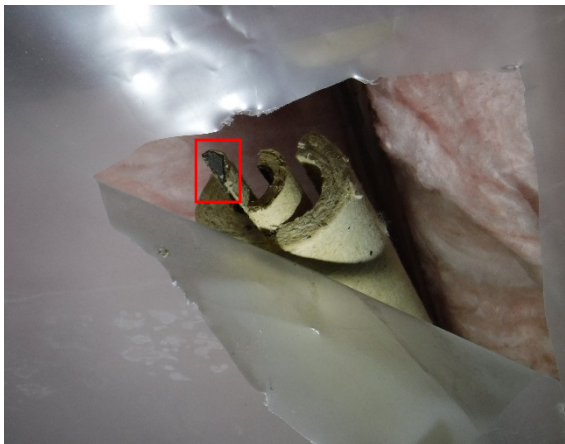
Photo 31: Photo of sample AS-24, Room 118, Ceiling – Piping Insulation, Tar Paper on Straight Run, 8% Chrysotile Asbestos.

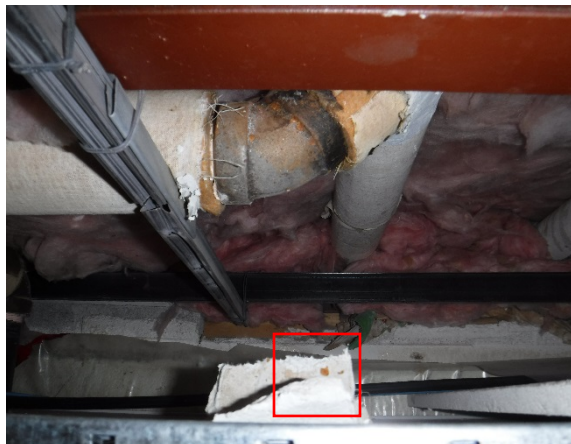
Photo 42: Photo of sample AS-26, Room 110 – Piping Insulation, Fitting, 55% Chrysotile Asbestos.

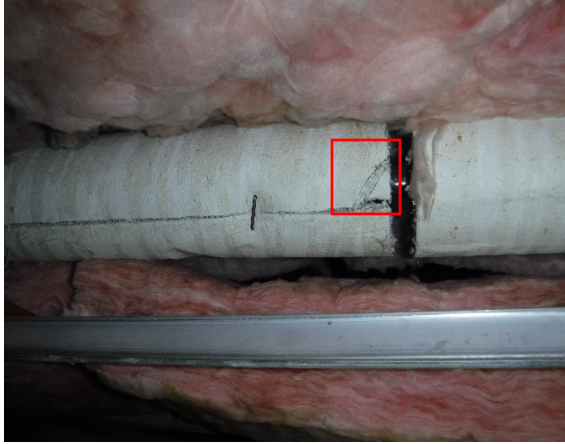
Photo 53: Photo of sample AS-27, Room 110 – Piping Insulation, Straight Run Air-Cell, 65% Chrysotile Asbestos.

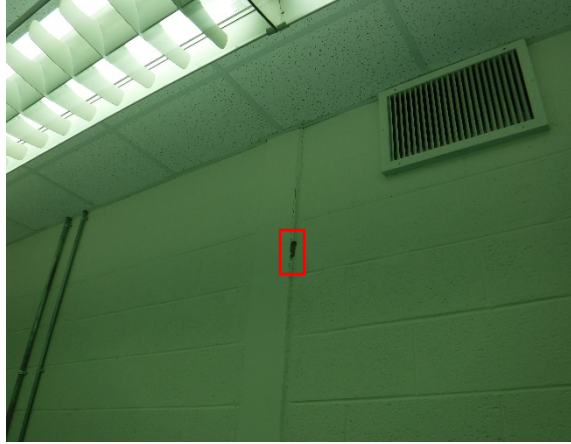
- Expansion joint material identified as asbestos containing was observed on the interior and exterior of the building (Sample AS-28 and EXT-AS-03). Room 110 has approximately 8 linear meters of compound between brick and structural steel within the room. Any other areas found to have the same material between two building components should be considered as an ACM. Expansion joint compound was also observed and collected from the between a seam on the brick wall of the building exterior. The material was also found to contain asbestos; and,

Photo 64: Photo of sample AS-28, Room 110, Wall – Expansion Joint Compound, White/Grey, 0.27% - 1.9% Chrysotile Asbestos.

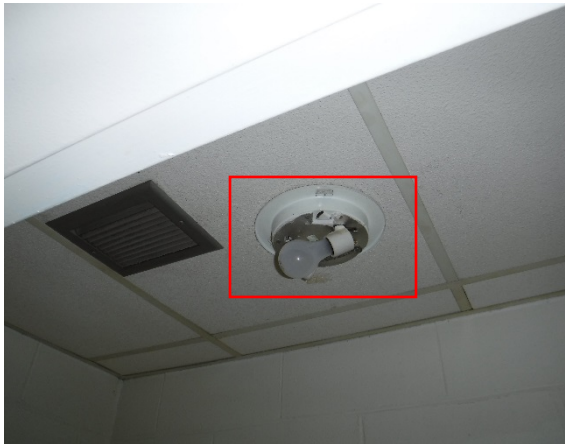
A lighting heat shield was observed within the bathroom of Room 105. This heat shield was found to contain 45% Chrysotile asbestos. Any other units visually similar to this lighting heat shield (Photo 15, Photo Log) should be considered an asbestos containing material.

Photo 75: Photo of sample AS-34, Room 105, Bathroom – Lighting Unit Heat Shield, 45% Chrysotile Asbestos.

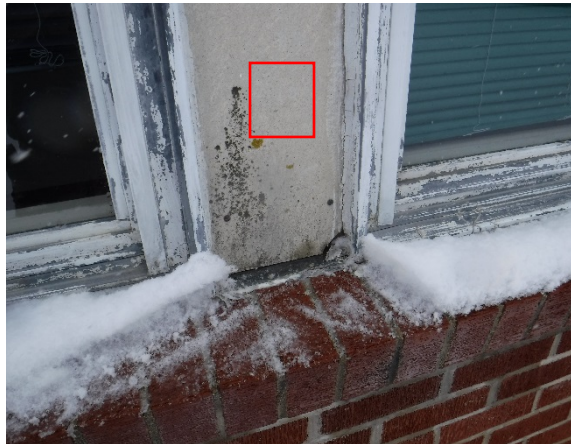
Photo 86: Photo of sample EXT-AS-01, Building Exterior – Transite Panel, 13.6% Chrysotile Asbestos.

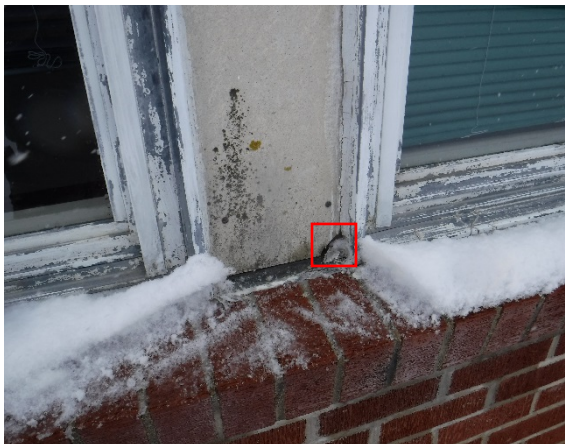
Photo 97: Photo of sample EXT-AS-02, Building Exterior – Caulking around Transite Panel, 2.2% Chrysotile Asbestos.

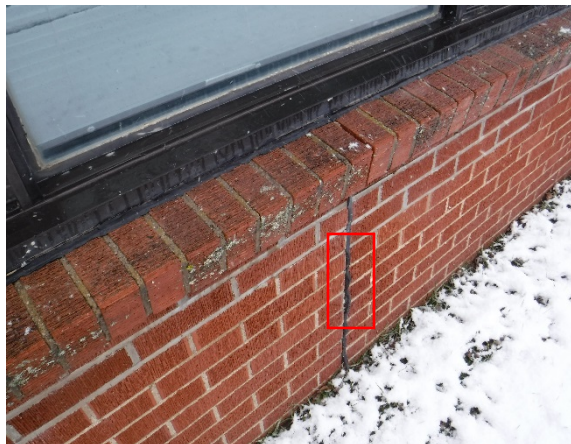
Photo 108: Photo of sample EXT-AS-03, Building Exterior, Wall – Expansion Joint Compound, Black/White, 0.76% - 1.2% Chrysotile Asbestos.

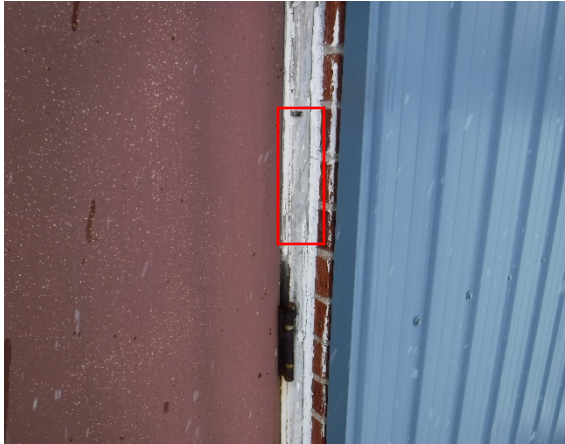
- Exterior caulking was collected from the building and found to contain asbestos (Sample EXT-AS-06). The material was collected from the seam between a door frame and brick wall. Any caulking materials found on the building exterior matching the description of the above noted sample should be considered as asbestos containing.

Photo 119: Photo of sample EXT-AS-06, Building Exterior, Wall – Caulking Around Door, 1.2% Chrysotile Asbestos.

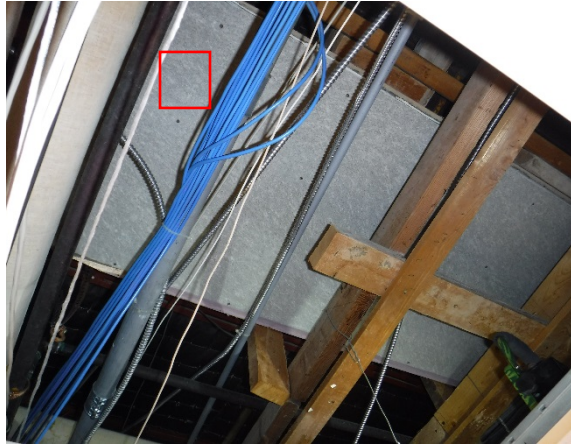
Transite panel was observed in one location within the south wing hallway. It is suspected that transite panels could be present in inaccessible wall and ceiling cavities throughout the building. All transite panels should be considered as asbestos containing materials.

Photo 20: Photo of transite panel found in Hallway (SW), Ceiling Cavity – Visually similar to EXT-AS-01, 13.6% Chrysotile Asbestos.

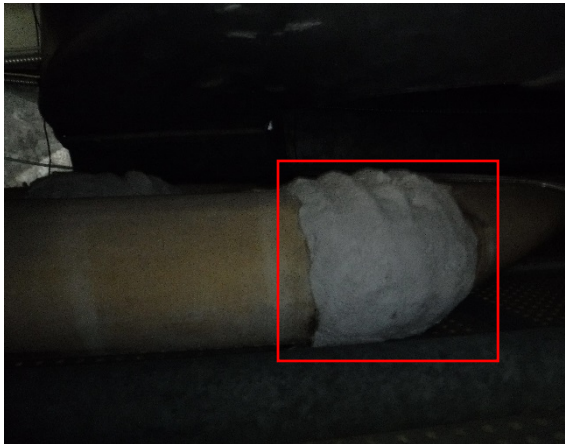
The general overall condition of piping insulation observed throughout the building interior was fair to poor (i.e., unwrapped, deteriorating, debris). Access into ceiling cavities should be limited until removal or remediation of the ACM piping insulations has been completed due to loose debris and deteriorating insulations being noted in several spaces.

Photo 21: Example Photo of Poor Condition, Unwrapped ACM Piping Insulation, Fitting – Hallway (Main), Ceiling Cavity.

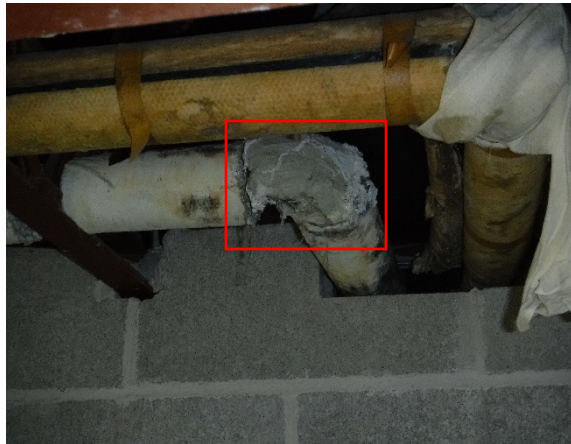
Photo 22: Example Photo of Poor Condition, Unwrapped ACM Piping Insulation, Fitting – Hallway (Main), Ceiling Cavity.

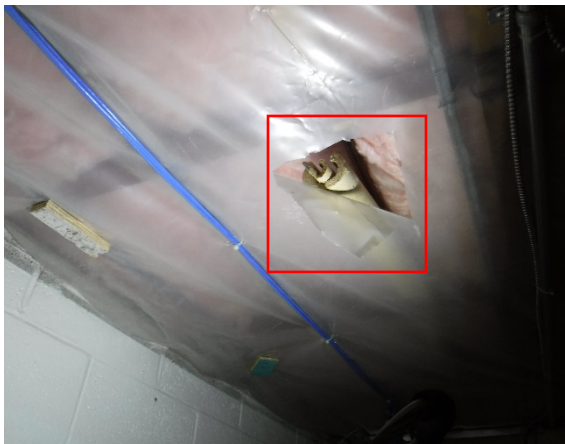
Photo 23: Example Photo of Poor Condition, Damaged ACM Piping Insulation, Straight Run – Room 118, Ceiling Cavity.

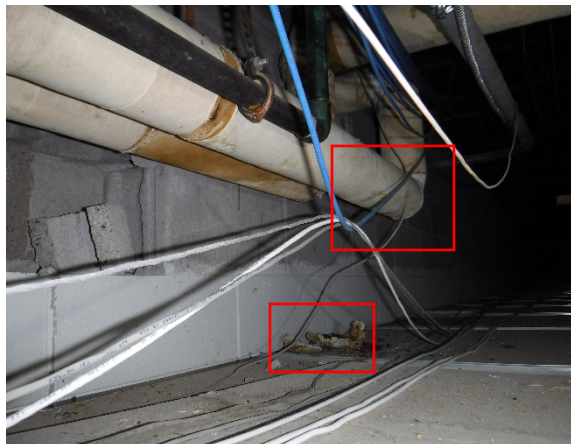
Photo 24: Example Photo of Poor Condition, Damaged ACM Piping Insulation with Debris on Ceiling Tile, Fitting – Hallway (SW), Ceiling Cavity.

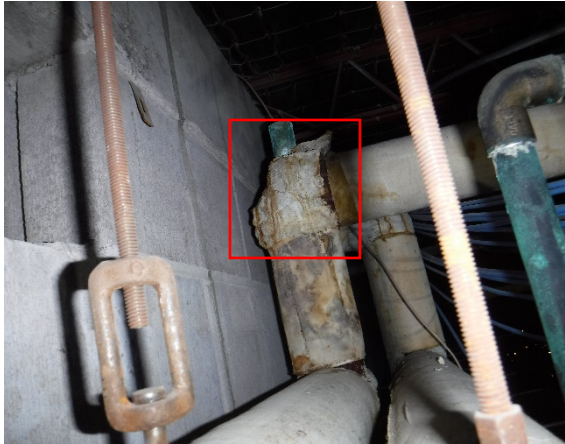
Photo 25: Example Photo of Poor Condition, Damaged ACM Piping Insulation, Fitting – Hallway (SW), Ceiling Cavity.

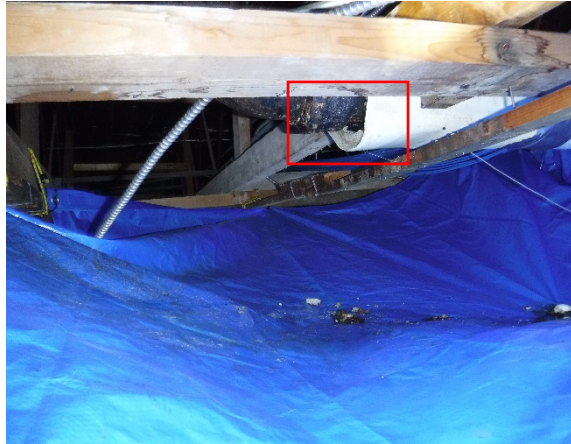
Water damaged building materials were not observed throughout the subject building, however previously leaking and repaired pipes were observed in various locations through the subject building. Evidence of an actively leaking, broken pipe was observed in the ceiling cavity of Hallway (SW) outside rooms 106 and 107. No visible mould growth was observed. No sampling of mould was conducted.

Photo 26: Example Photo of Poor Condition, ACM Piping Insulation damaged from Actively Leaking Pipe, Straight Run – Hallway (SW), Ceiling Cavity.

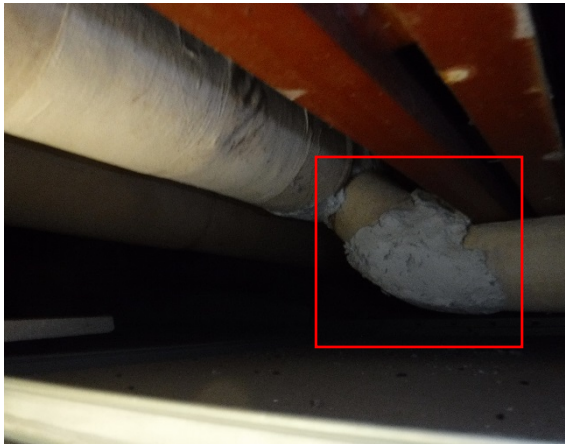
Photo 27: Example Photo of Poor Condition, Unwrapped ACM Piping Insulation, Fitting – Room 106, Ceiling Cavity.

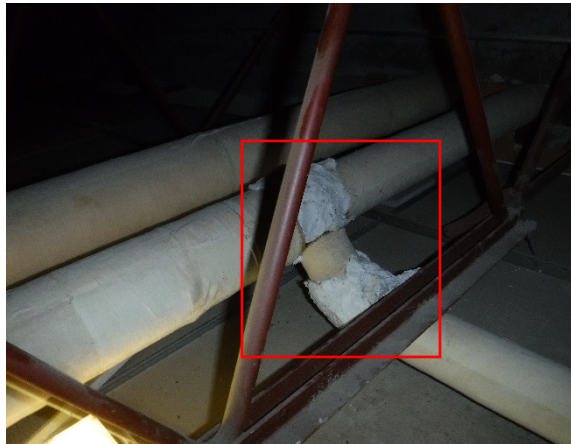
Photo 28: Example Photo of Poor Condition, Unwrapped ACM Piping Insulation, Fitting – Room 106, Ceiling Cavity.

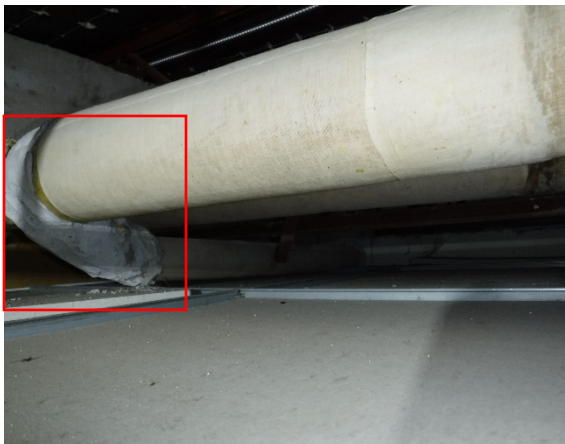
Photo 29: Example Photo of Poor Condition, Unwrapped ACM Piping Insulation, Fitting – Room 104, Ceiling Cavity.

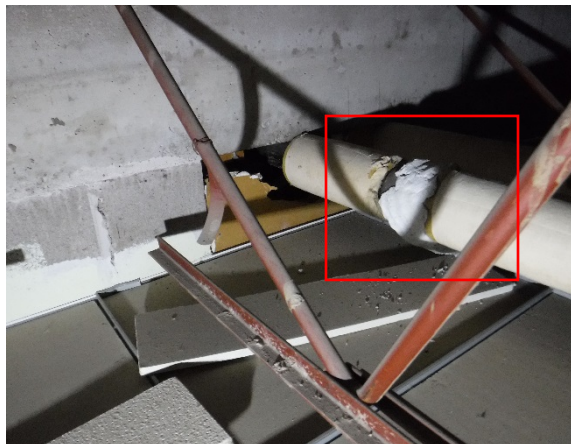
Photo 30: Example Photo of Poor Condition, Unwrapped ACM Piping Insulation, Fitting – Room 104, Ceiling Cavity.

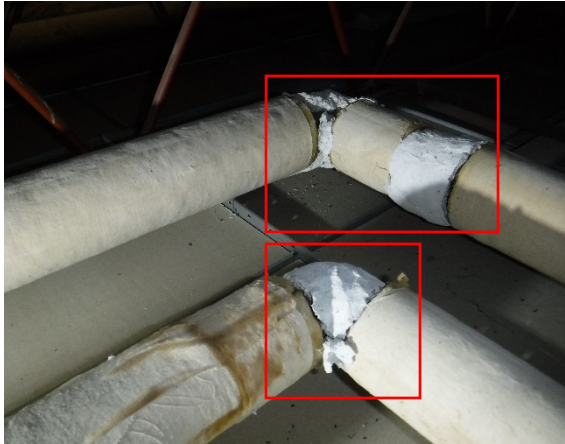
Photo 31: Example Photo of Poor Condition, Unwrapped ACM Piping Insulation, Fitting – Room 100, Ceiling Cavity.

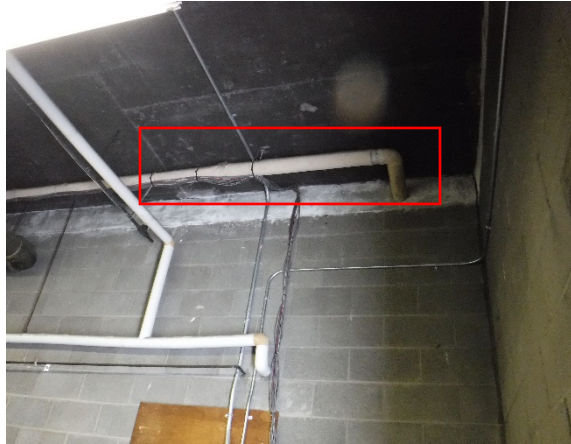
Photo 32: Example Photo of Remaining ACM Piping Insulation – Mechanical Room.

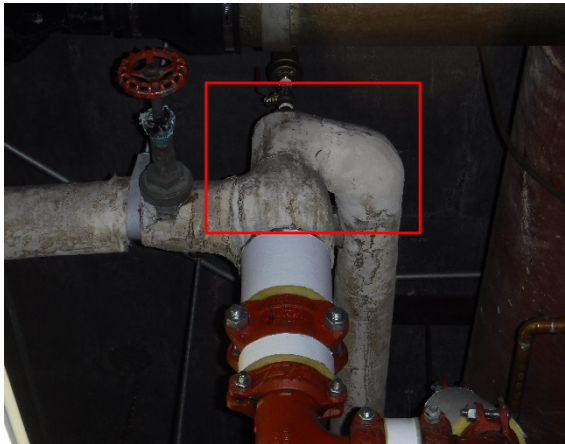
Photo 33: Example Photo of Remaining ACM Piping Insulation – Mechanical Room.

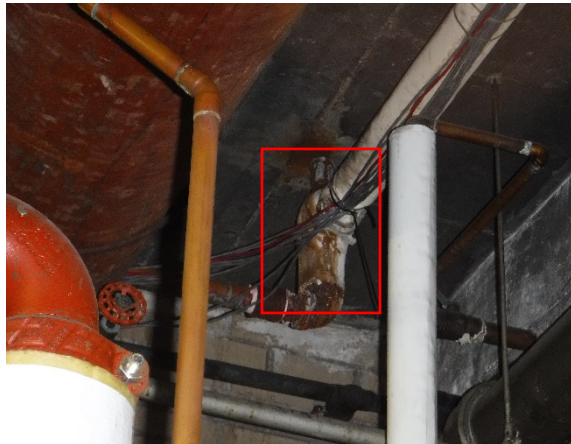
Photo 34: Example Photo of Remaining ACM Piping Insulation – Mechanical Room.

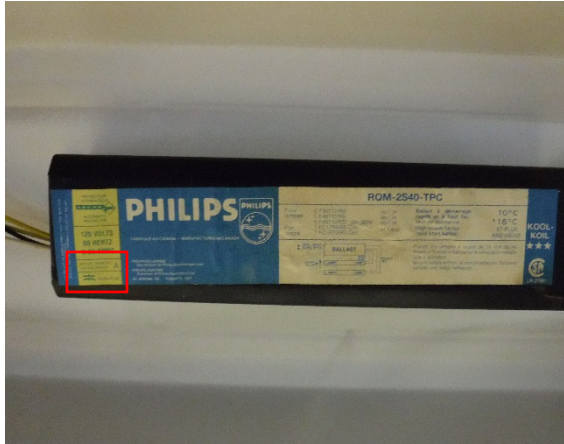
Fluorescent light fixtures were observed and inspected in the subject building. Approximately 10% of the lighting ballasts were visually checked for the presence of PCB containing ballasts. All inspected ballasts were non-PCB containing.

Photo 43: Example Photo of Inspected Lighting Ballasts – Hallway (Main), “Non-PCB”.

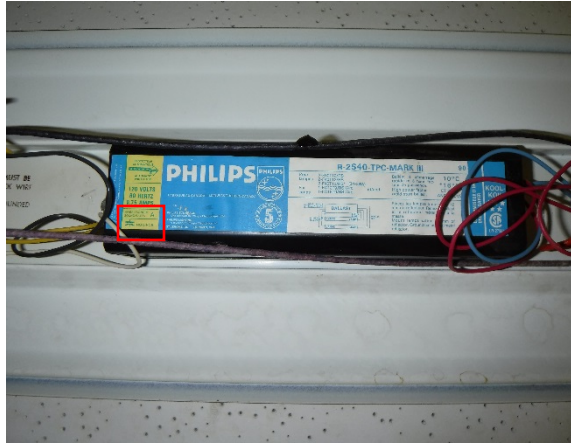
Photo 44: Example Photo of Inspected Lighting Ballasts – Men’s Washroom (SW), “Non-PCB”.

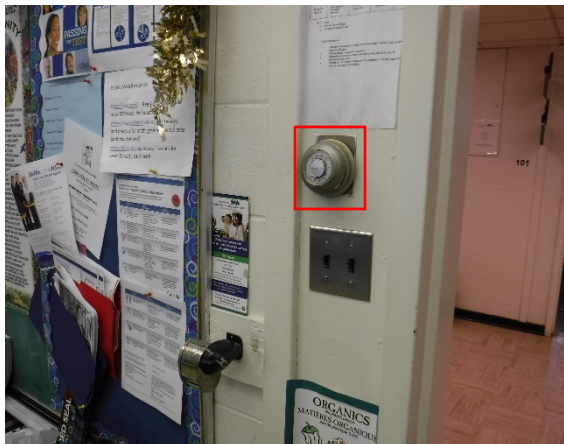
- Four foot linear fluorescent lamps, which contain mercury vapour, were observed throughout lighting fixtures within the subject building. Spare lamps were also observed in storage boxes in various rooms in the building; and,
- Older style thermostats which contain liquid mercury vials were observed throughout the building.

Photo 45: Example Photo of Mercury Thermostats observed throughout building.

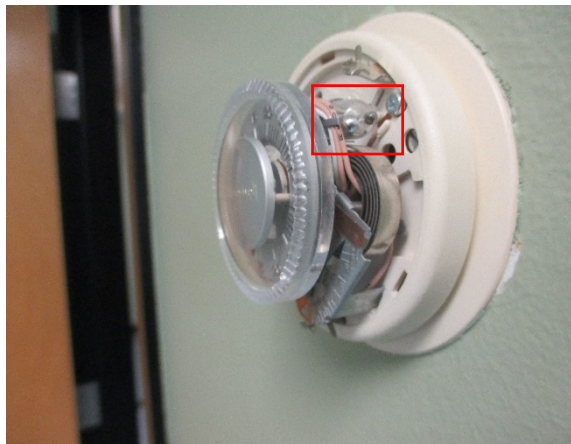
Photo 46: Example Photo of Mercury vial in older style thermostats observed throughout building.
