# Flood Risk Mitigation Strategy

Barneys Brook

EAST HANTS

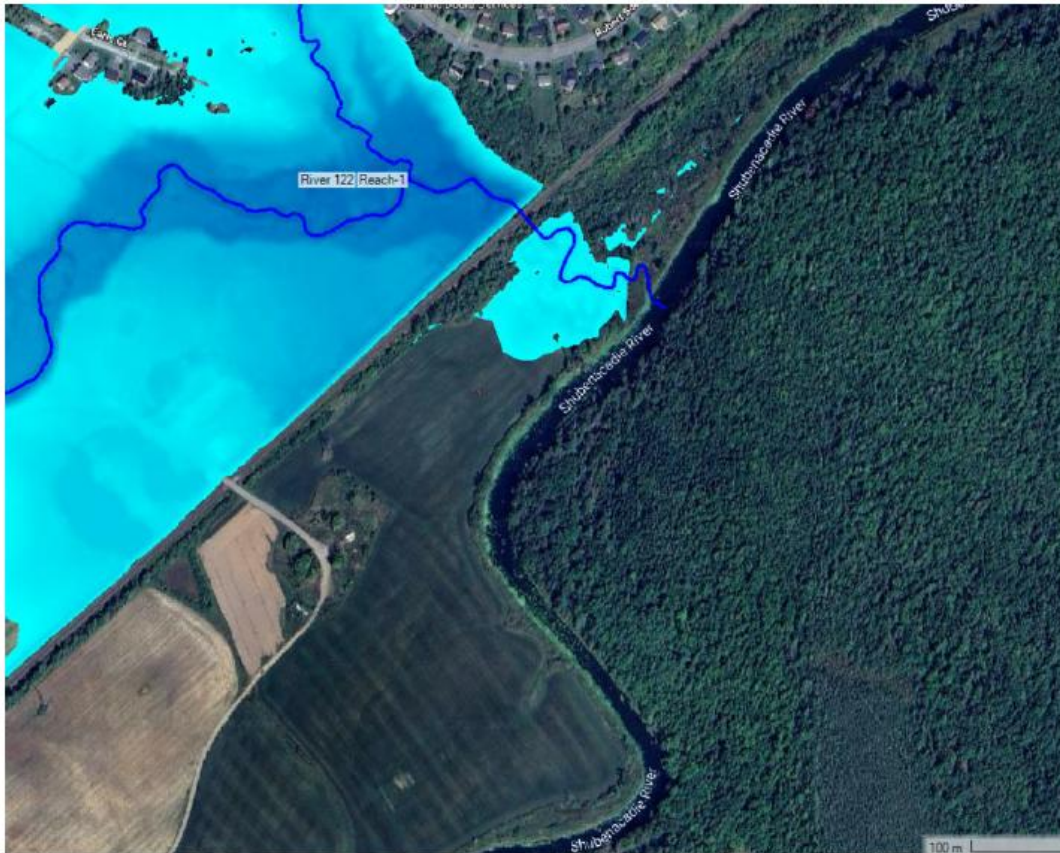
# 1. The Outlet of Barneys Brook at the CN Railway

#	Location	Existing 1% AEP Elevation (m CGVD2013)	Climate Change 1% AEP Elevation (m CGVD2013)	Difference (m CGVD2013)
1	The outlet of Barneys Brook at the CN Railway	16.0	17.5	1.5
2	Highway 2 near Robert Scott Drive	15.6	17.5	1.7
3	Highway 2 between Barneys Lane and Myers Lane	15.5	17.5	2.0
4	Highway 102: The east side of Highway 102 towards the northern end of the watershed	23.0	25.0	2.0

Figure 8: CN Railway at the outlet of the river – 1% AEP Climate Change

- Recommendation #1:** Structure upgrades (culvert - DCS007)  
CN Railway culvert upgrade at the system outlet

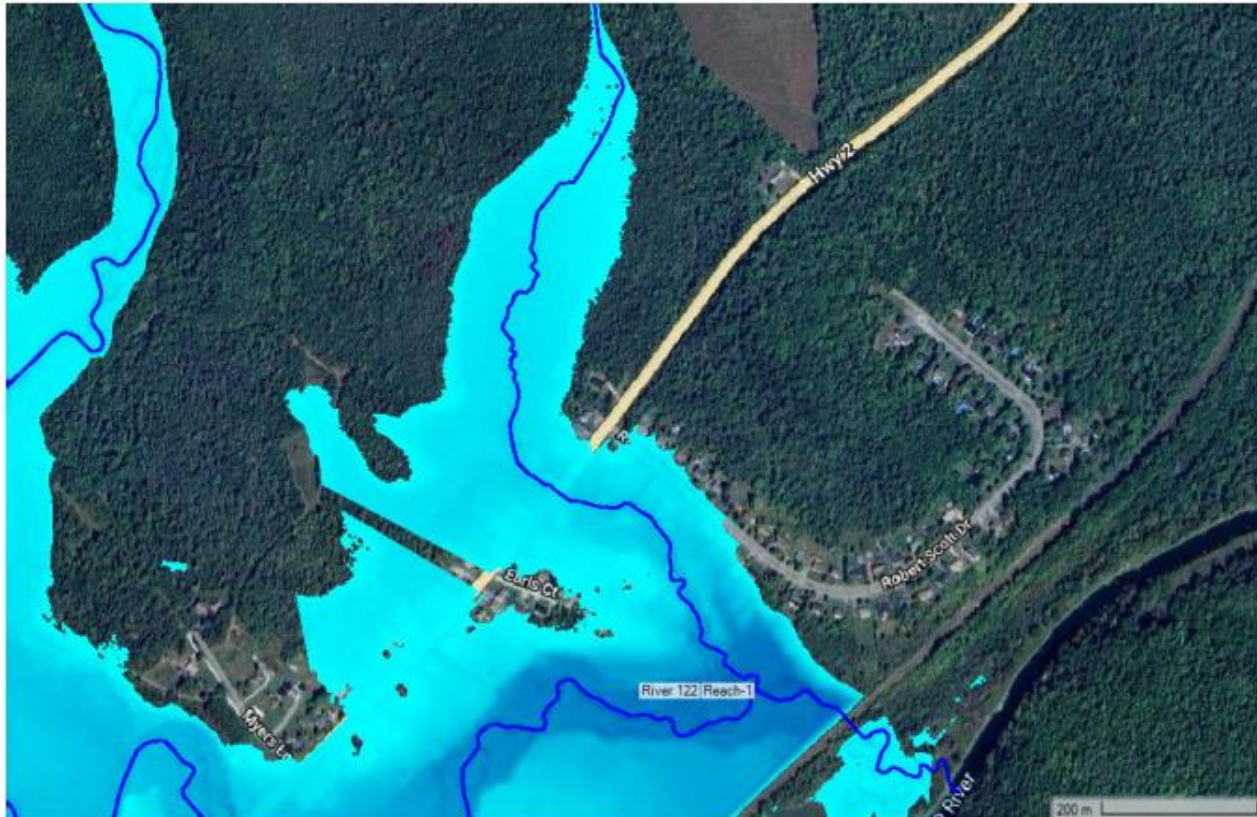
## 2. Hwy 2 near Robert Scott Drive

**Figure 10: Highway 2 near Robert Scott Drive - 1% AEP 2100 Climate Change**

*\*Please note while there is a gap in the model, this gap was compensated for in the mapping phase*

- Recommendation #2:** Structure upgrades (culvert - DCS001)  
Highway 2 near Robert Scott Drive

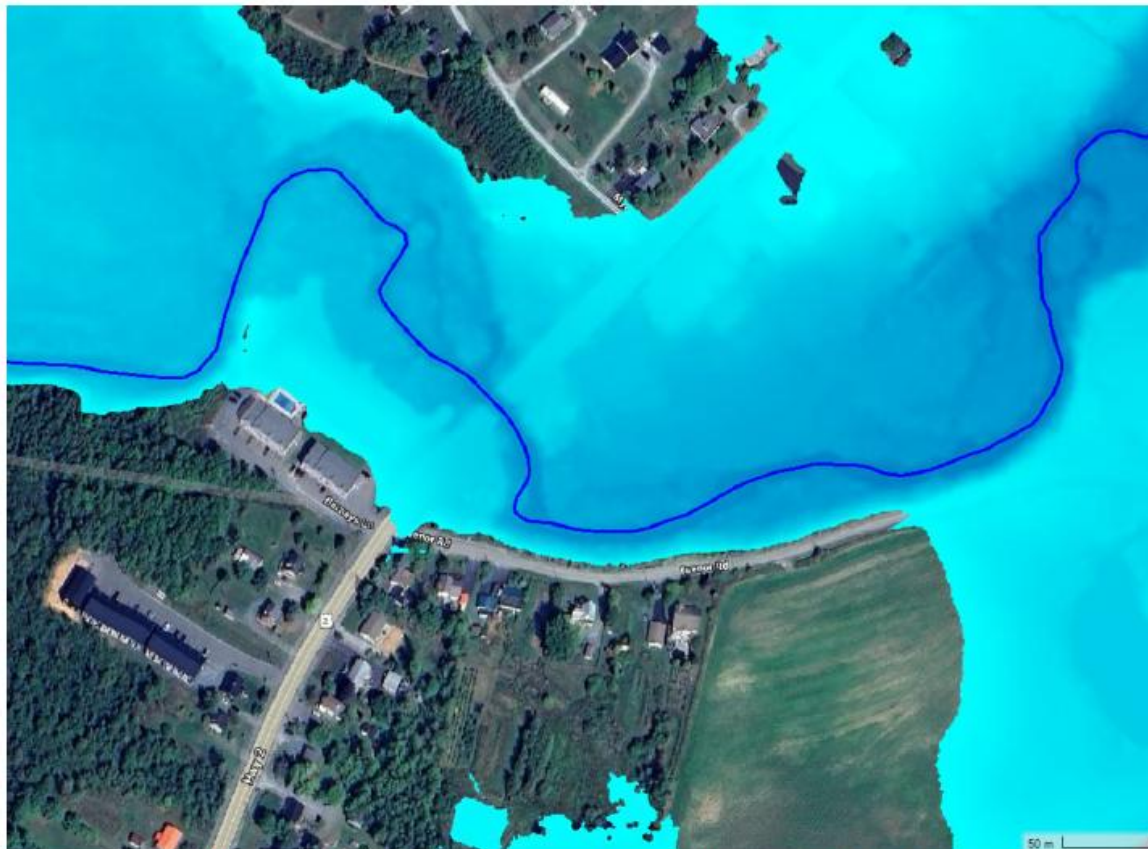
### 3. Hwy 2 between Barneys Lane and Myers Lane

Figure 12: Highway 2 between Barneys Lane and Myers Lane- 1% AEP 2100 Climate Change

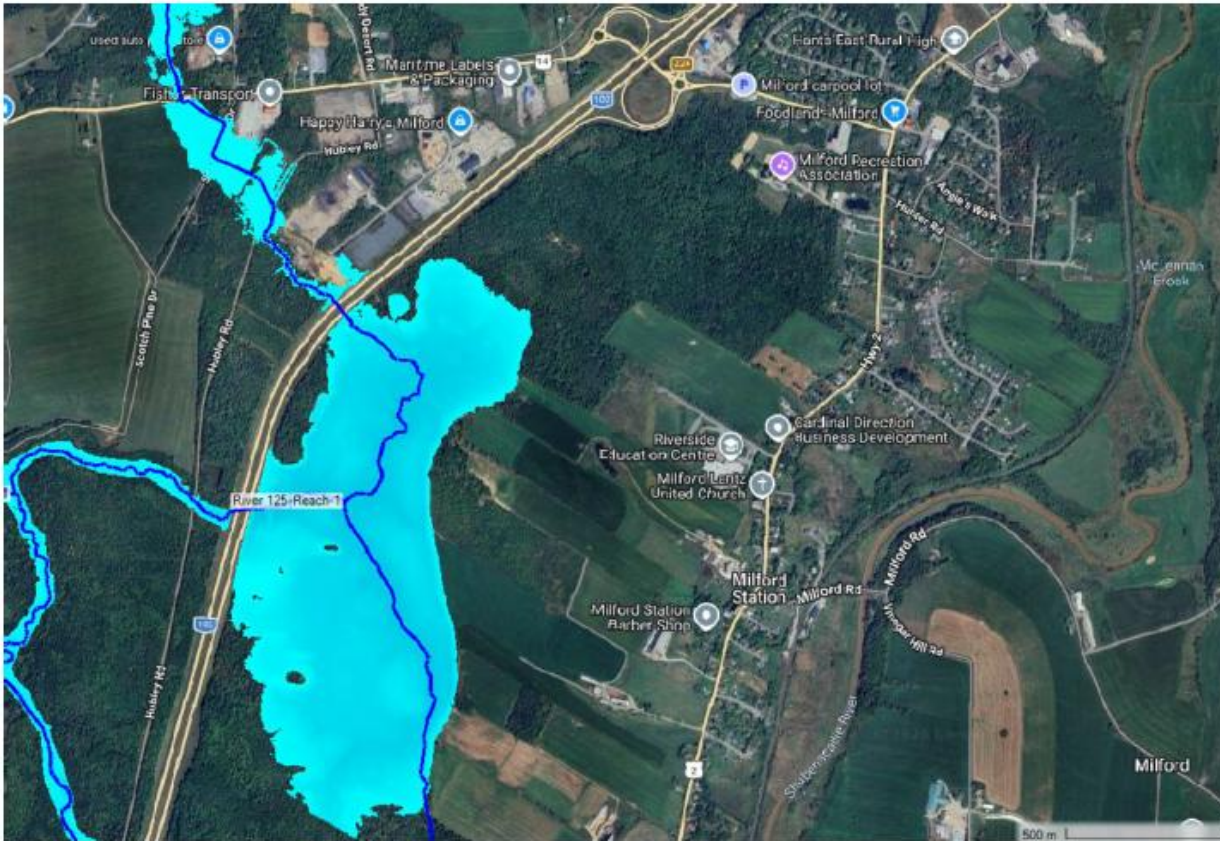
## 4. Hwy 102: The East side of Highway 102 towards the Northern end of the watershed

Figure 14: Highway 102 Flood Extent - 1% AEP 2100 Climate Change

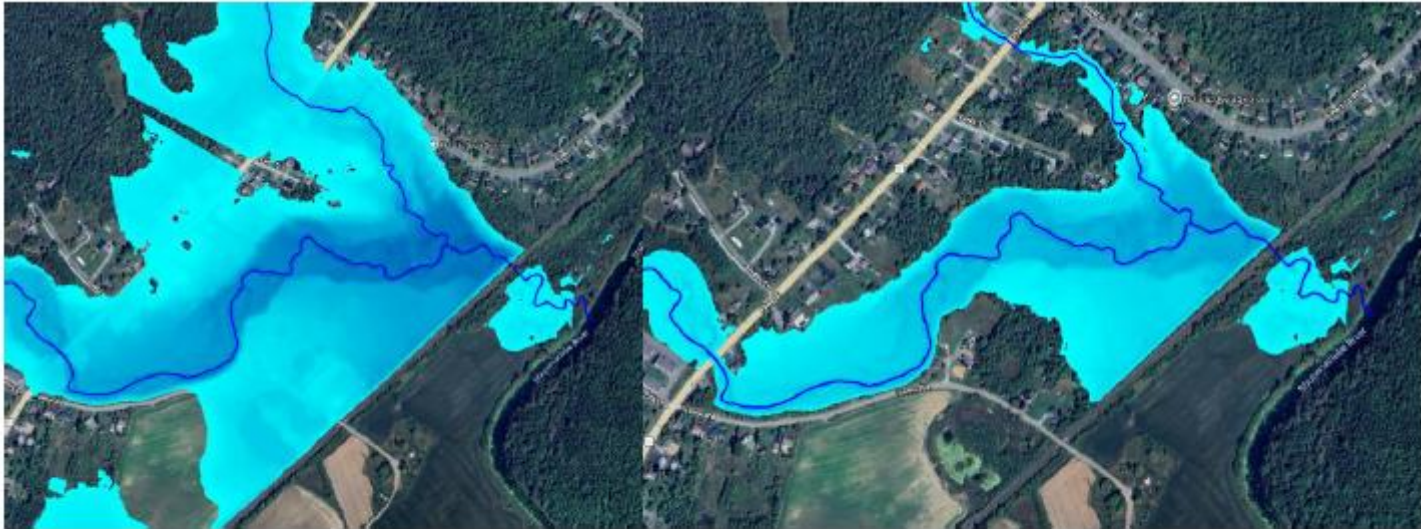
## Recommendation #1: DCS007 at the outlet of the system under the CN Railway

Figure 15: Outlet of the system with triple barrel upgrade (existing condition left, proposed recommendations right)– 1% AEP (2100)

Structure ID	Location	Existing Size and Material	Proposed Recommendation	Existing Conditions Water Elevations – Climate Change (1% AEP)*	Proposed Upgrade Water Elevations – Climate Change (1% AEP)*	Elevation Difference*
DBS001	Highway 14 near Moxsom Rd	1 x 2,400 Corrugated Metal Semi-Circular Culvert at DCS007	3 x 2,800mm Concrete Circular Culverts at DCS007	17.5	14.4	3.1
DCS001	Highway 2 near Robert Scott Dr			17.5	15.2	2.3
DCS007	Outlet of Barneys Brook			17.5	14.5	3.0

- **Information Sharing:**
  - Hydraulic modelling results and simulated energy grade line profiles can be provided to CN Rail to illustrate the impact of the existing culvert bottleneck on upstream water surface elevations. Based on preliminary results presented in this study, Dillon recommends an upgrade from the existing infrastructure at the railway crossing to triple barrel concrete 2,800 mm culverts to reduce upstream water surface elevations.

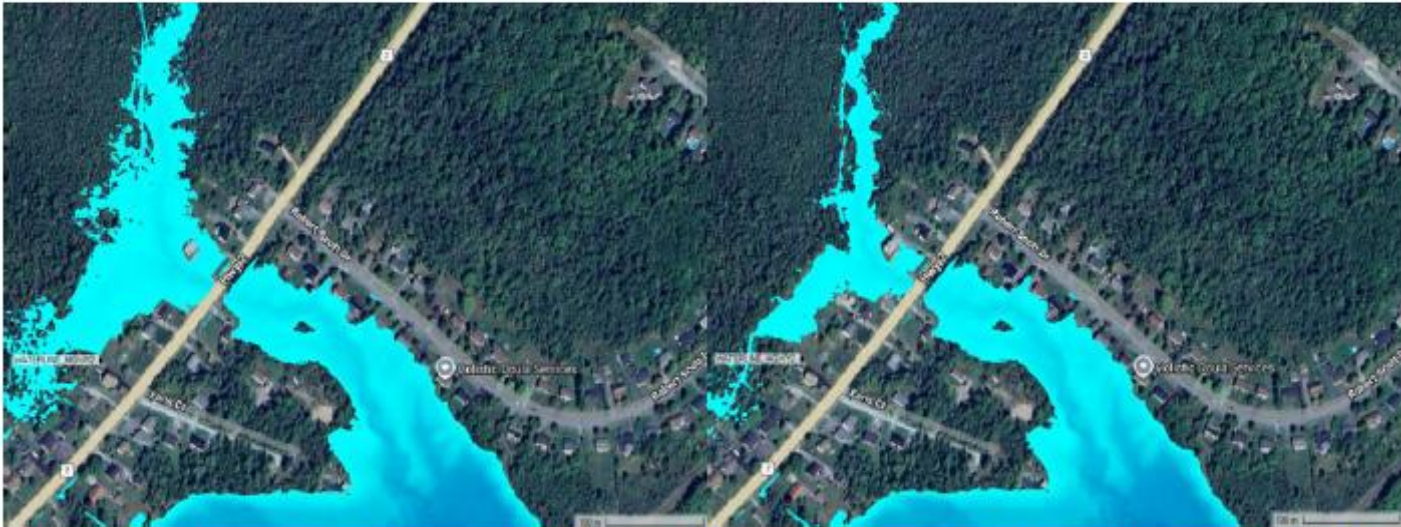
## Recommendation #2: DCS001 Highway 2 near Robert Scott Drive

Figure 16: Highway 2 near Robert Scott Drive with twin 2,400mm upgrade (existing condition left, proposed recommendations right)– 1% AEP (Existing)

Structure ID	Location	Existing Size and Material	Proposed Recommendation	Existing Conditions Water Elevations – Existing (1% AEP)*	Proposed Upgrade Water Elevations – Existing (1% AEP)*	Elevation Difference*
DCS001	Highway 2 near Robert Scott Drive	A 900mm Steel Circular Culvert and a 1,500mm Concrete Circular Culvert.	Twin 2,400mm Circular Concrete Culvert	15.86	15.63	0.23

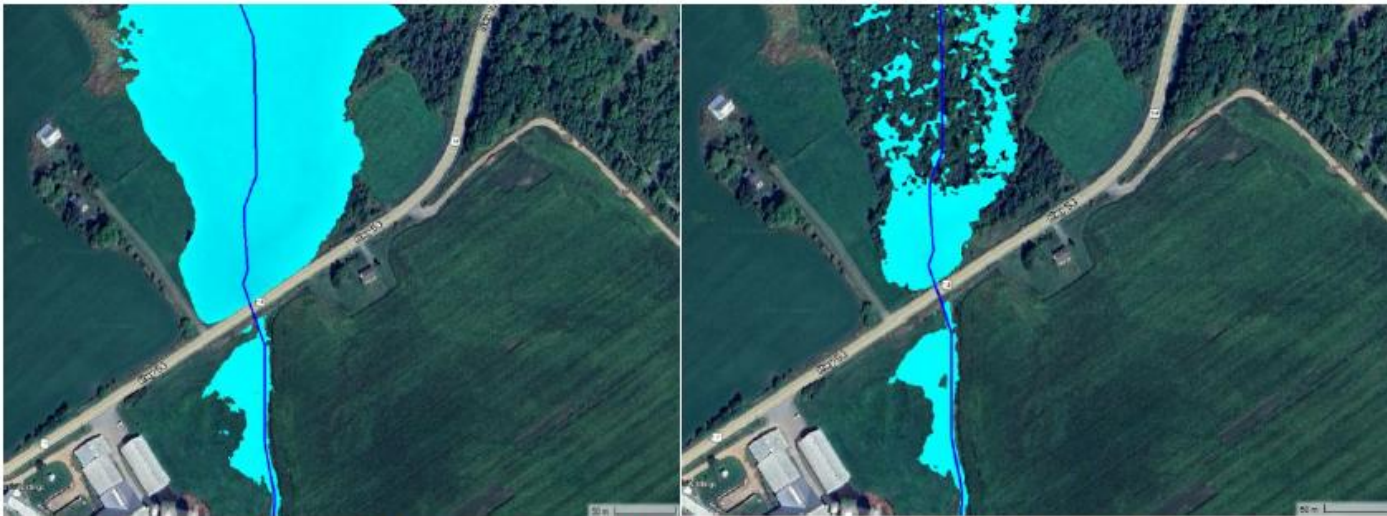
## Recommendation #3: DCS005 Highway 14 near Moxsom Road

Figure 17: Highway 1 near Moxsom Road with 1,200mm upgrade (existing condition left, proposed recommendations right)– 1% AEP (2100)

Structure ID	Location	Existing Size and Material	Proposed Recommendation	Existing Conditions Water Elevations – Climate Change (1% AEP)*	Proposed Upgrade Water Elevations – Climate Change (1% AEP)*	Elevation Difference*
DCS005	Highway 14 near Moxsom Rd	900 mm Circular Concrete Culvert	1,200 mm Circular Concrete Culvert	47.98	46.70	1.3
