**Re: Geotechnical Investigation – Proposed Building Development
Lot 92-5a1, Commerce Court, Elmsdale, NS**

This is our geotechnical investigation report for the proposed building development at Lot 92-5a1 on Commerce Court in Elmsdale, NS. It is understood that the lot is intended to be developed for new municipal infrastructure, possibly home to the new Municipal Aquatic Centre. The subsurface conditions are generally good for conventional spread footing foundations and a grade slab.

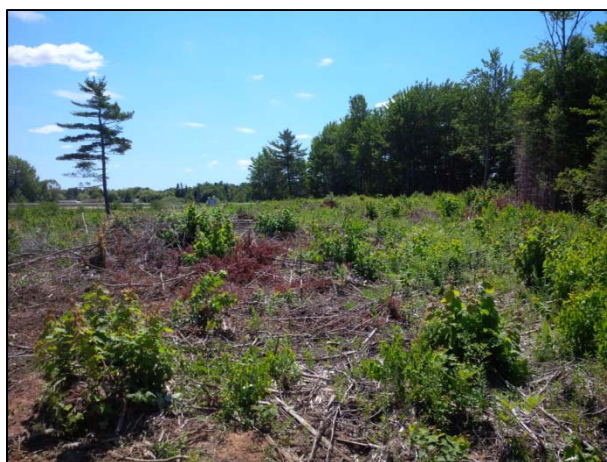
The proposed building development is located at Lot 92-5a1 on Commerce Court in Elmsdale, Nova Scotia. The proposed development is currently an undeveloped lot covered in vegetation (most trees have been removed).

Photograph A: View of the site looking south.

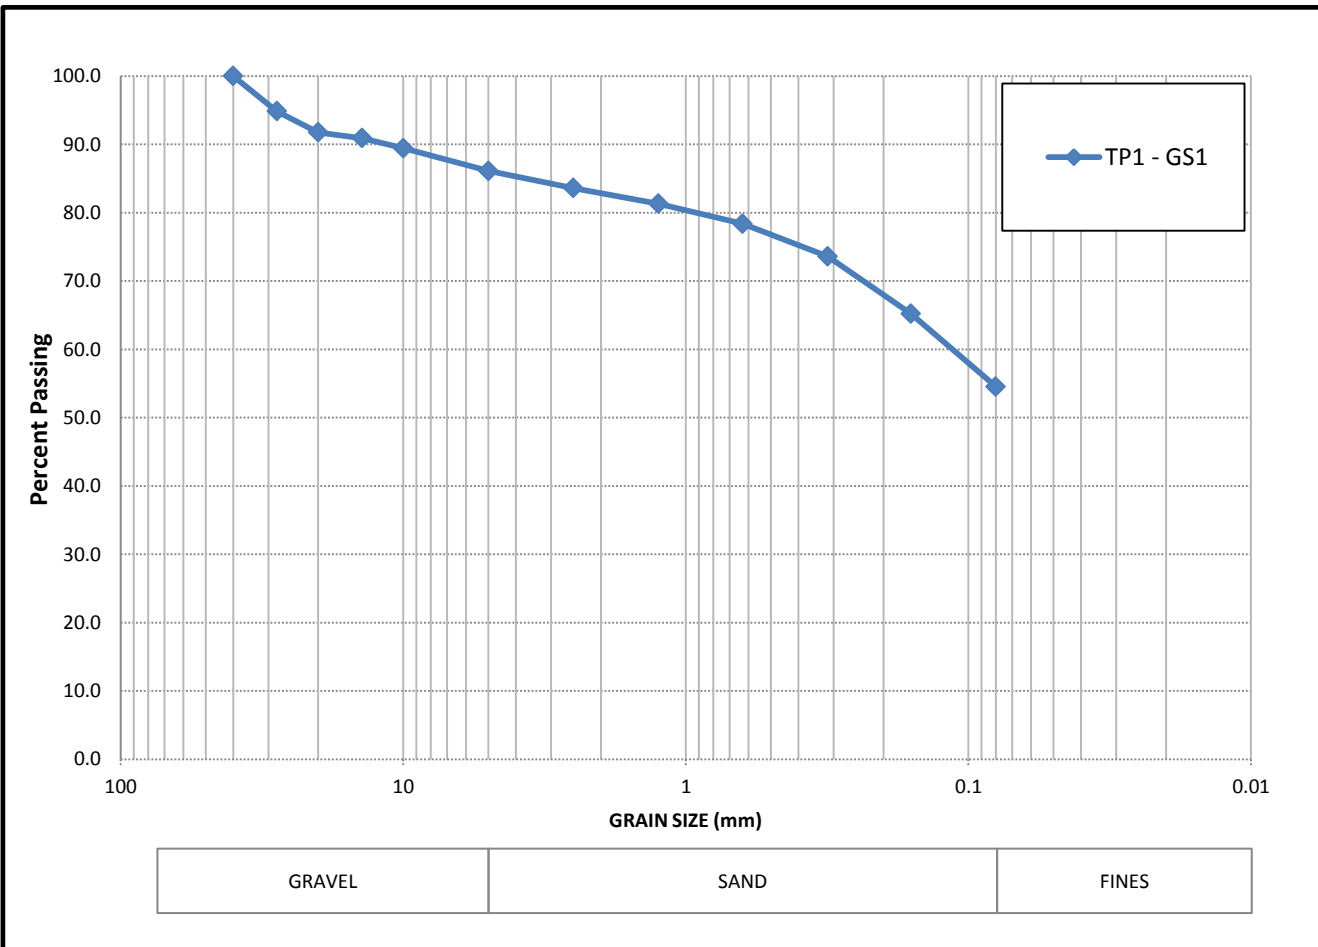
GRAIN SIZE DISTRIBUTION PLOT

Grain size testing conducted on one sample of the native glacial till shows 14% gravel, 32% sand, and 55% fines (silt and clay). Moisture content of the sample was 10.9%. The grain size curve is shown in Figure 1 in the appendix.

Sample No	Depth	Classification	Moisture Content (%)	Gravel (%)	Sand (%)	Silt and Clay (%)
TP1 - GS1	1.2 m	Sandy lean clay (CL)	10.9	14	32	55

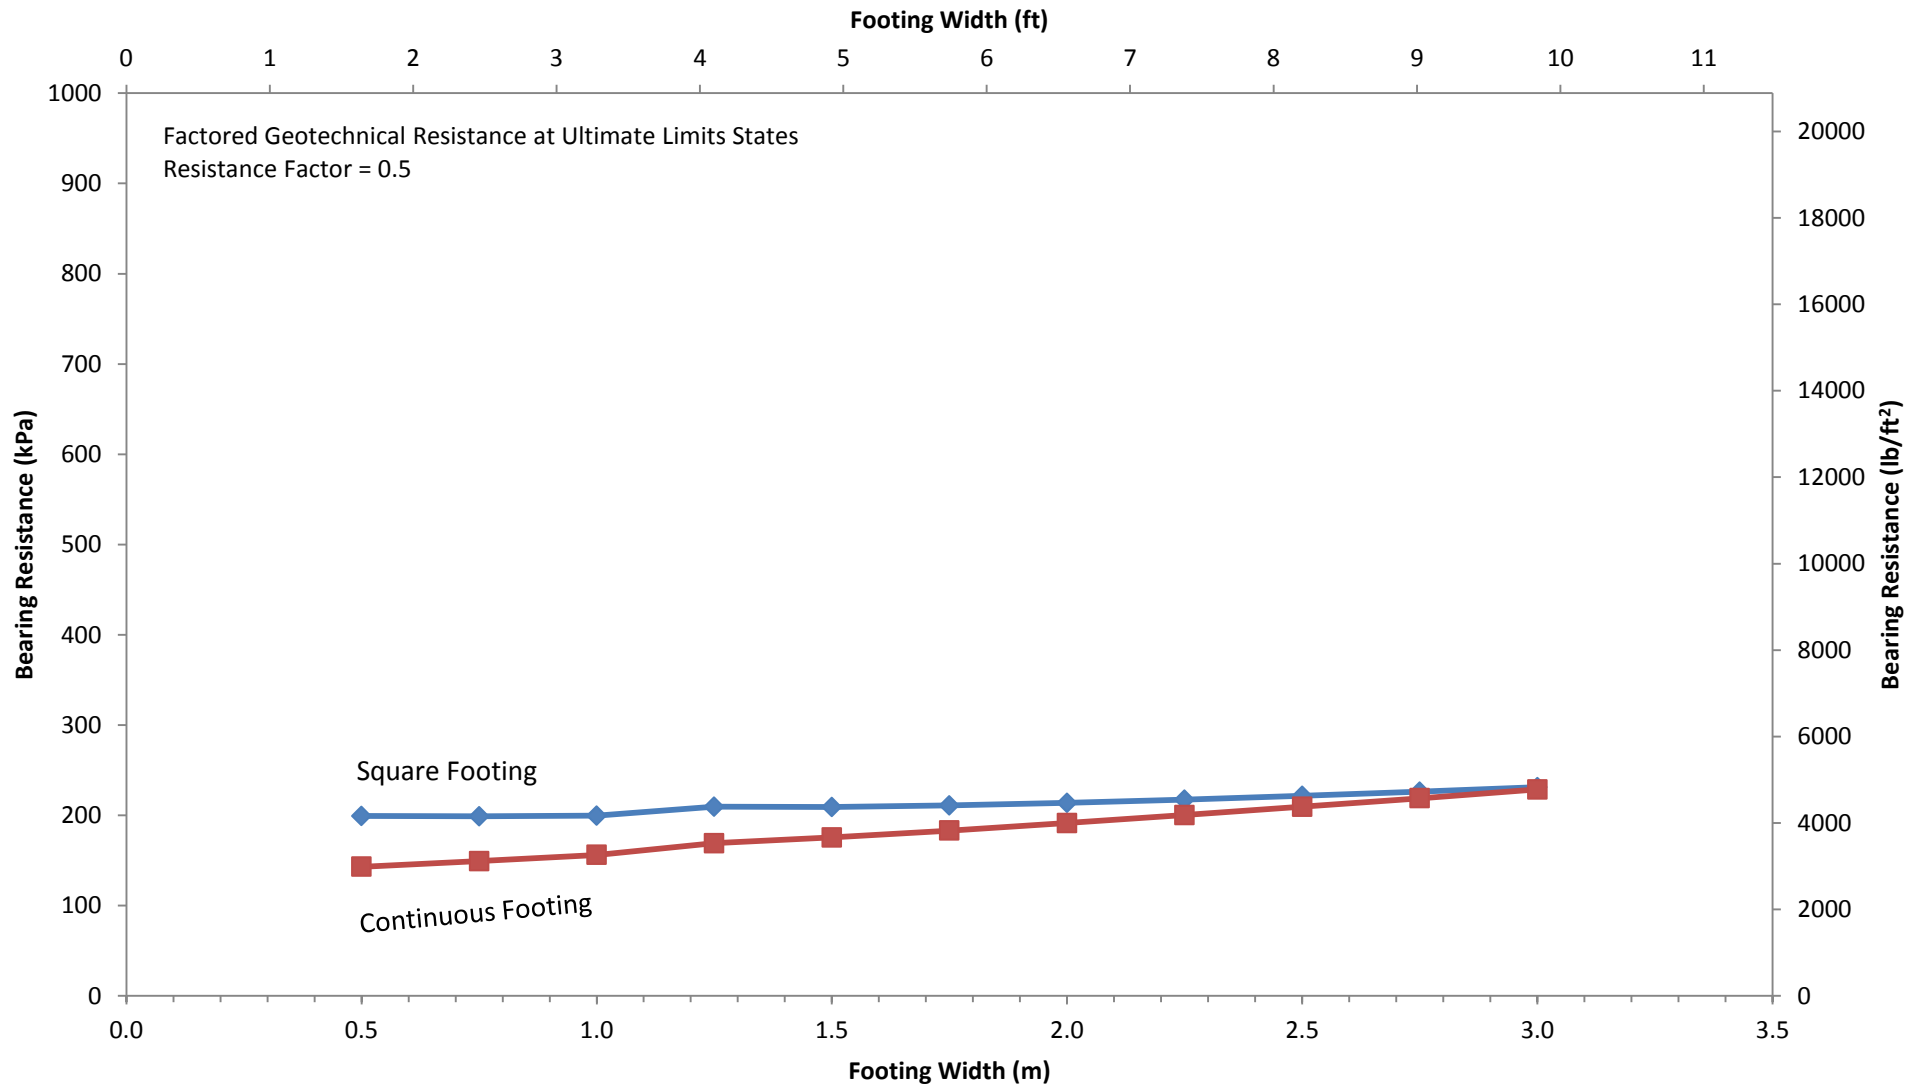
Figure 2

For analysis using Limit States Design, we calculated bearing capacities for square and strip footings up to 3 m for a settlement tolerance of 25 mm. Other bearing capacities for other footing sizes (or settlement tolerances) can be provided at your request. Bearing resistance values for square and strip footings founded on native soil or structural fill are plotted on Figures 2 and 3 in the appendix.

FACTORED ULS BEARING RESISTANCE (NATIVE SOIL OR STRUCTURAL FILL)

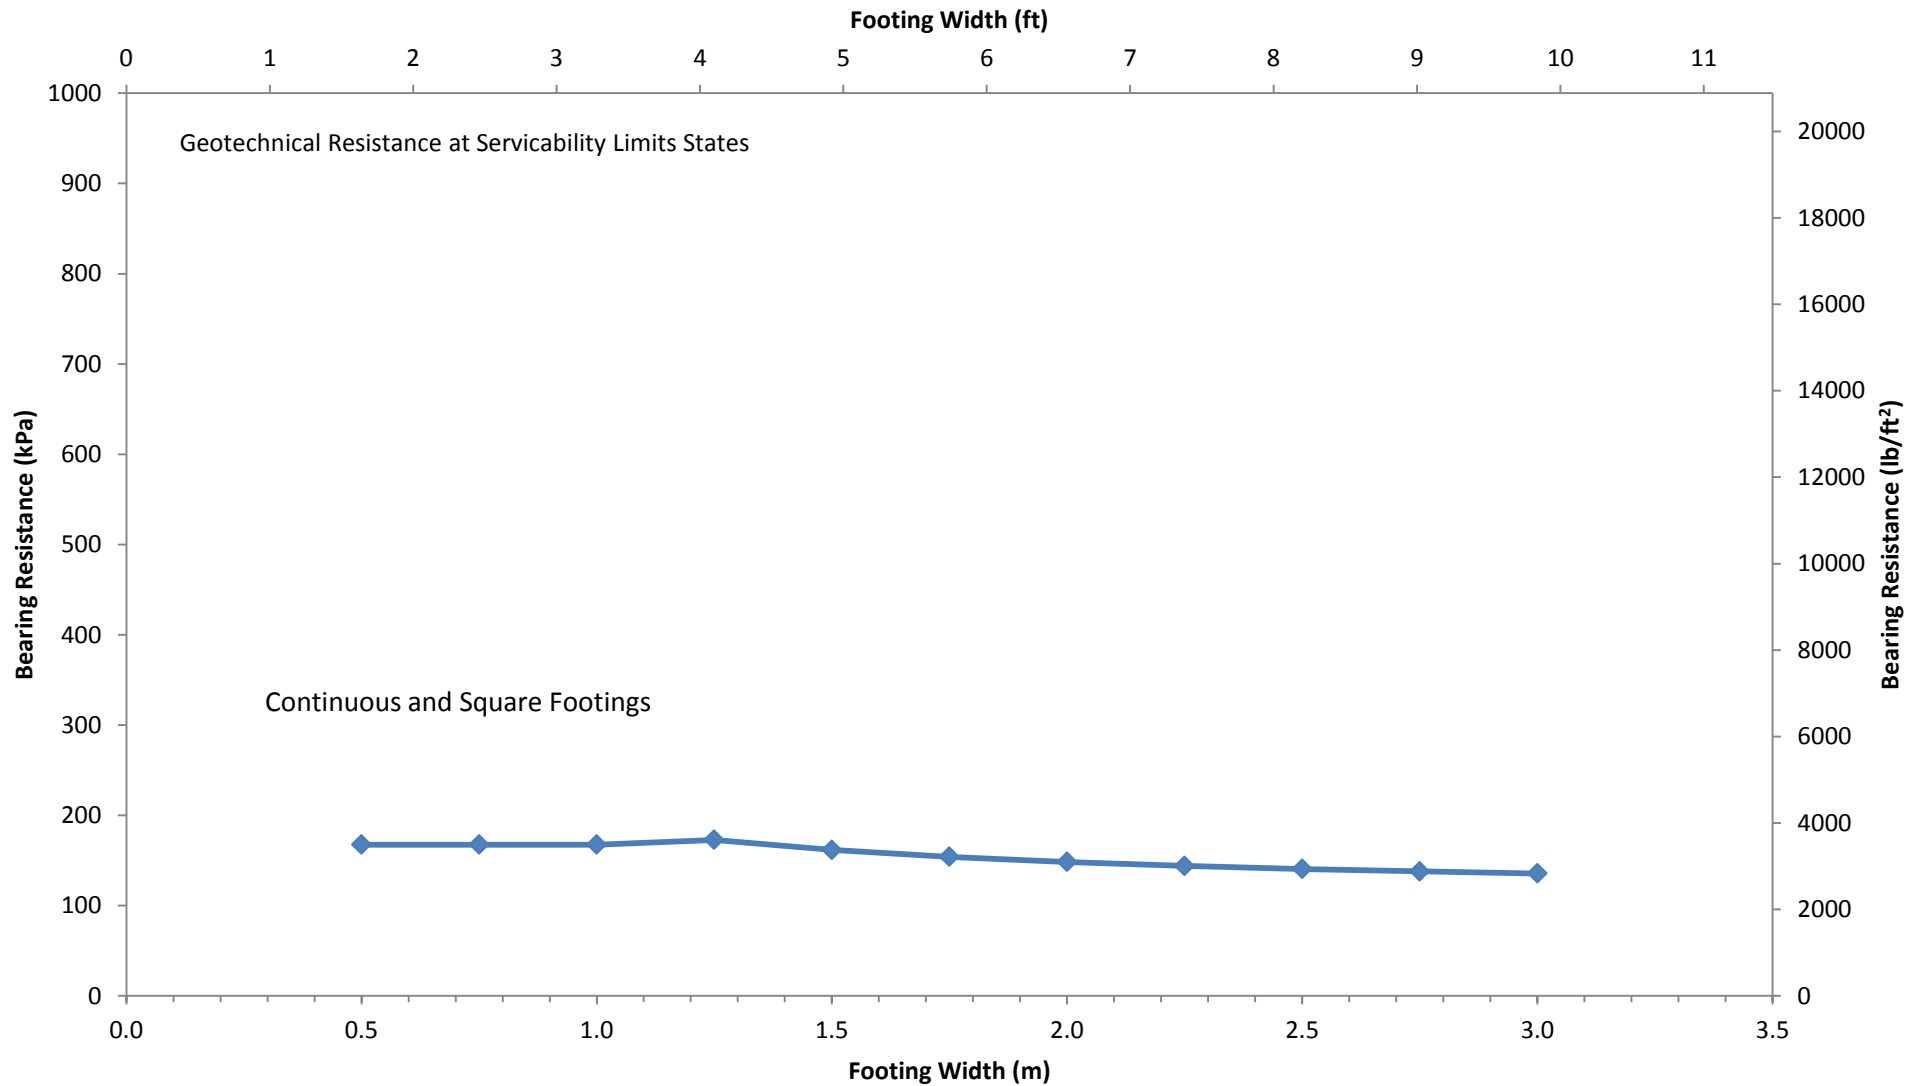
Figure 3

SLS BEARING RESISTANCE (NATIVE SOIL OR STRUCTURAL FILL)

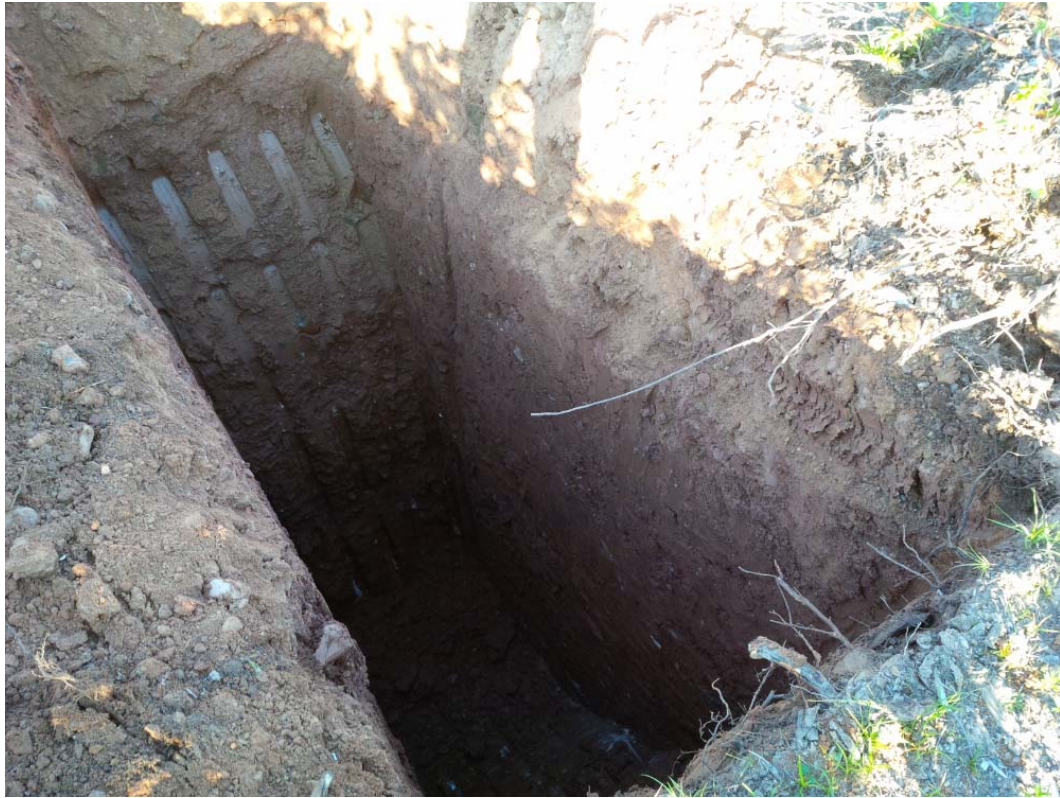
Depth (m)	Symbol	Soil and/or Rock Description	Elevation (m)	Water Level (m)	Type	Number	Comments
0		Ground Surface	20.7				
		RE-WORKED TILL: Stiff, light brown, sandy clay -trace organics -trace gravel -subrounded to subangular clasts -dry to moist	20.2				
1		TILL: Very stiff to hard, brown, sandy clay -trace gravel and cobbles -subrounded to subangular clasts -moist					
					GS	1	Moisture Content = 10.9%
2							
3							
4							
			16.1		GS	2	
5		End of Test Pit at 4.6 m -no bedrock encountered -no groundwater encountered

Photograph 1: Test Pit 101. August 3, 2016.

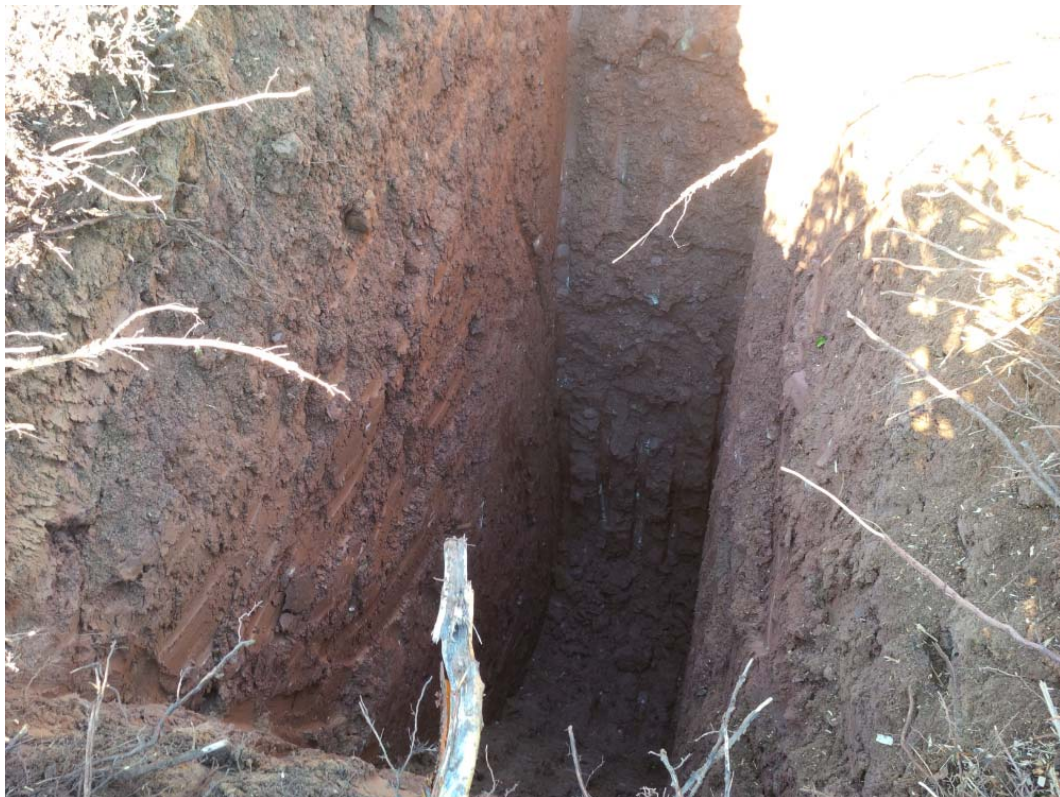
Depth (m)	Symbol	Soil and/or Rock Description	Elevation (m)	Water Level (m)	Type	Number	Comments
0		Ground Surface	19.3				
		ROOTMAT	19.2				
		TILL: Loose, grey, silty sand -trace roots/rootlets -trace gravel	18.8		GS	1	
		-subrounded to subangular clasts -moist to wet					
1		TILL: Stiff, light brown, sandy clay -trace gravel and cobbles -subrounded to subangular clasts -moist	18.2				
		TILL: Very stiff to hard, brown, sandy clay -trace gravel -trace cobbles and boulders (up to 1.0 m in diameter) -subrounded to subangular clasts -moist					
2							
3							
4							
5

Photograph 2: Test Pit 102. August 3, 2016.

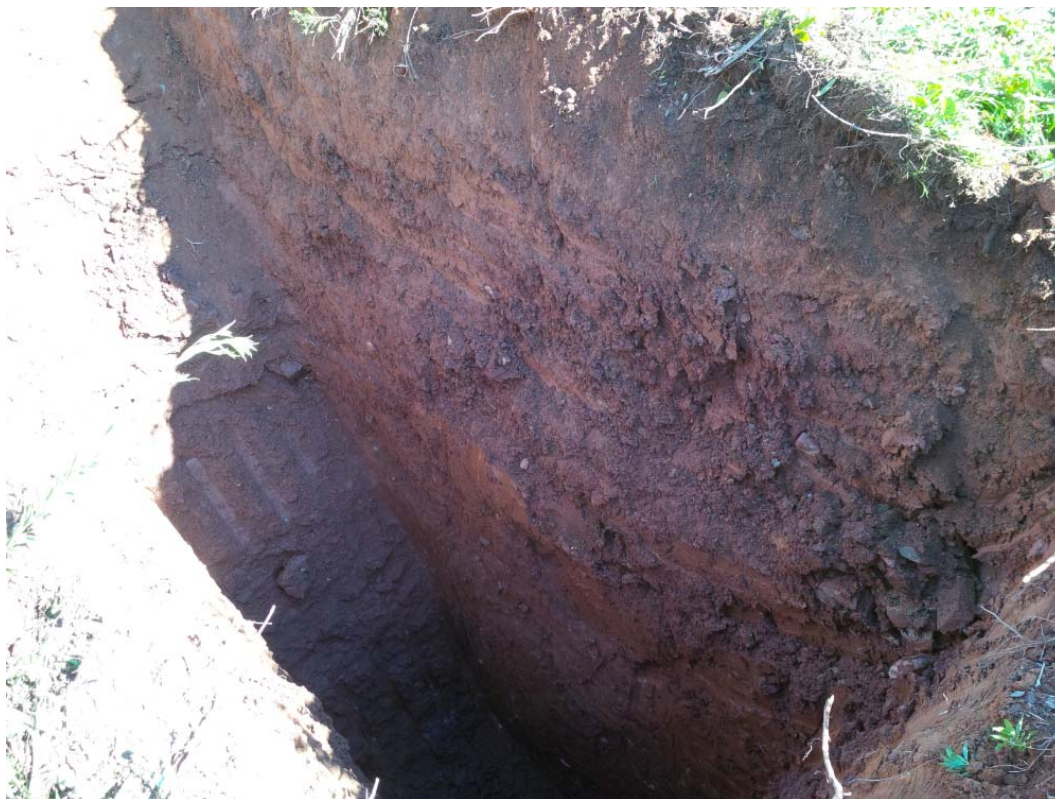
Depth (m)	Symbol	Soil and/or Rock Description	Elevation (m)	Water Level (m)	Type	Number	Comments
0		Ground Surface	20.2				
		ROOTMAT	20.1				
		TILL: Loose, grey, silty sand -trace rootlets -trace gravel	19.7				
		-subrounded to subangular clasts -moist					
1		TILL: Stiff, light brown, sandy clay -trace gravel -trace cobbles and boulders (up to 0.3 m in diameter) -subrounded to subangular clasts -moist	19.0				
		TILL: Very stiff to hard, brown, sandy clay -trace gravel -trace cobbles and boulders (up to 0.3 m in diameter) -subrounded to subangular clasts -moist					
2							
3							
4							
5		End of Test Pit at 5.0 m -no bedrock encountered -no groundwater encountered	15.2

Photograph 3: Test Pit 103. August 3, 2016.

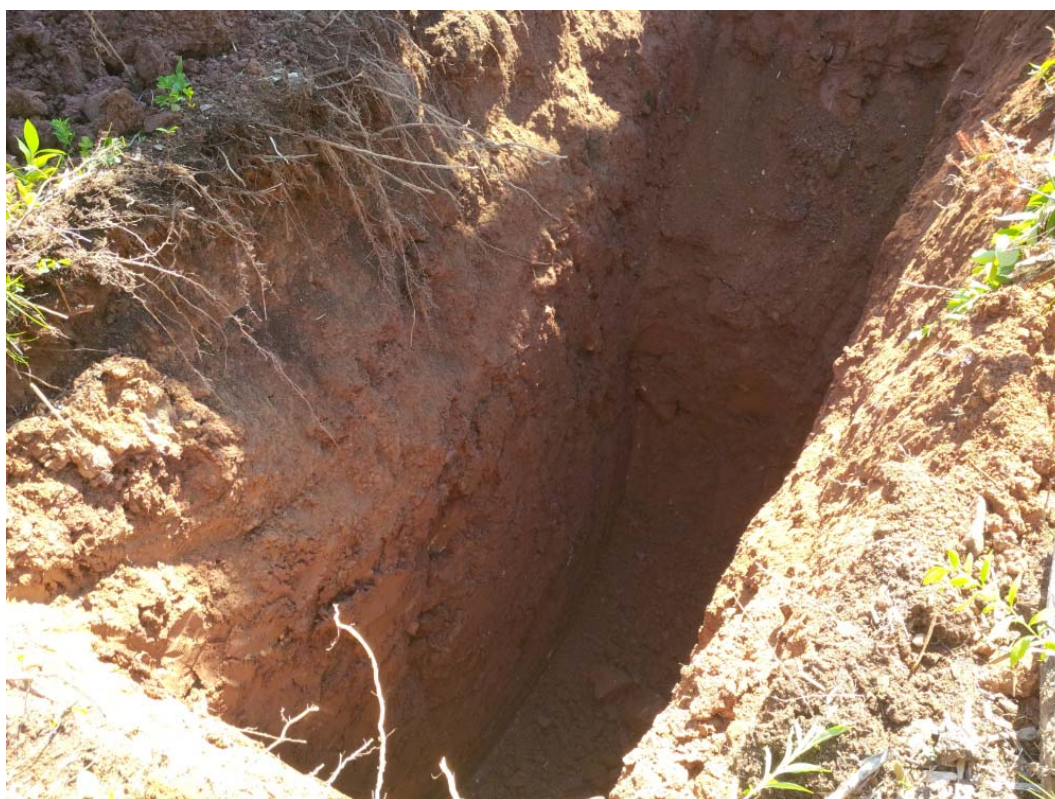
SUBSURFACE PROFILE				SAMPLE			Comments
Depth (m)	Symbol	Soil and/or Rock Description	Elevation (m)	Water Level (m)	Type	Number	
0		Ground Surface	21.0				
		ROOTMAT	20.9				
		TILL: Loose, grey, silty sand -trace rootlets -trace gravel -subrounded to subangular clasts -moist	20.5				
1		TILL: Stiff, light brown, sandy clay -trace gravel -trace cobbles and boulders (up to 0.5 m in diameter) -subrounded to subangular clasts -moist	19.8				
		TILL: Very stiff to hard, brown, sandy clay -trace gravel -trace cobbles and boulders (up to 0.5 m in diameter) -subrounded to subangular clasts -moist			GS	1	
2							
3							
			17.2				
4		End of Test Pit at 3.8 m -no bedrock encountered -no groundwater encountered					
5

Photograph 4: Test Pit 104. August 3, 2016.

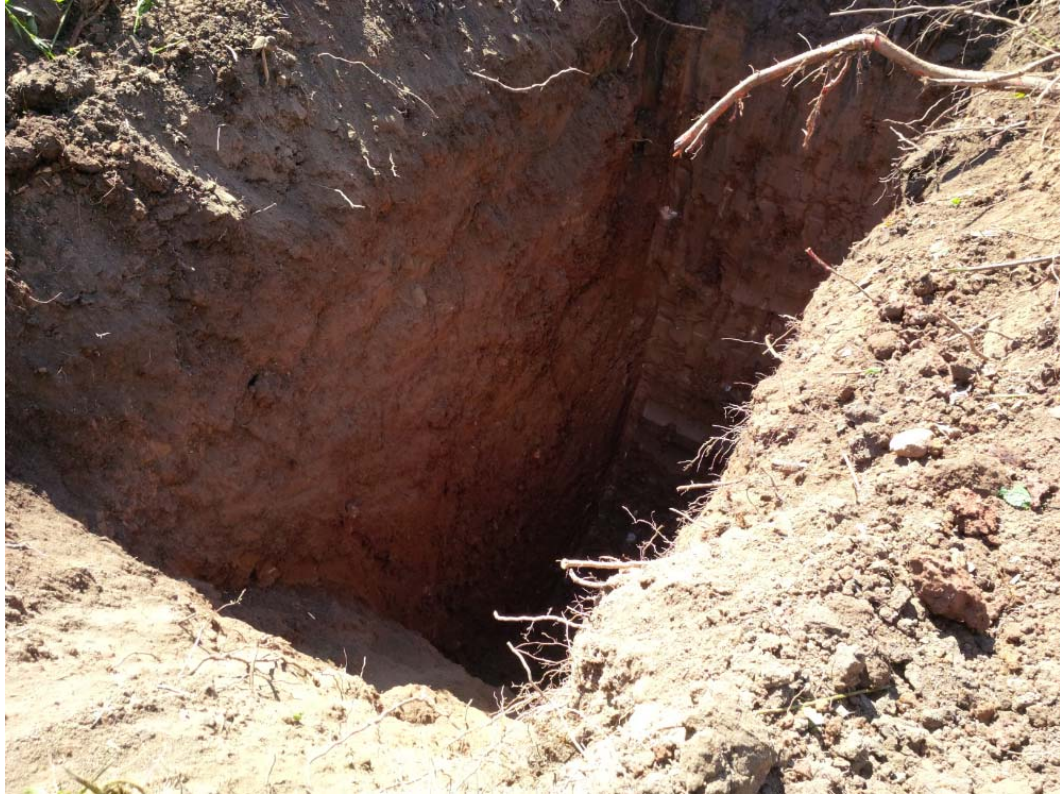
Depth (m)	Symbol	Soil and/or Rock Description	Elevation (m)	Water Level (m)	Type	Number	Comments
0		Ground Surface	20.3				
		ROOTMAT	20.2				
		CLAY: Stiff, dark grey, clay -trace rootlets and organics -trace sand -subrounded to subangular clasts -dry to moist	19.5		GS	1	
1		TILL: Loose to compact, brown, silty sand -trace rootlets -trace gravel -subrounded to subangular clasts -moist	19.2				
2		TILL: Very stiff to hard, brown, sandy clay -trace gravel -trace cobbles and boulders (up to 0.3 m in diameter) -subrounded to subangular clasts -moist					
3							
4		End of Test Pit at 3.8 m -no bedrock encountered -no groundwater encountered	16.5				
5

Photograph 5: Test Pit 105. August 3, 2016.

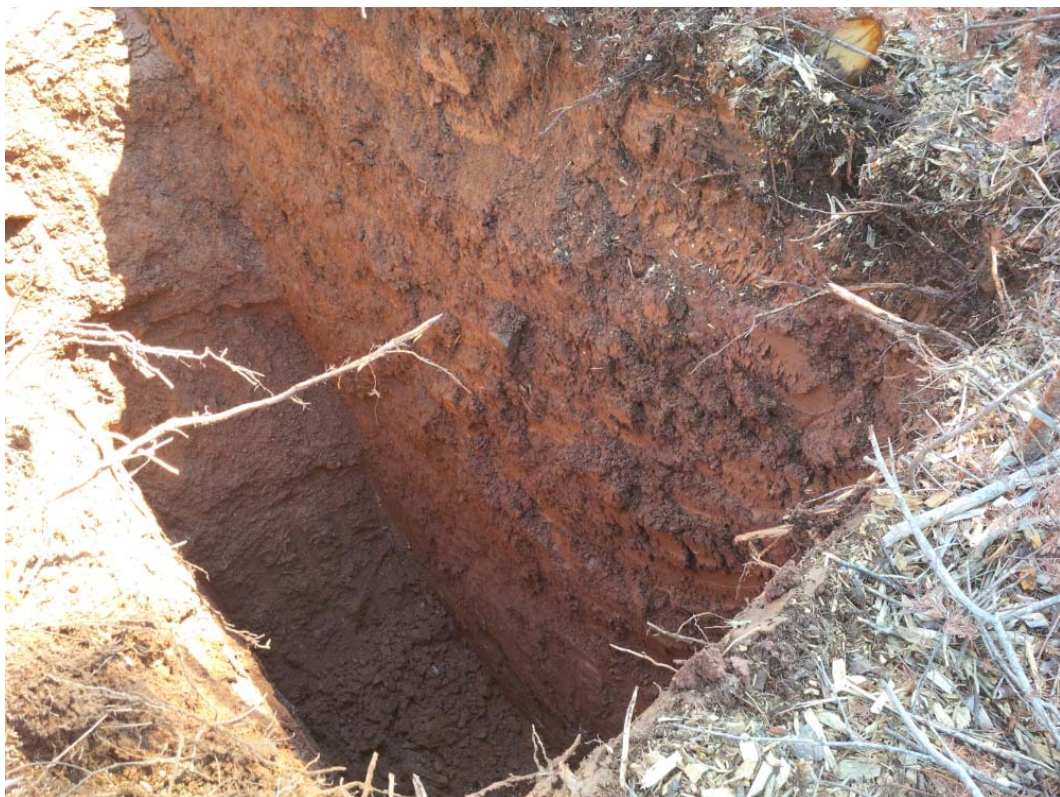
Depth (m)	Symbol	Soil and/or Rock Description	Elevation (m)	Water Level (m)	Type	Number	Comments
0		Ground Surface	20.2				
		ROOTMAT	20.0				
		TILL: Loose to compact, brown, silty sand -trace gravel -subrounded to subangular clasts -moist	19.6				
1		TILL: Stiff, brown, sandy clay -trace gravel and cobbles -subrounded to subangular clasts -moist	19.3				
2		TILL: Very stiff to hard, brown, sandy clay -trace gravel and cobbles -subrounded to subangular clasts -moist					
3							
4			16.1				
		End of Test Pit at 4.1 m -no bedrock encountered -no groundwater encountered					
5

Photograph 6: Test Pit 106. August 3, 2016.

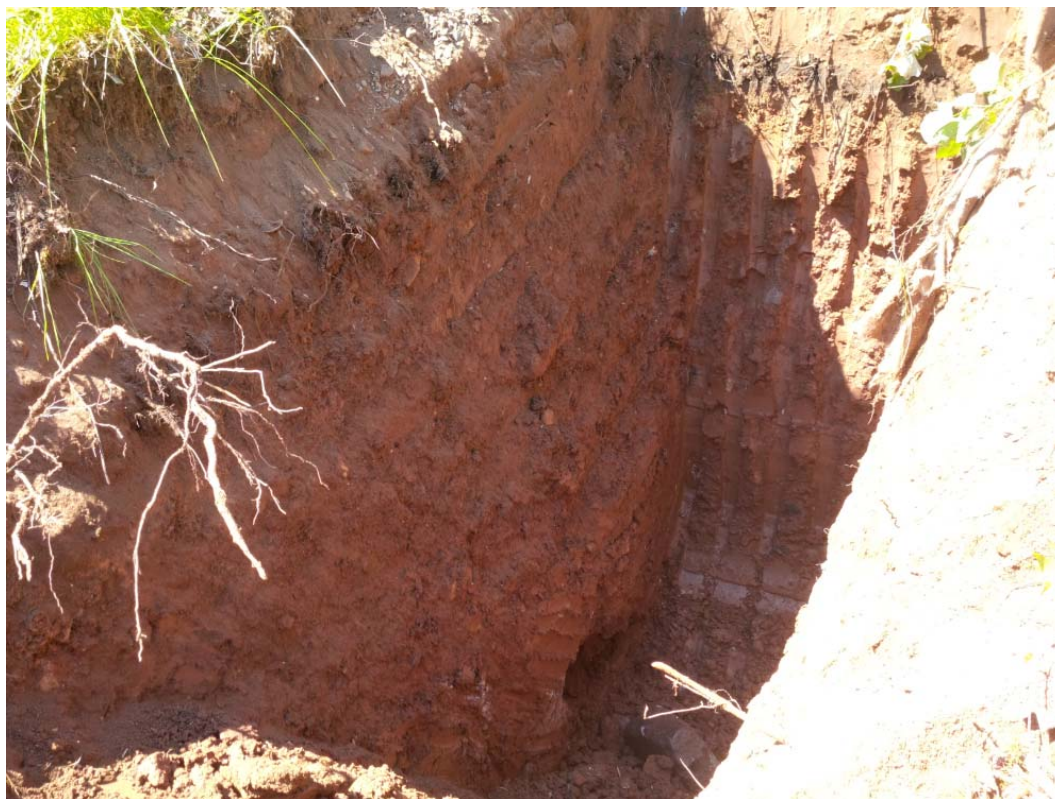
Depth (m)	Symbol	Soil and/or Rock Description	Elevation (m)	Water Level (m)	Type	Number	Comments
0		Ground Surface	22.0				
		FILL: Loose to compact, brown, sand with gravel -french drain at surface -15 mm of rootmat at surface -subrounded to subangular clasts -moist	21.4				
		ROOTMAT	21.3				
		TILL: Loose to compact, light brown, silty sand -trace gravel -subrounded to subangular clasts -moist	21.1				
1		TILL: Very stiff, brown, sandy clay -trace to some gravel -trace cobbles and boulders (up to 0.6 m in diameter) -subrounded to subangular clasts -moist					
2							
3							
4		End of Test Pit at 3.8 m -no bedrock encountered -no groundwater encountered	18.2				
5

Photograph 7: Test Pit 107. August 3, 2016.

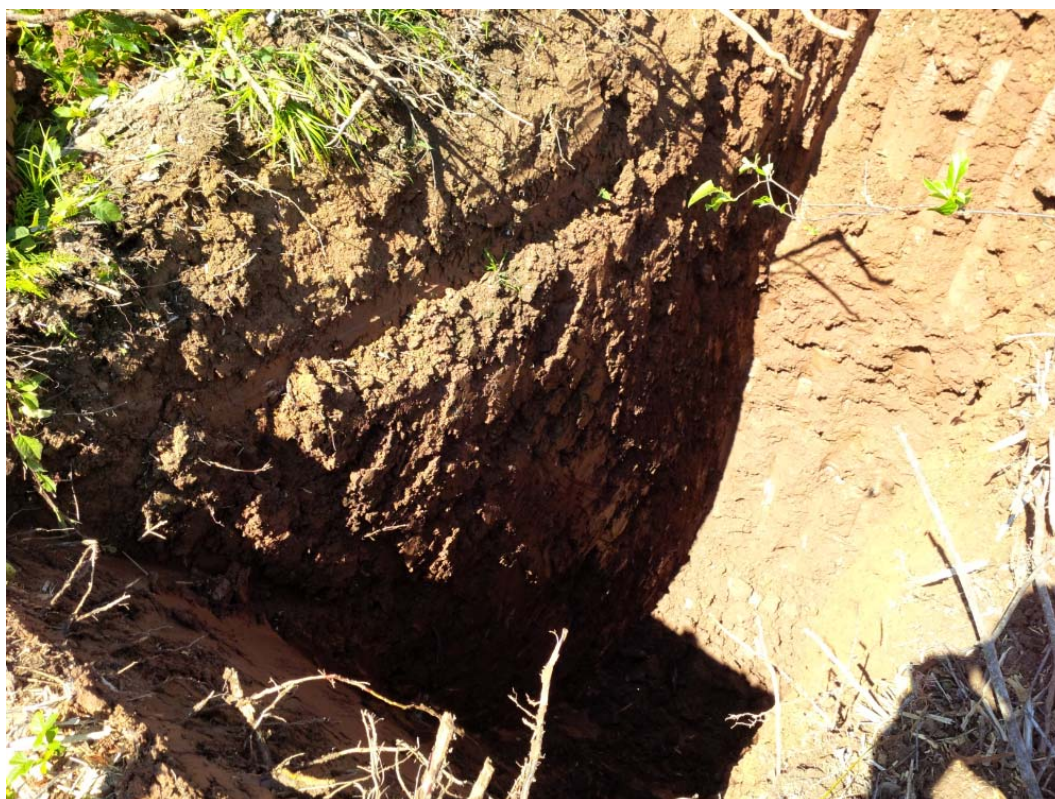
SUBSURFACE PROFILE				SAMPLE			Comments
Depth (m)	Symbol	Soil and/or Rock Description	Elevation (m)	Water Level (m)	Type	Number	
0		Ground Surface	19.9				
		ROOTMAT	19.8				
		TILL: Soft to stiff, brown, clayey sandy silt -trace rootlets -trace gravel -moist	19.1				
1		TILL: Stiff to very stiff, brown, sandy clay -trace gravel -trace boulders (up to 0.3 m in diameter) -subrounded to subangular clasts -moist					
2					GS	1	
3							
4		End of Test Pit at 3.8 m -no bedrock encountered -no groundwater encountered	16.1				
5

Photograph 8: Test Pit 108. August 3, 2016.
