Professional Engineering Study Services for Solar Panel Investigation

Municipality of East Hants Pool - Milford
August 2013

MSK-1 – Boiler & DHW Heater Schematics

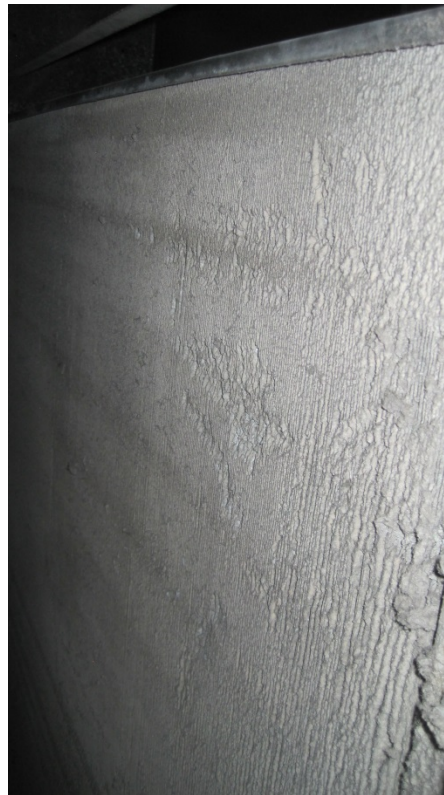
- .5 **Energy – Equipment Life Expectancy:** The dehumidification system was noted as being in fair to poor condition during our site investigation. The fresh air dampers were in poor shape, the pool air coil was extremely dirty, and the operational details of the system did not seem to be clear. An assessment of the dehumidification system by a qualified technician should be undertaken to review the operational performance. An integrated control strategy should be incorporated into the dehumidification system and the heating system including humidity levels, fresh air requirements, operational hours, etc. This may be a contributing factor to the increase in the oil energy bills.

(Figure 1) The air coil in the Dehumidification Unit

- Poor maintenance on the dehumidification system can contribute to increased oil costs as the dehumidifier will have to work harder in order to output the same energy to the pool air. Dirty coils will not transfer the energy as easily as clean coils.

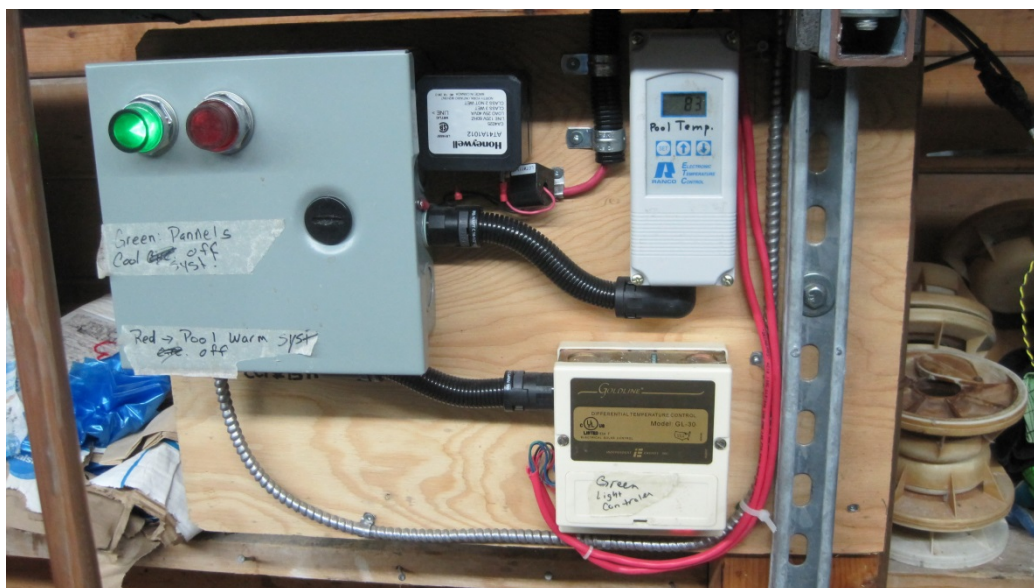
- .7 **Safety – Energy:** Some of the controls which were installed on the new solar heating system were noted during our site investigation as being faulty. The differential temperature controller (GL-30) which controls the circulator pumps on the solar array was malfunctioning at the time of our site investigation. This was noted to John Conrod and subsequently discussed with Babak Farsi. Some of the temperature sensors which are strapped to pipes are not fastened securely and are not making good contact with the pipes and under the pipe insulation. A comprehensive review should be undertaken by Scotian Renewables Inc. to make sure that all controls are working properly and are located and secured as intended by the original design. This may be a contributing factor to the increase in the oil energy bills.

(Figure 2) GL-30 controller
