**Re: Geotechnical Investigation, Rev.1 – Proposed Road (Revised Alignment)**  
**Mount Uniacke Business Park, Mount Uniacke, NS**

This provides the findings of our geotechnical investigation for the proposed road (revised alignment) in the Mount Uniacke Business Park on James Boyle Drive in Mount Uniacke, NS. Bedrock was encountered at shallow depths between 0.2 m to 2.1 m from existing grades in the recent test pits (TP101 to TP107). Blasting or hydraulic breaking may be needed depending on design grades. Recommendations are provided herein for road design and earthworks for the proposed development. This report was updated with the recent slate testing results and grain size testing results.

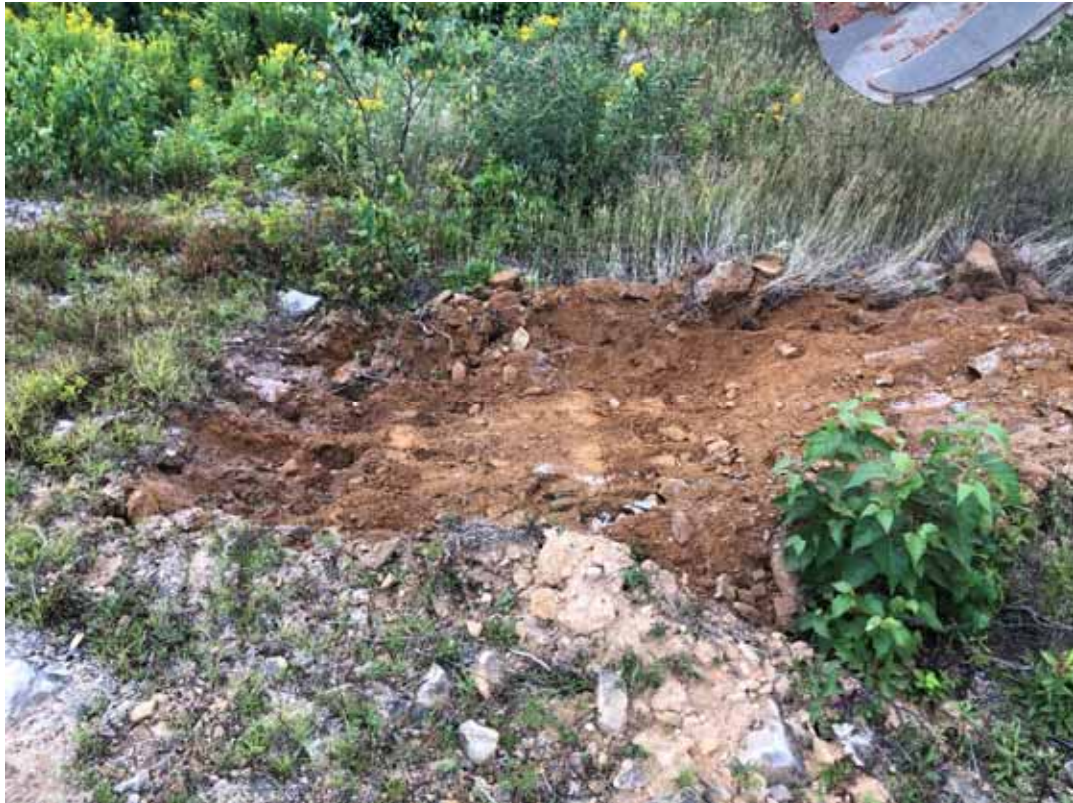
TILL: Compact light brown silty sand with gravel	159.3				
		End of Test Pit at 0.2 m - REFUSAL ON BEDROCK - no groundwater encountered					
1							
2							
3							
4							
5

Photograph 1: Test pit 101. August 20, 2019.

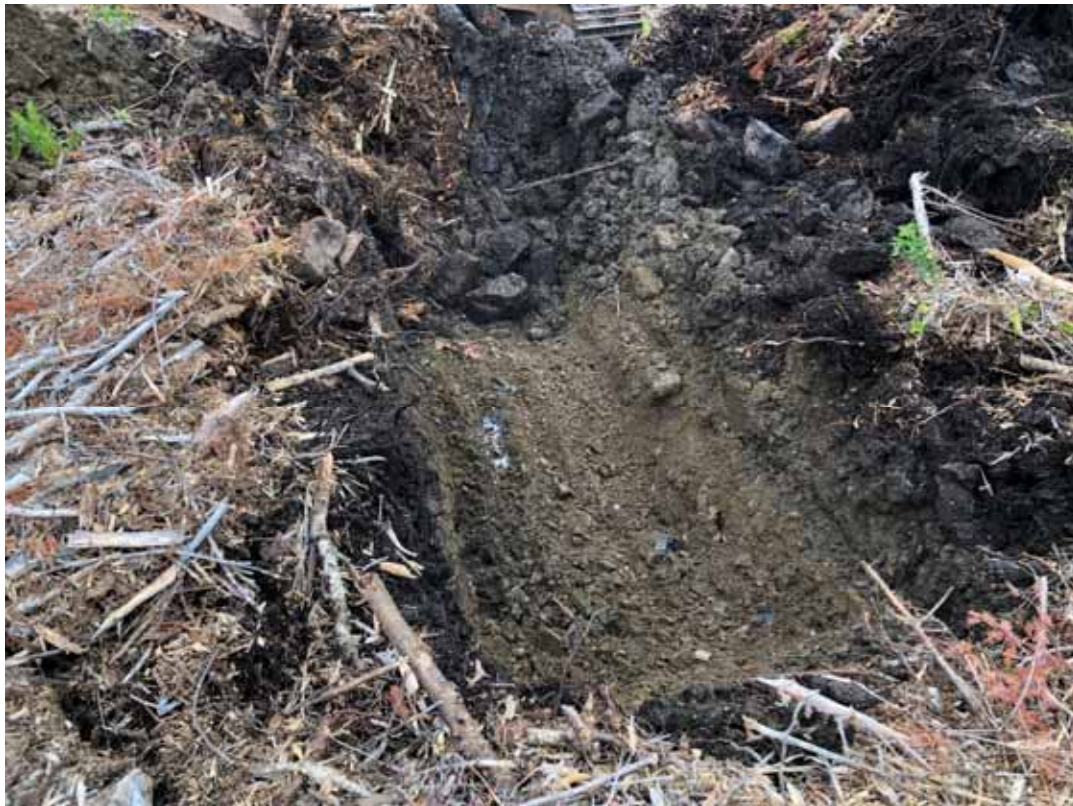
SUBSURFACE PROFILE				SAMPLE			Comments
Depth (m)	Symbols	SOIL AND/OR ROCK DESCRIPTION	Elevation (m)	Water Level (m)	Type	Number	
0		Ground Surface	150.7				
		ROOTMAT/TOPSOIL					
			150.2				
		TILL: Compact brownish grey silty sand with gravel					
1			149.5				
		WEATHERED BEDROCK	149.3				
		End of Test Pit at 1.4 m - REFUSAL ON BEDROCK - no groundwater encountered					
2							
3							
4							
5

Photograph 2: Test pit 102. August 20, 2019.

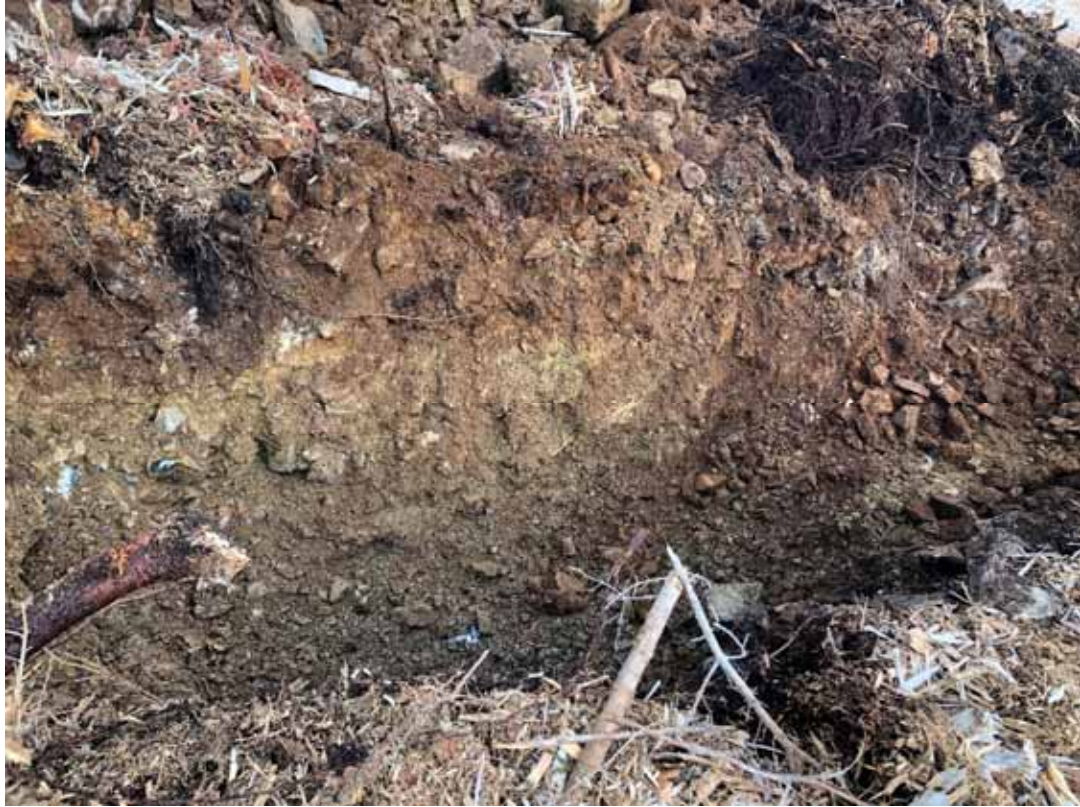
SUBSURFACE PROFILE				SAMPLE			Comments
Depth (m)	Symbols	SOIL AND/OR ROCK DESCRIPTION	Elevation (m)	Water Level (m)	Type	Number	
0		Ground Surface	148.2				
		ROOTMAT/TOPSOIL	147.9				
		TILL: Compact greyish brown silty sand with gravel - some cobbles					
1							
2		WEATHERED BEDROCK	146.1				
		End of Test Pit at 2.4 m - REFUSAL ON BEDROCK - slight to moderate seepage at 2.2 m	145.8				
3							
4							
5

Photograph 3: Test pit 103. August 20, 2019.

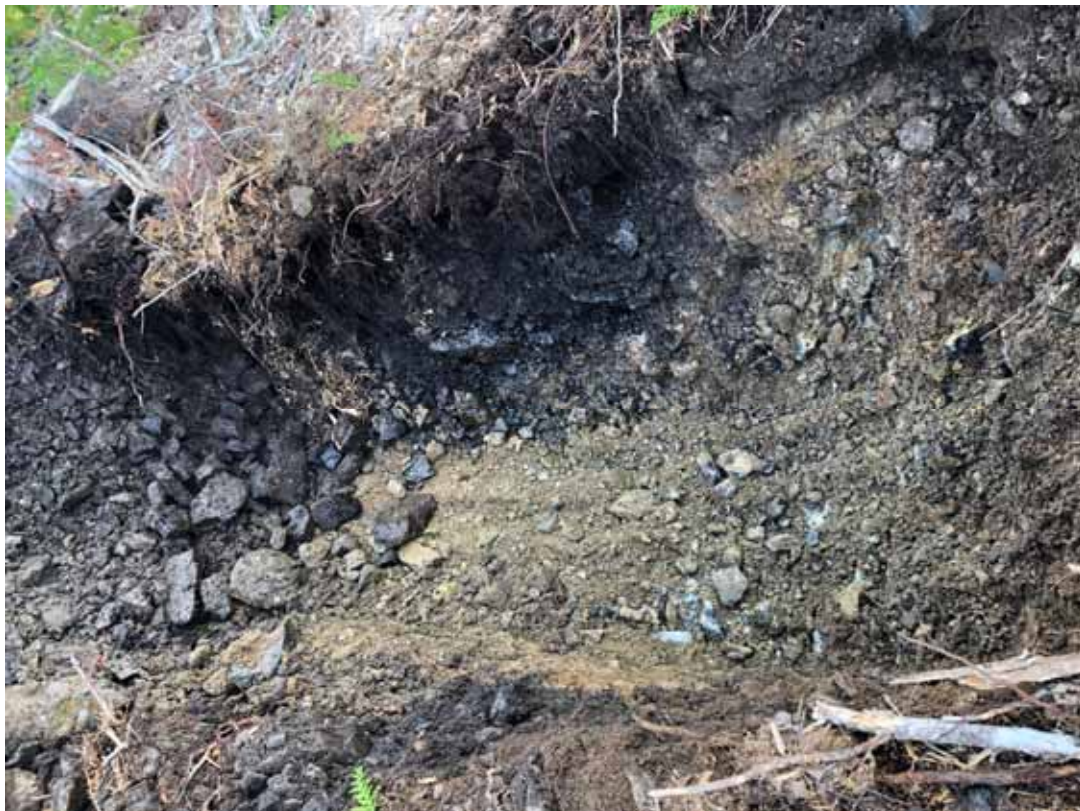
SUBSURFACE PROFILE				SAMPLE			Comments
Depth (m)	Symbols	SOIL AND/OR ROCK DESCRIPTION	Elevation (m)	Water Level (m)	Type	Number	
0		Ground Surface	144.3				
		ROOTMAT/TOPSOIL	144.1				
		TILL: Compact light grey to greyish brown silty sand with gravel - some cobbles					
1			143.1				
		WEATHERED BEDROCK					
			142.6				
2		End of Test Pit at 1.7 m - REFUSAL ON BEDROCK - slight seepage at 0.5 m					
3							
4							
5

Photograph 4: Test pit 104. August 20, 2019.

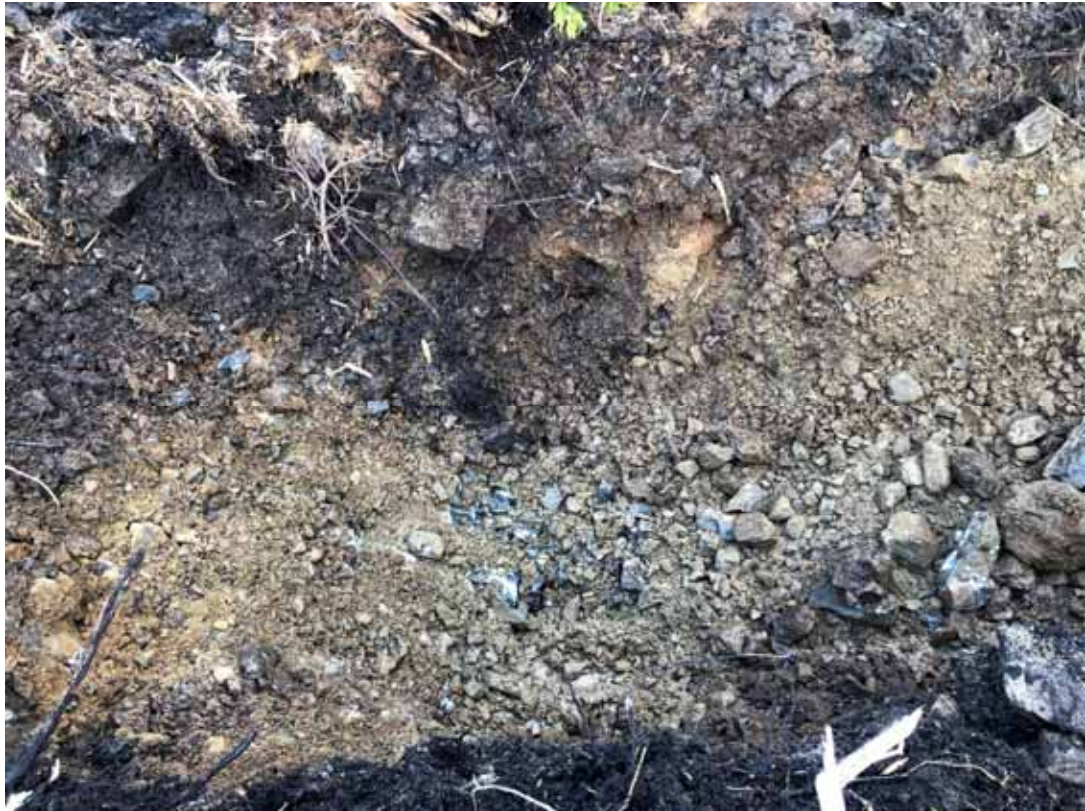
ROOTMAT/TOPSOIL					
			140.6				
1		TILL: Compact dark grey to brownish grey silty sand with gravel - some cobbles	140.0				
		WEATHERED BEDROCK	139.5				
2		End of Test Pit at 1.7 m - REFUSAL ON BEDROCK - slight seepage at 1.2 m					
3							
4							
5

Photograph 5: Test pit 105. August 20, 2019.

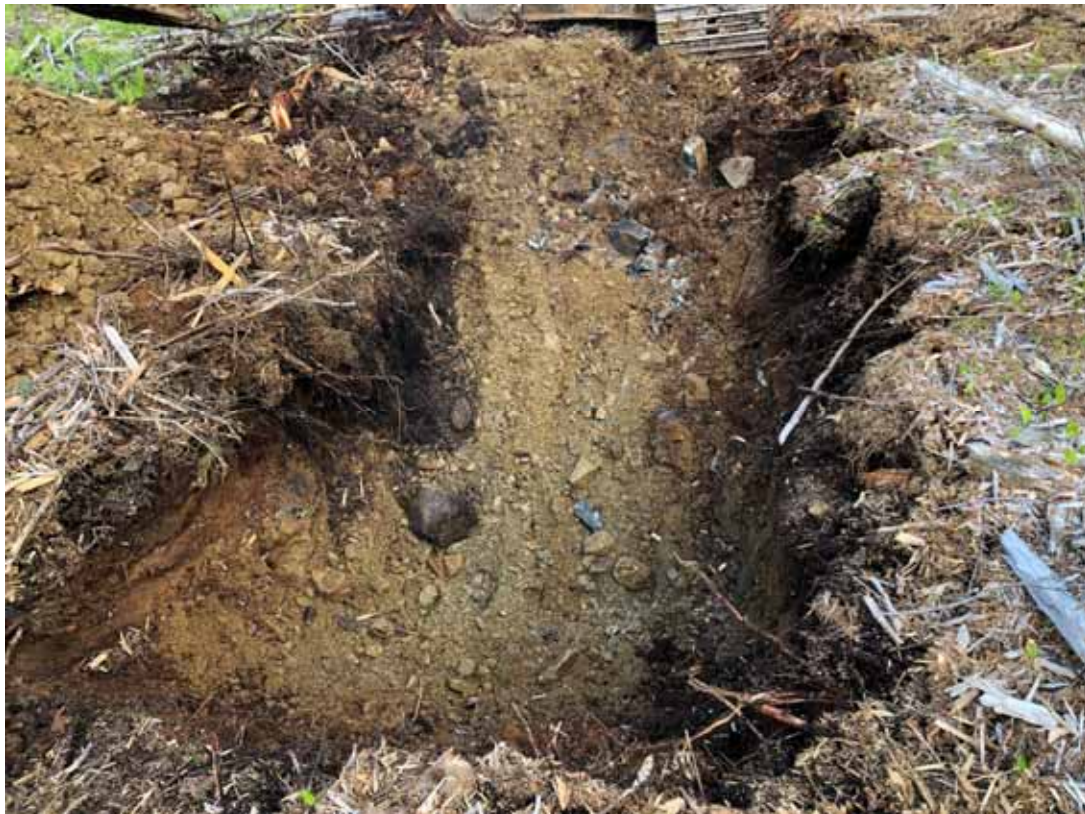
SUBSURFACE PROFILE				SAMPLE			Comments
Depth (m)	Symbols	SOIL AND/OR ROCK DESCRIPTION	Elevation (m)	Water Level (m)	Type	Number	
0		Ground Surface	136.8				
		ROOTMAT/TOPSOIL					
			136.3				
		TILL: Compact brownish grey silty sand with gravel					
1			135.6				
		WEATHERED BEDROCK	135.4				
		End of Test Pit at 1.4 m - REFUSAL ON BEDROCK - no groundwater encountered					
2							
3							
4							
5

Photograph 6: Test pit 106. August 20, 2019.

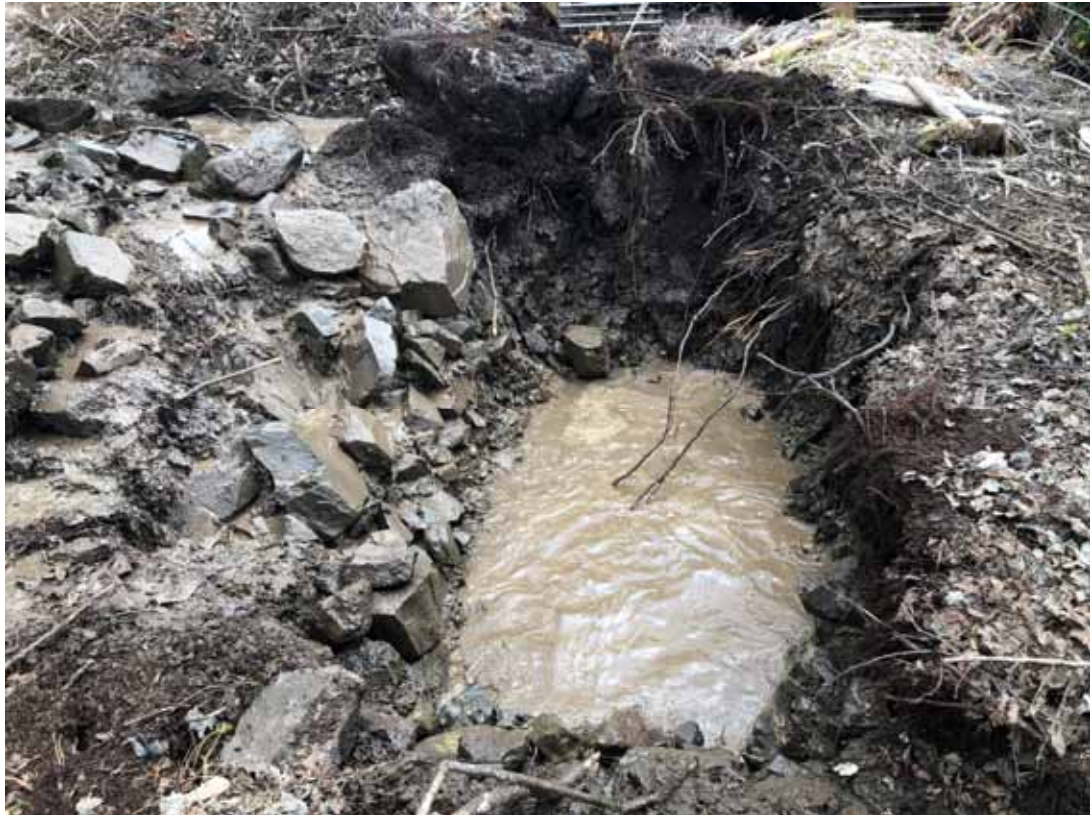
SUBSURFACE PROFILE				SAMPLE			Comments
Depth (m)	Symbols	SOIL AND/OR ROCK DESCRIPTION	Elevation (m)	Water Level (m)	Type	Number	
0		Ground Surface	135.6				
		ROOTMAT/TOPSOIL	135.4				
		TILL: Compact brownish grey silty sand with gravel - frequent cobbles and boulders (up to 0.9 m in diameter)					
1							
			133.8				
		WEATHERED BEDROCK	133.7				
2		End of Test Pit at 1.9 m - REFUSAL ON BEDROCK - heavy seepage at 0.6 m					
3							
4							
5

Photograph 7: Test pit 107. August 20, 2019.

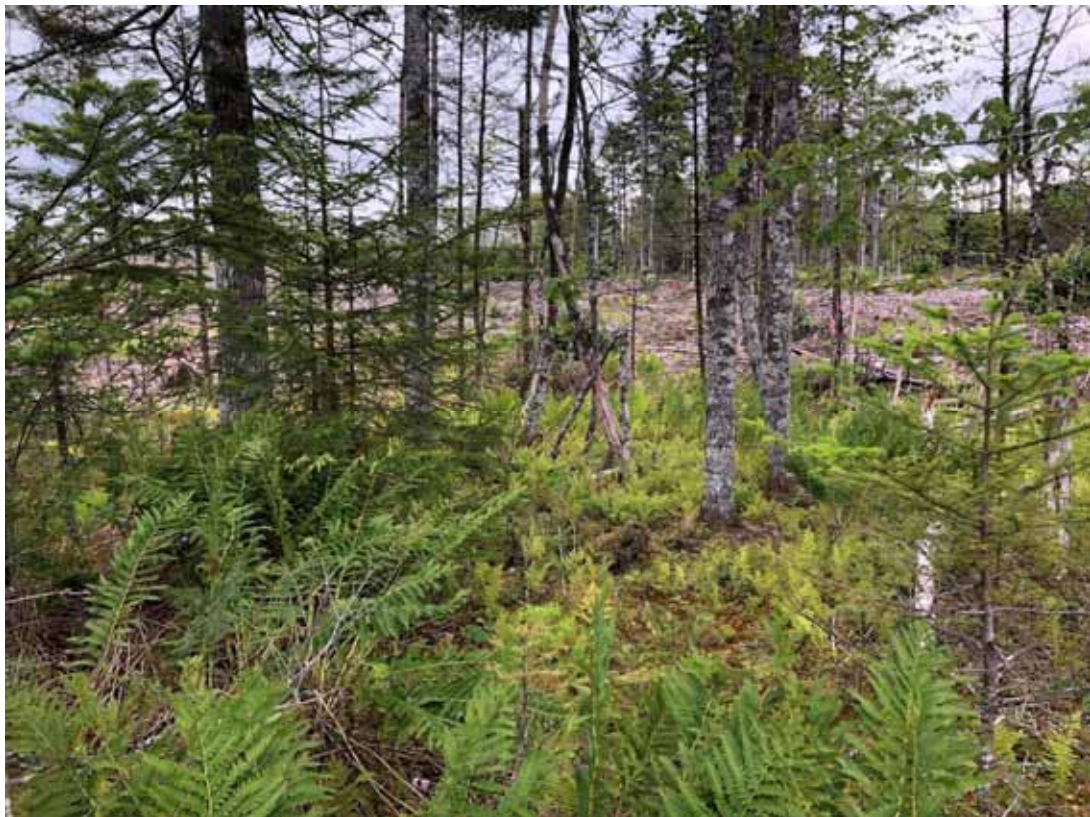
Photograph 8: Hand probe 2 area. August 20, 2019.

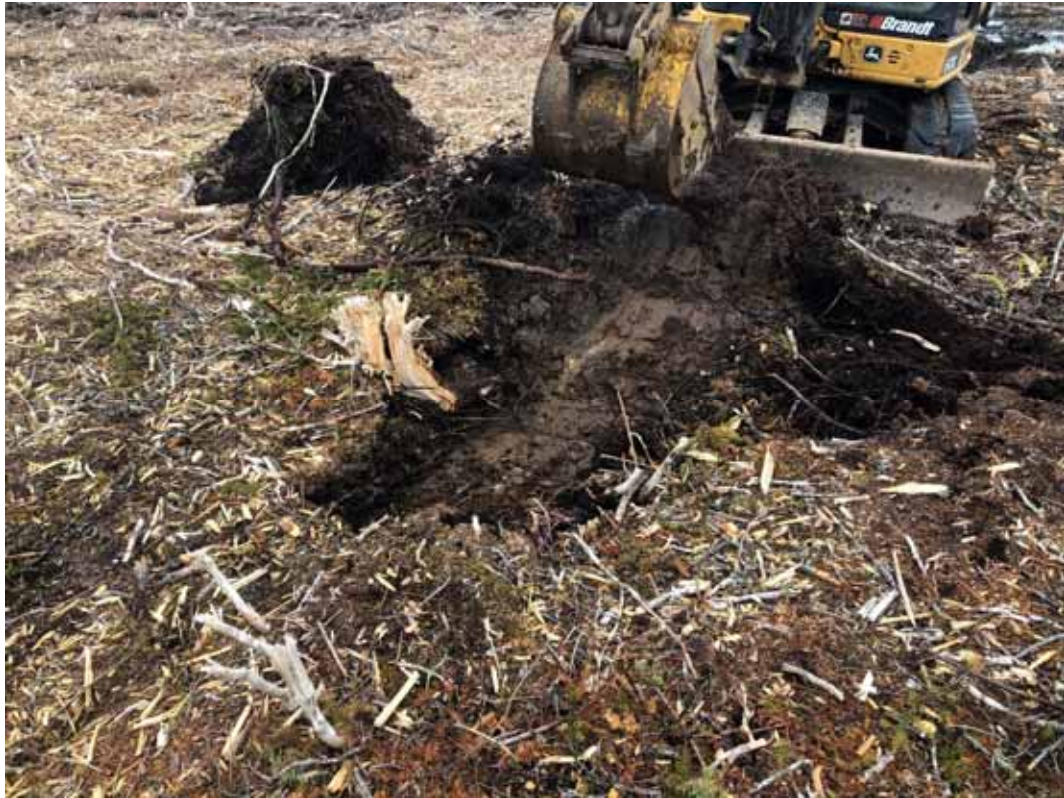
Photograph 13: Excavating test pit 1. May 30, 2019.

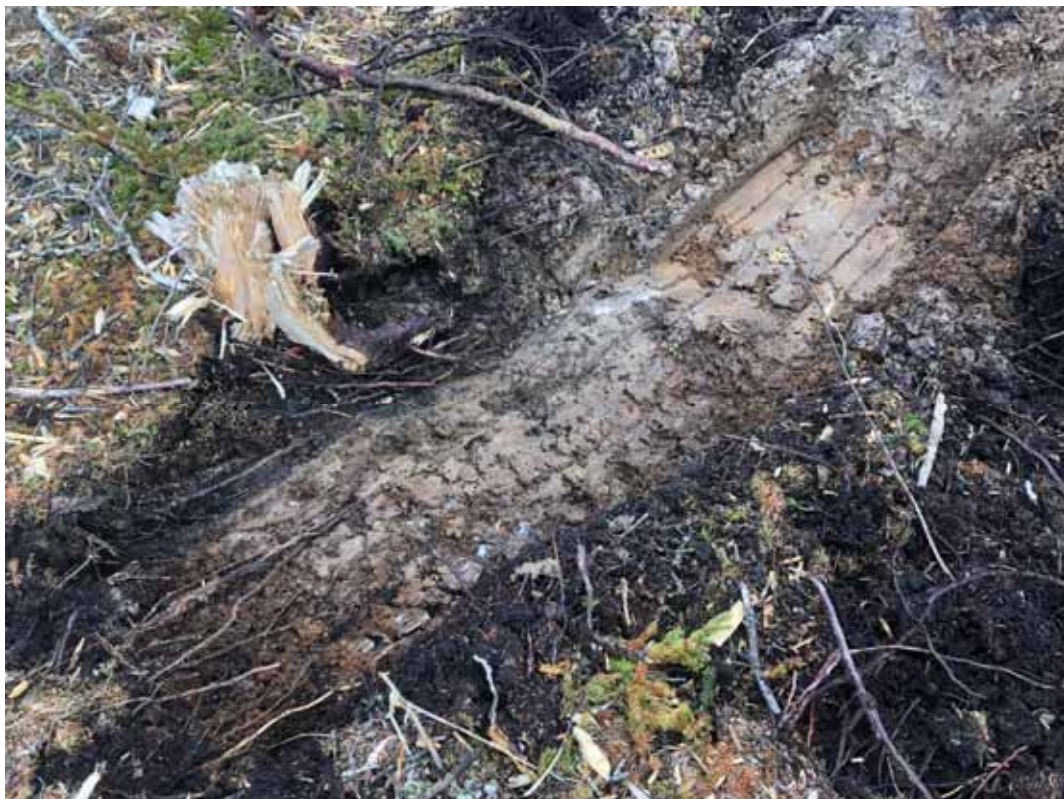
Ground Surface	161.3				
		ROOTMAT/TOPSOIL					
			161.0				
		End of Test Pit at 0.3 m - REFUSAL ON BEDROCK - no groundwater encountered					
1							
2							
3							
4							
5

Photograph 14: Test pit 1. May 30, 2019.

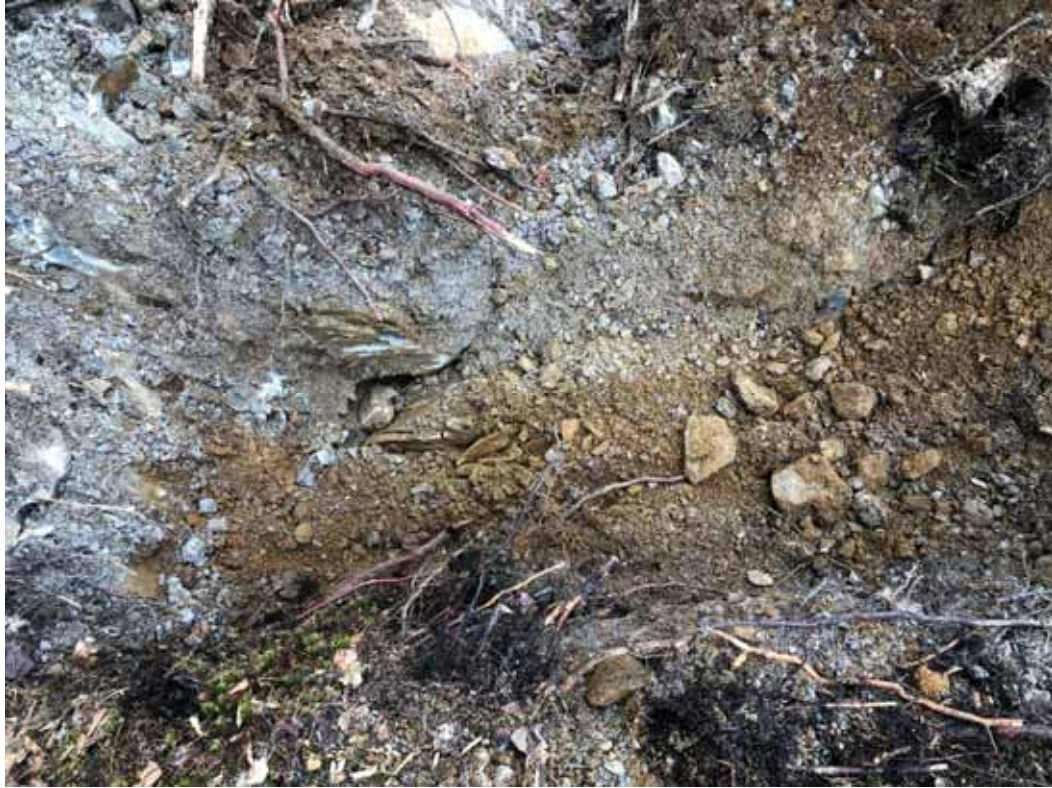
Ground Surface	159.4		RS	1	
		ROOTMAT/TOPSOIL					
			159.1				
		End of Test Pit at 0.3 m - REFUSAL ON BEDROCK - no groundwater encountered					
1							
2							
3							
4							
5

Photograph 15: Test pit 2. May 30, 2019.

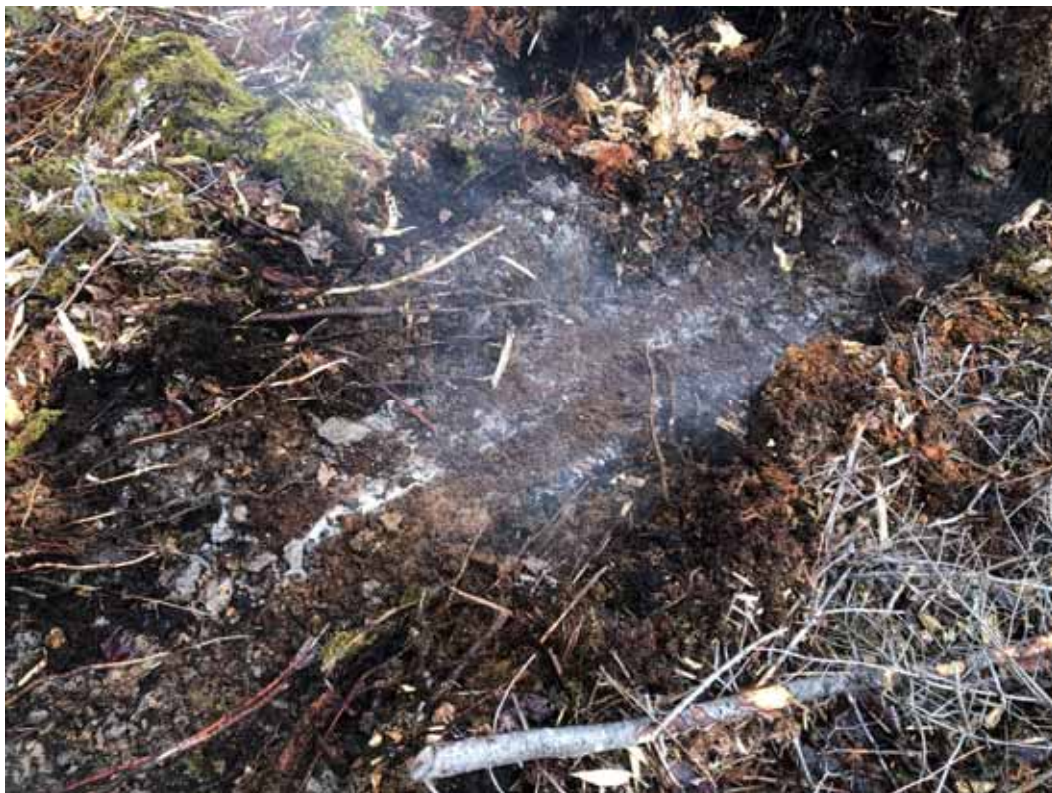
ROOTMAT	157.6				
		End of Test Pit at 0.1 m - REFUSAL ON BEDROCK - no groundwater encountered					
1							
2							
3							
4							
5

Photograph 16: Test pit 3. May 30, 2019.

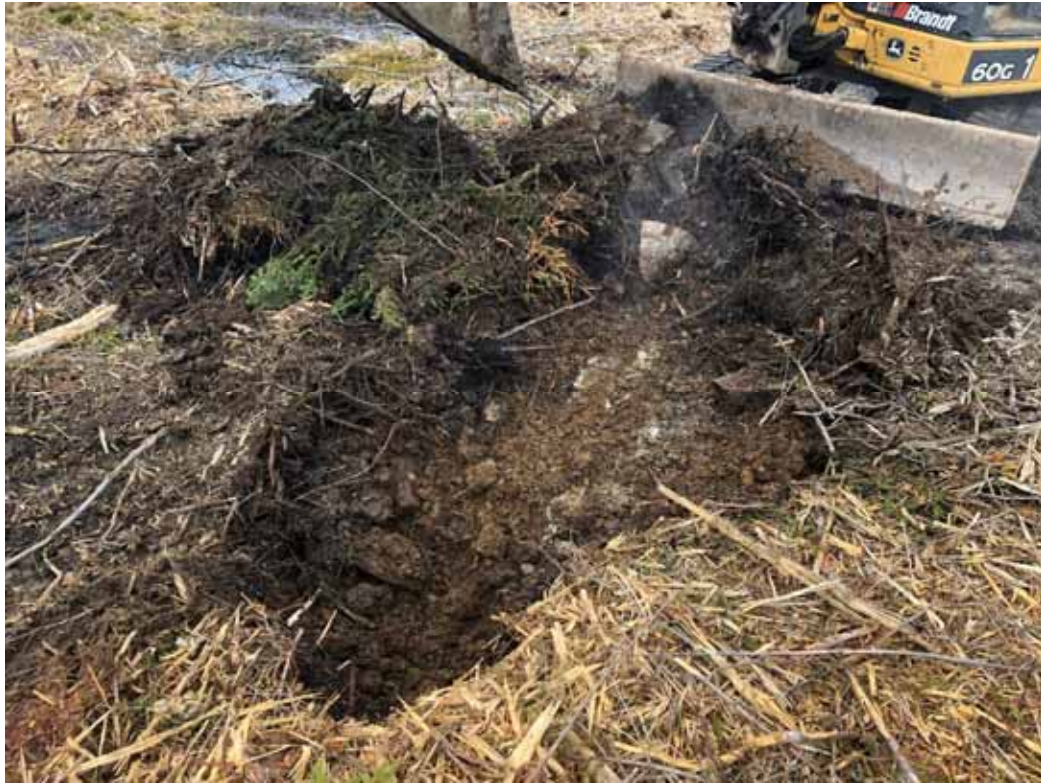
SUBSURFACE PROFILE				SAMPLE			Comments
Depth (m)	Symbols	SOIL AND/OR ROCK DESCRIPTION	Elevation (m)	Water Level (m)	Type	Number	
0		Ground Surface	157.7				
		ROOTMAT/TOPSOIL	157.5				
		End of Test Pit at 0.2 m - REFUSAL ON BEDROCK - no groundwater encountered					
1							
2							
3							
4							
5

Photograph 17: Test pit 4. May 30, 2019.

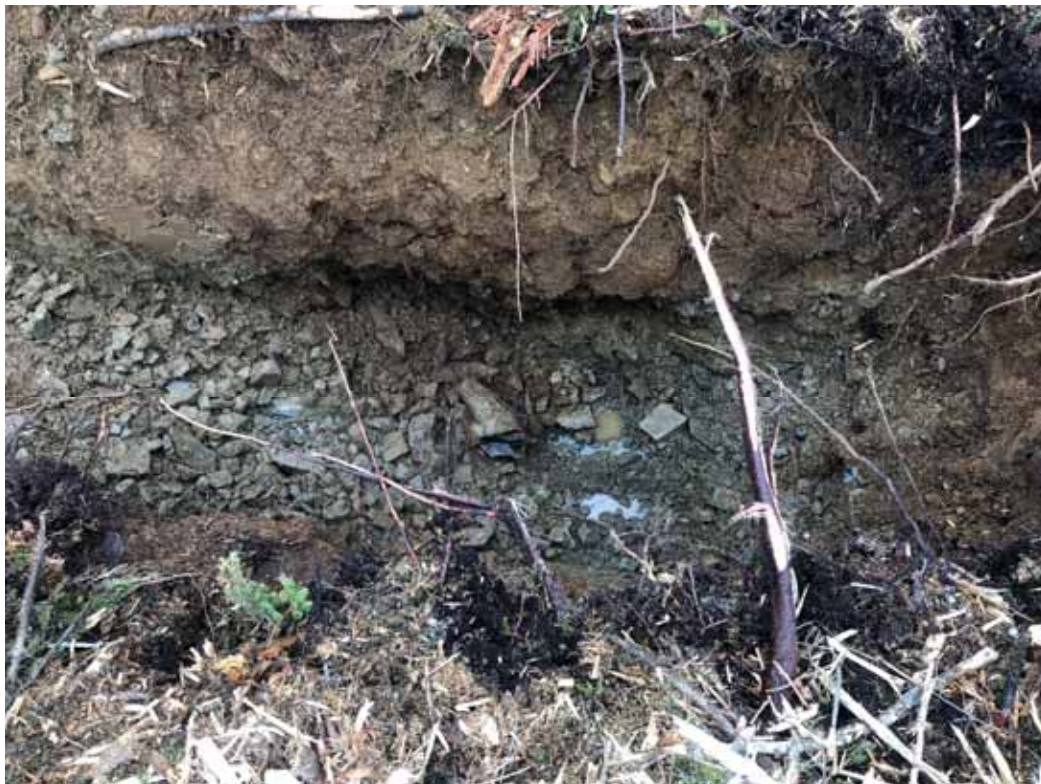
SUBSURFACE PROFILE				SAMPLE			Comments
Depth (m)	Symbols	SOIL AND/OR ROCK DESCRIPTION	Elevation (m)	Water Level (m)	Type	Number	
0		Ground Surface	156.6				
		ROOTMAT/TOPSOIL					
			156.0				
		TILL: Compact to dense light brown to brown silty sand with gravel - occasional cobble					
1			155.4				
		WEATHERED BEDROCK					
			155.1				
		End of Test Pit at 1.5 m - REFUSAL ON BEDROCK - no groundwater encountered			RS	1	
2							
3							
4							
5

Photograph 18: Test pit 5. May 30, 2019.

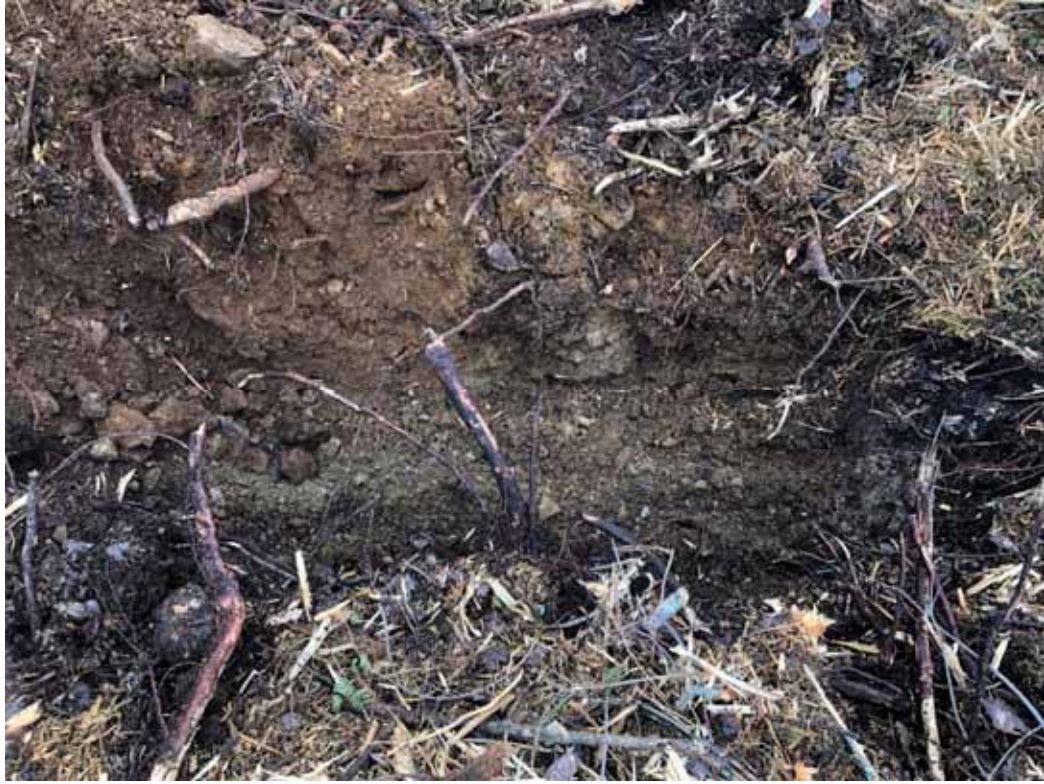
SUBSURFACE PROFILE				SAMPLE			Comments
Depth (m)	Symbols	SOIL AND/OR ROCK DESCRIPTION	Elevation (m)	Water Level (m)	Type	Number	
0		Ground Surface	148.7				
		ROOTMAT/TOPSOIL					
			148.3				
		TILL: Compact to dense light brown to brown silty sand with gravel - occasional cobble	148.1				
		WEATHERED BEDROCK	148.0				
		End of Test Pit at 0.7 m - REFUSAL ON BEDROCK - no groundwater encountered					
1							
2							
3							
4							
5

Photograph 19: Test pit 8. May 30, 2019.

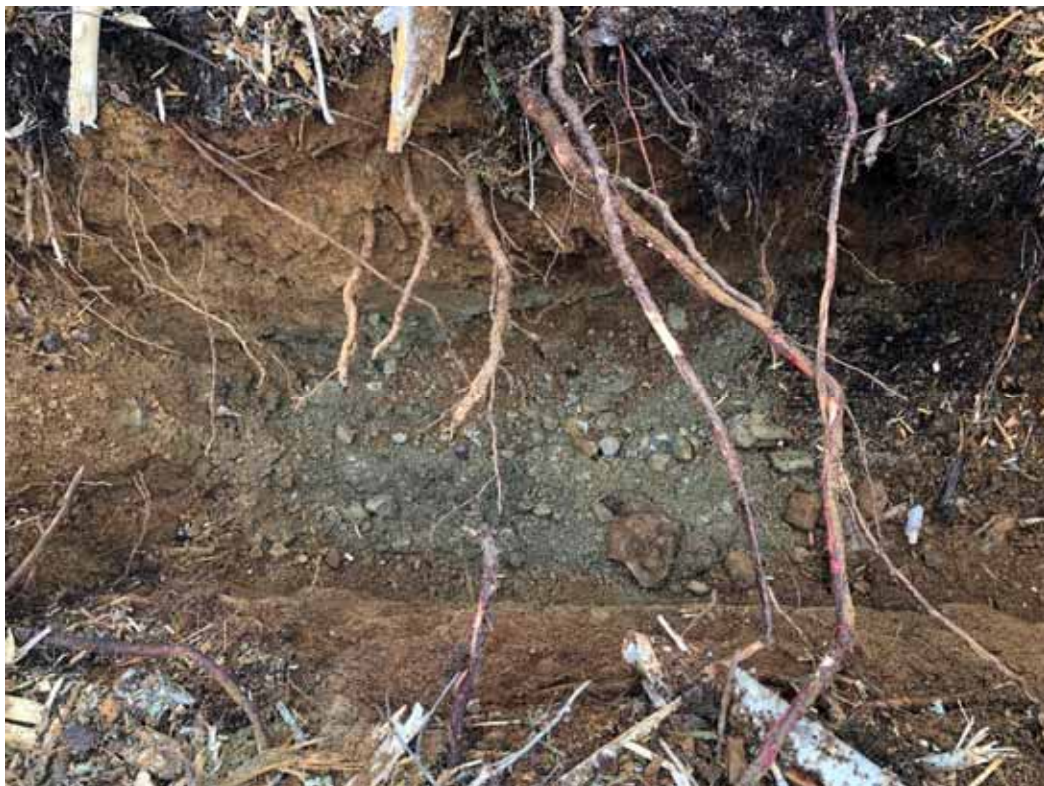
SUBSURFACE PROFILE				SAMPLE			Comments
Depth (m)	Symbols	SOIL AND/OR ROCK DESCRIPTION	Elevation (m)	Water Level (m)	Type	Number	
0		Ground Surface	143.1				
		ROOTMAT/TOPSOIL					
			142.5				
		TILL: Compact grey silty sand with gravel					
1			142.0		GS	1	
		End of Test Pit at 1.1 m - REFUSAL ON BEDROCK - no groundwater encountered					
2							
3							
4							
5

Photograph 20: Test pit 9. May 30, 2019.

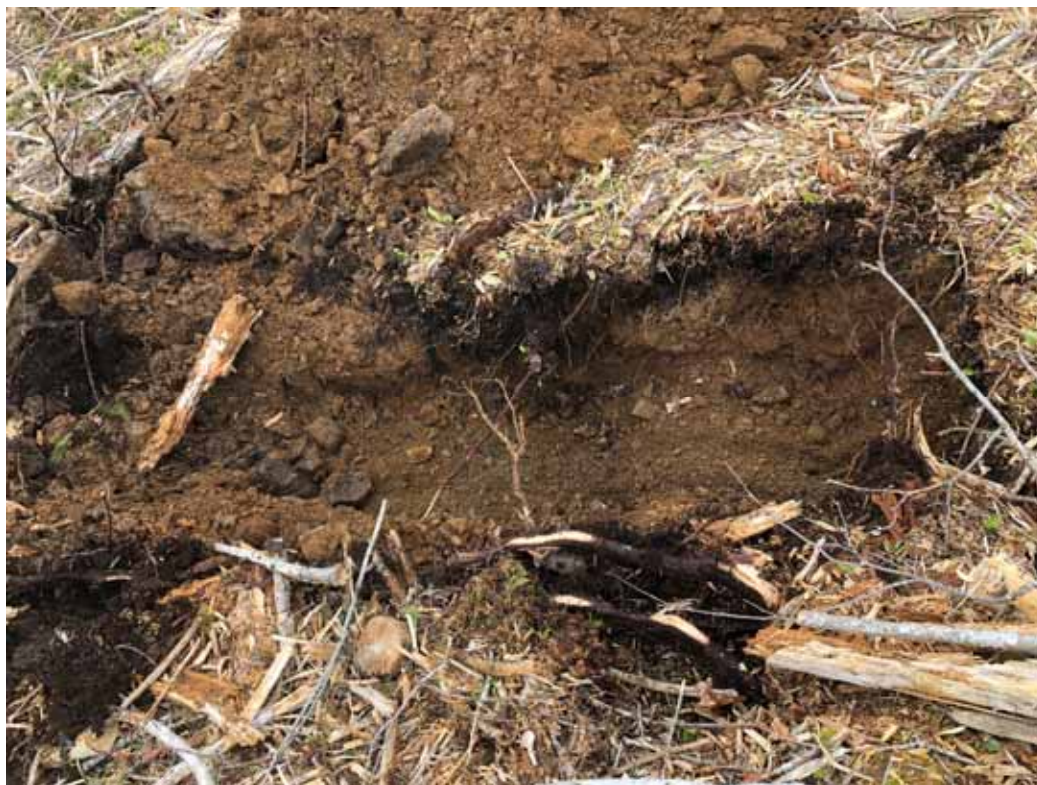
Ground Surface	137.5		RS	1	
		ROOTMAT/TOPSOIL	137.2				
		TILL: Compact greyish brown to brown silty sand with gravel	137.1				
		End of Test Pit at 0.4 m - REFUSAL ON BEDROCK - no groundwater encountered					
1							
2							
3							
4							
5

Photograph 21: Test pit 10. May 30, 2019.
