**PHASE I ENVIRONMENTAL SITE ASSESSMENT**

**224 HIGHWAY 214 (PID 45147998)**

**ELMSDALE, MUNICIPALITY OF EAST HANTS**

***FINAL REPORT***

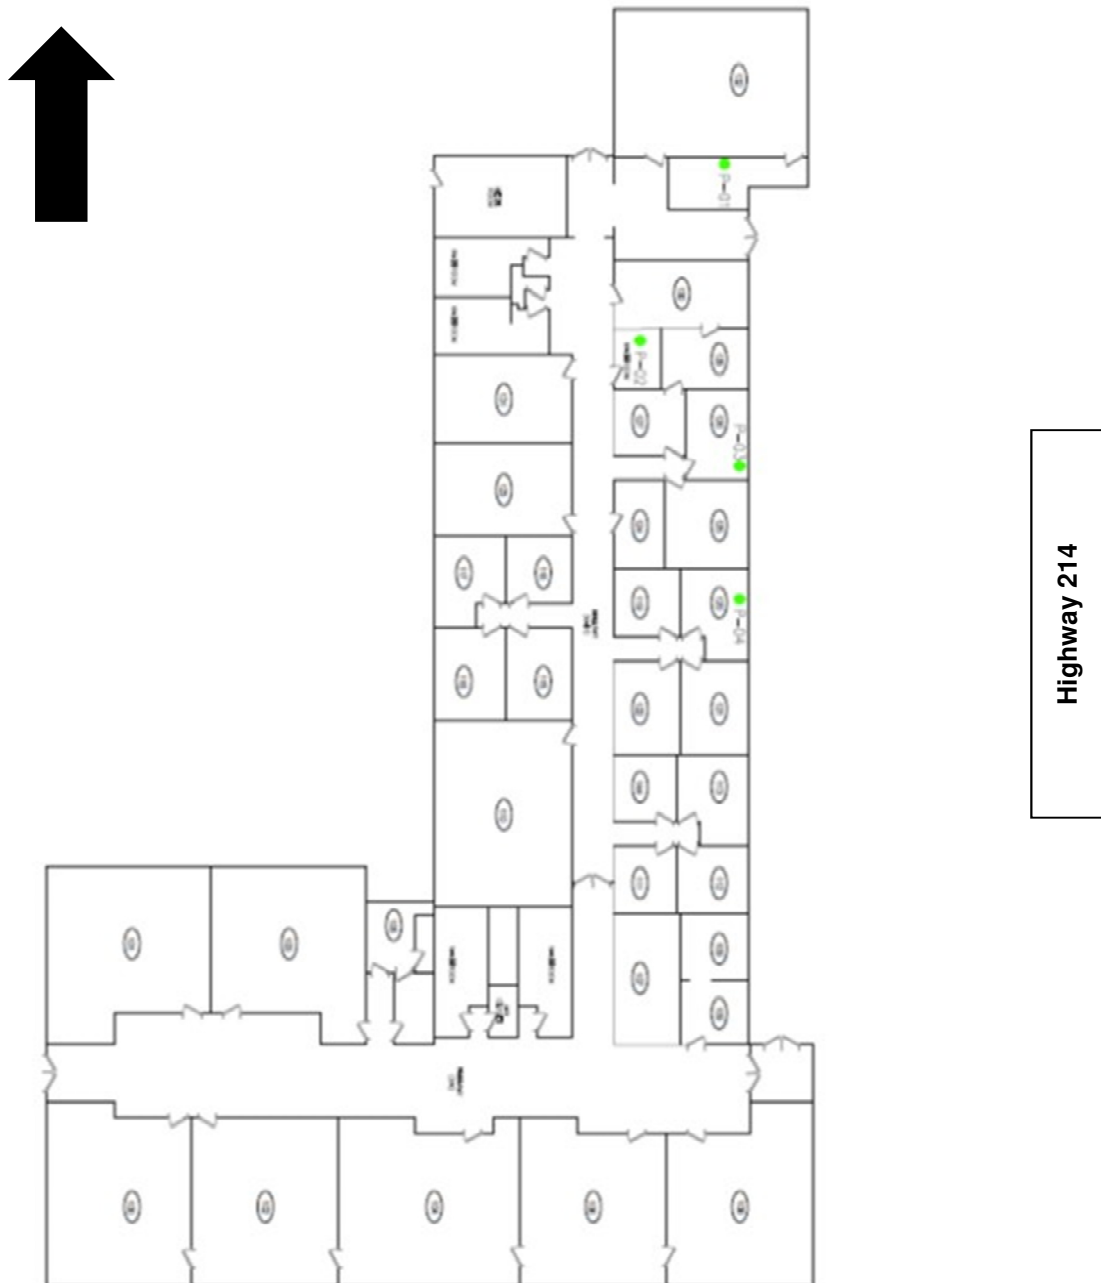
Based on the age of the Building, there was a potential for some paints and finishes to be classed as "lead containing paints"; i.e., containing more than 0.1% or 1,000 mg/kg lead. Reference to the 2019 Hazardous Materials Survey indicated four samples of paint were tested for "leachable lead" (see Figure 15). Concentrations in three samples were less than the detection limit; 49 mg/kg in one sample, which was much less than the Guideline of 1,000 mg/kg. The presence of lead-based paints poses a negligible environmental liability. Should older materials be encountered during renovation, materials should be tested and if found to be lead-containing be appropriately removed and disposed.

**Figure 15:** View of locations of areas sampled for lead-based paints.  
(from CBCL, 2019)

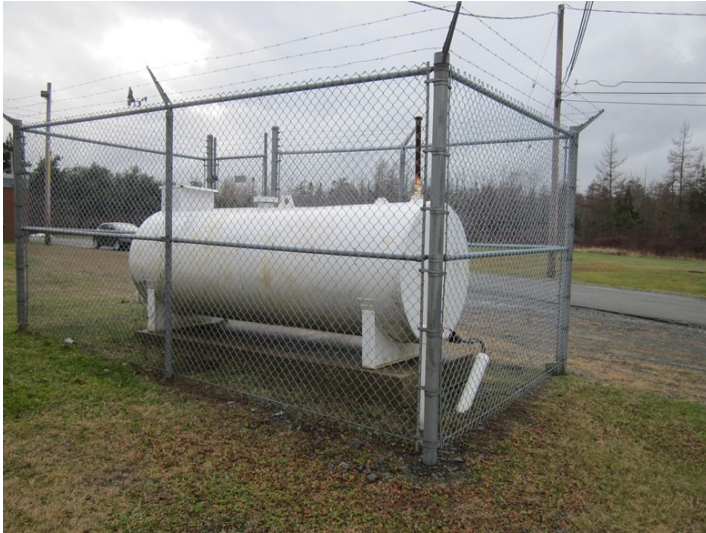
**Figure B-7:** View of the aboveground, double wall, steel tank serving the Subject Building.

supplied from one, 4,457 L, Registered (2013-085167-001), steel, double-wall fuel storage tank (dated 1998) and situated within a locked chain link compound to the west of the Mechanical Room. The feeder lines are located underground within plastic piping extending from the fuel tank enclosure to the Mechanical Room and are not protected (coated) within the Mechanical Room. There was no evidence of fuel spills around the tank or the furnaces. *Note: The tank was originally identified as 98-8540-01 and assumed to have replaced previous fuel tank/s.*

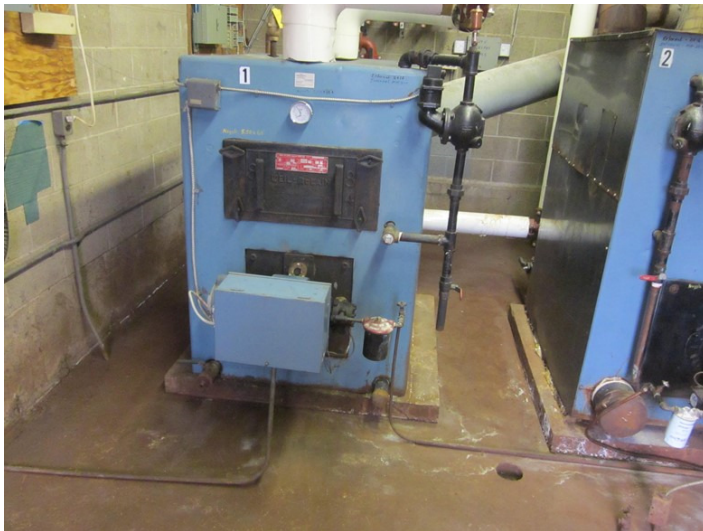
**Figure B-8:** View of furnace 1 – serving the Subject Building.

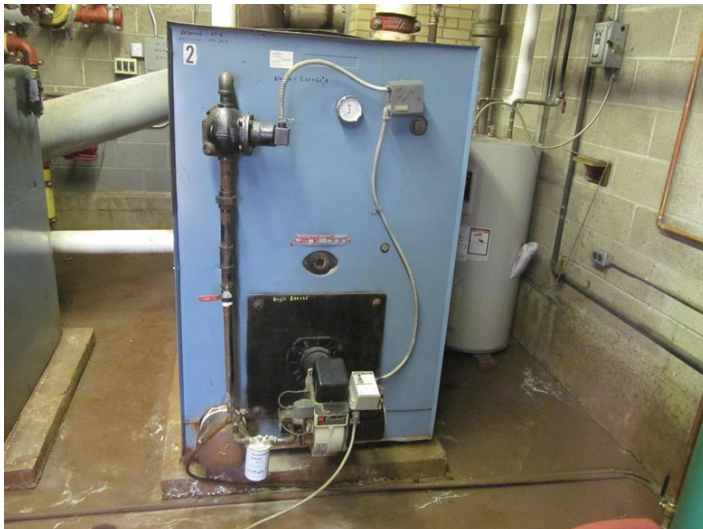
**Figure B-9:** View of furnace 2 and the hot-water tank serving the Subject Building.

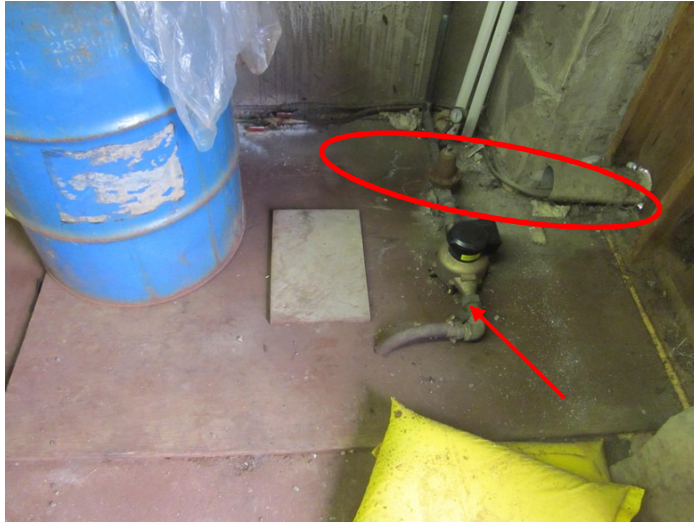
**Figure B-10:** View of furnace fuel lines and water meter.

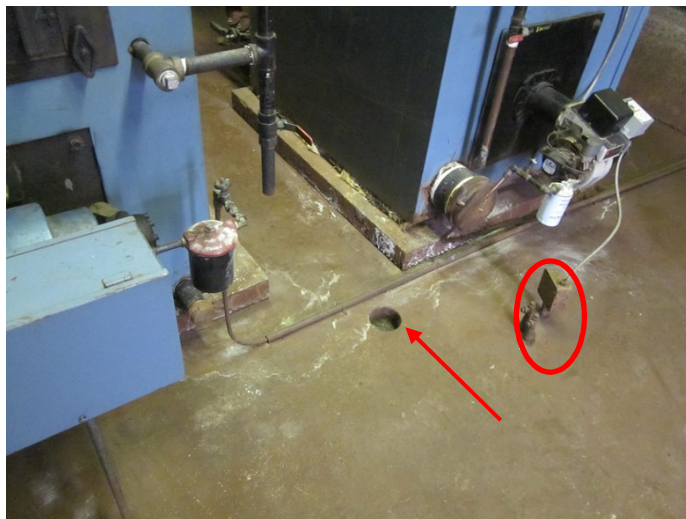
**Figure B-11:** View of furnace fuel lines. Red arrow indicates former under floor fuel lines. Note assumed borehole between the two furnaces.

Anecdotal information indicates a former fuel storage system is reported to have leaked in 1997-1998, with resultant contamination of soils around and under a portion of the original gymnasium, several classrooms and the caretakers' room. It is believed the current tank replaced one or more original tanks. Normally, all of the information related to the spill and subsequent remediation would have been registered with Nova Scotia Environment. The information can then be accessed, pursuant to a standard *Freedom of Information and Protection of Privacy Act (FOIPOP)* request. However, between September 2018 and January 2019, *OCL Services Ltd.* submitted three *FOIPOP* requests for the Subject Property and each time the Department has indicated they have no records of previous tanks nor any documentation regarding fuel spills and remedial activities. This was confirmed by a District Manager, Nova Scotia Environment. Further, inquiries to Chignecto Central Regional Centre for Education (former Regional School Board) indicated they also had no documentation regarding a spill or subsequent remediation. Therefore, to define and describe the environmental status of the Subject Property, it is recommended a Phase II Environmental Site Assessment be conducted, with particular focus on the area of the Subject Property adjacent to the northern end of the Subject Building.

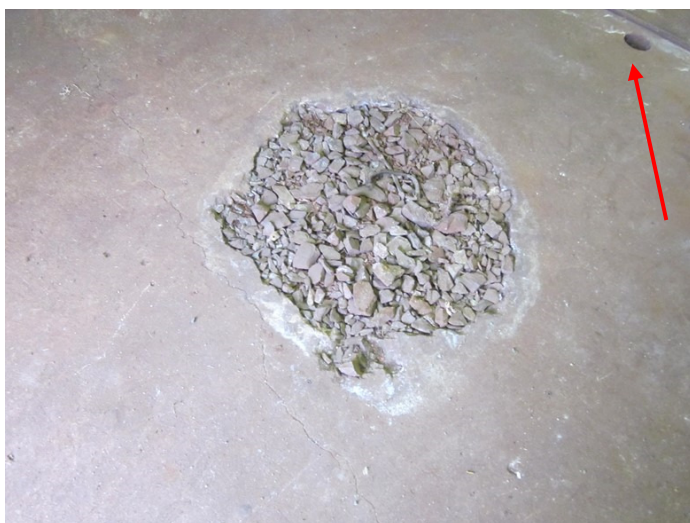
**Figure B-12:** View of assumed former excavation under furnace room slab. Red arrow denotes assumed borehole within the furnace room.

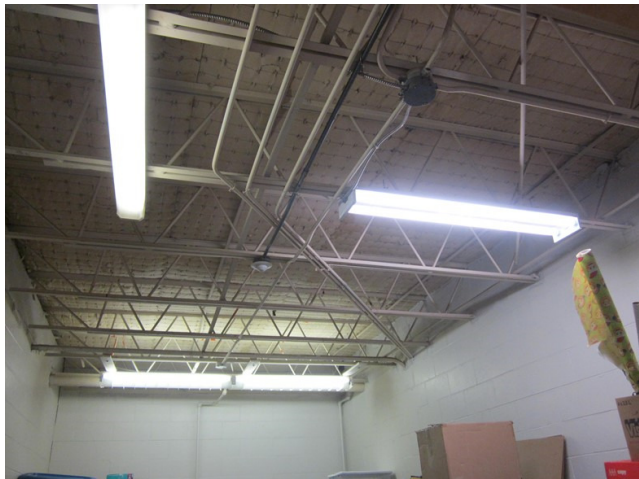
**Figure B-14:** Room 107 exposed ceiling, providing illustration of roof construction.

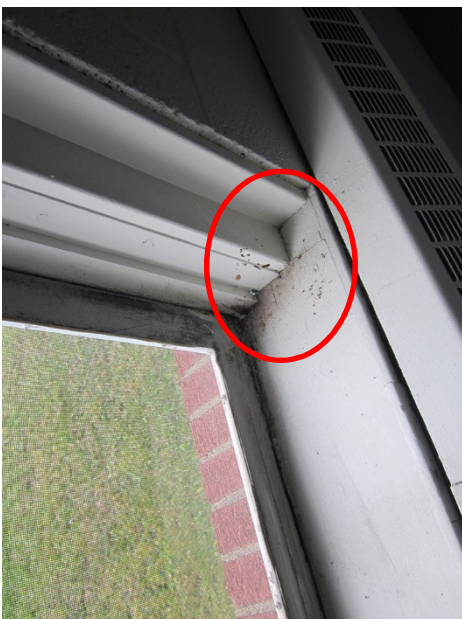
**Figure B-15:** Room 109 water damage associated with moisture condensation on metal window frame.

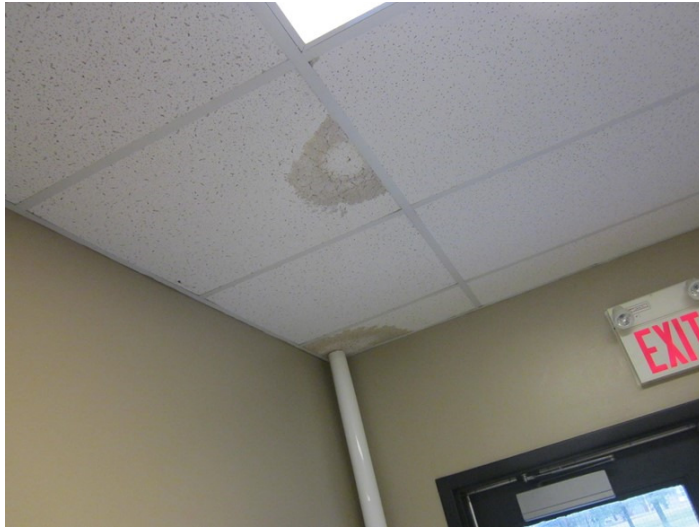
There was visible water damage to ceiling tiles at the North entry to the Subject Building. In addition, there was possible water damage to the hallway ceiling due to a roof vent leak. There was no visible mould. It is recommended any water damage materials be removed and replaced. The potential presence of limited mould is considered a negligible environmental liability to the Subject Property, as currently constituted.

**Figure B-20:** View of water-damaged ceiling tile at the north entry.

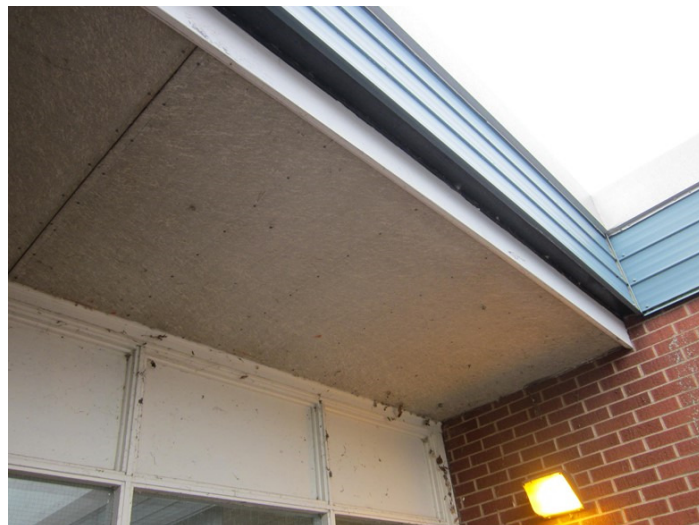
Reference to historical summaries of testing for asbestos-containing material<sup>14,15</sup> within the Subject Building and the results of the 2019 Hazardous Materials Survey<sup>16</sup> indicated numerous sites were tested (see Figure 14) (e.g., exposed piping; texture coating, pipe elbows, vinyl tile, calking (interior and exterior), transite board, cementitious board (interior and exterior), expansion joint calking material, etc.). Concentrations of asbestos range from 1% to 65%, most as chrysotile. These concentrations exceed both the Nova Scotia Labour guidelines of 0.5% and the Asbestos Waste Management Regulations of 1%.

**Figure B-21:** View of transite panels (asbestos containing) above the south entry.

The presence of readily visible friable asbestos is considered a high environmental liability. It is recommended readily-visible asbestos containing and/or deteriorated other asbestos containing materials be removed by an approved contractor under controlled conditions and appropriately disposed. Not-readily visible areas containing asbestos (e.g., ceilings, wall cavities) should be isolated. An Asbestos Management Plan should be prepared, following Nova Scotia Labour guidelines, so that any future workers/contractors, can be made aware of the presence of asbestos in work areas (e.g., repair of heating pipes; installation of new electrical or communications lines).
