PHASE I ENVIRONMENTAL SITE ASSESSMENT

**1157 NO 2 HIGHWAY (PID 45148111)
AND
1175 HIGHWAY 2 (PID 45088614)**

**LANTZ
MUNICIPALITY OF EAST HANTS**

DECEMBER 2020

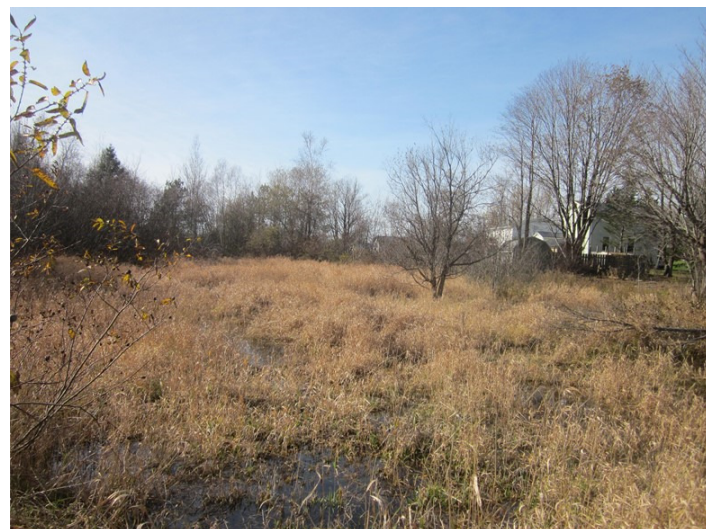
Figure B-12: View northwest across the wetland within the 1175 Highway 2 Component.

There is a large un-delineated wetland occupying the nominal centre of this Component. It is recommended the wetland be properly delineated, pursuant to Nova Scotia Environment policy on wetlands. The delineation can only be undertaken between May and 30 October. The delineation should also include a determination of water flow via the broken drainage culvert within the driveway – right-of-way along the east boundary.

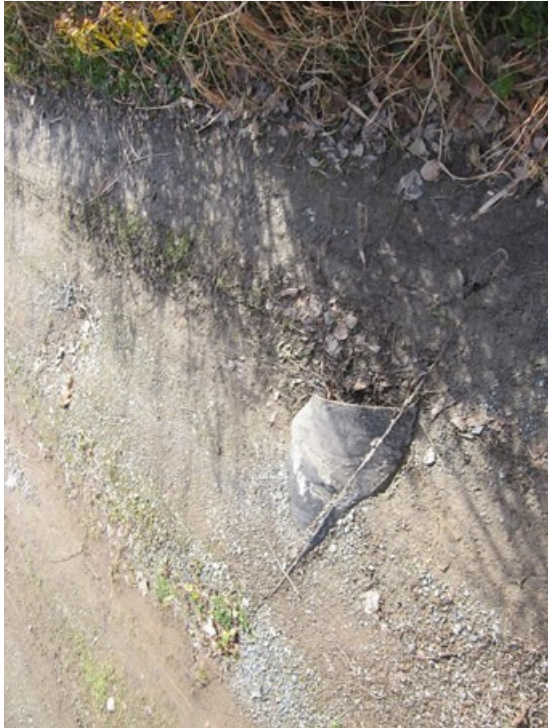
Figure B-13: View of broken drainage pipe in the driveway right-of-way along the eastern side of the 1175 Highway 2 Component.

DETERMINATION: *As currently constituted, there are no significant environmental liabilities associated with the Subject Property. No further environmental site assessment is recommended. The 1175 Highway 2 Component contains a large un-delineated wetland. It is recommended this wetland be properly delineated, including the nominal drain/culvert under the right-of-way driveway on the east side.*

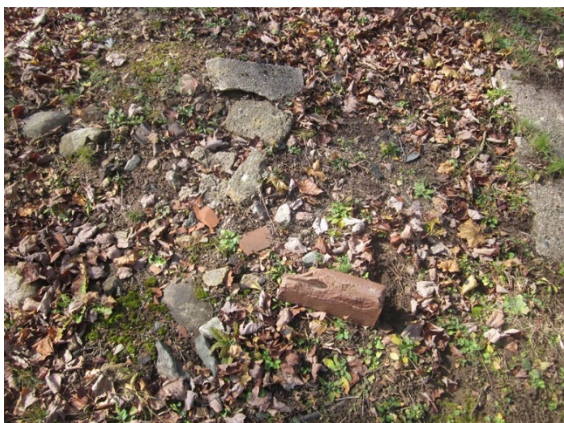
Figure B-15: View of remnant building debris of former civic address 1175 Highway 2.
