LEVEL I GROUNDWATER ASSESSMENT
Hants County, NS

June 6, 2023

Re: Level I Groundwater Assessment
Hants County, NS

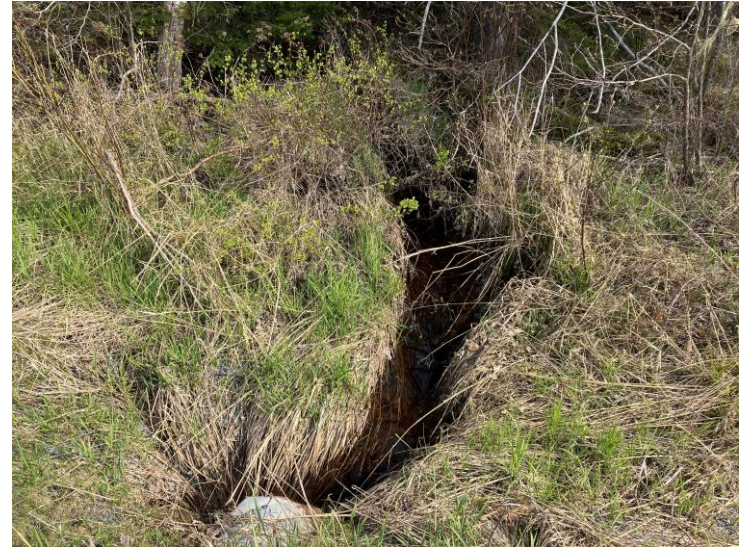
Photo 4: View looking north from Renfrew Road of a mapped watercourse along the eastern boundary of the site.

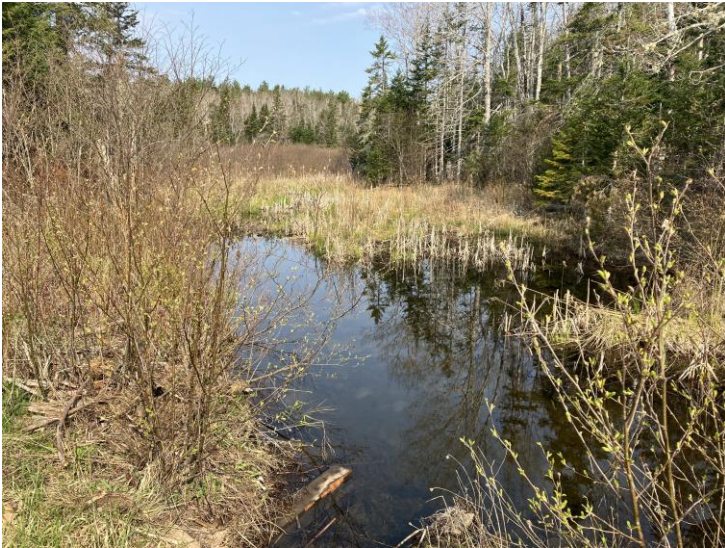
Photo 5: View looking northwest on the Renfrew Road, from the southwest corner of the site. Mapped wetland that abuts site boundary.

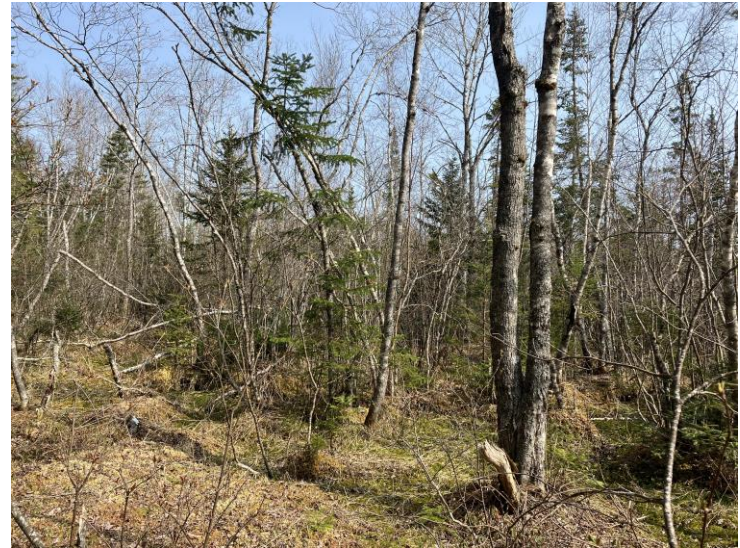
Photo 6: View looking north from the within the center of the site. Apparent wetland as seen from imagery.

Wetlands	Wetlands were observed on the site. Wetland delineation for this site has not been completed. Prior to any future development, such as disturbance, alteration, or infilling in these areas of the property, the completion of a wetland assessment consisting of characterization and delineation is recommended, as per NSECC regulations.

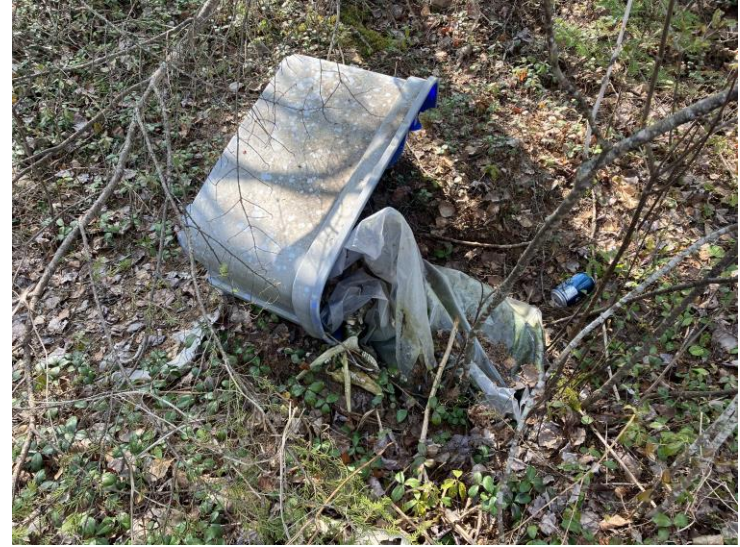
Photo 10: Rubbish found within site. Including a plastic bin, plastic bag, an aluminium can, and animal remains.

an apparent large wetland complex. Renfrew Road along the site is a dirt road with limited drivability. Solid waste (i.e., plastic containers) and animal remains were found within the site, although nothing significant was observed.
