APPENDIX E: PICTURES

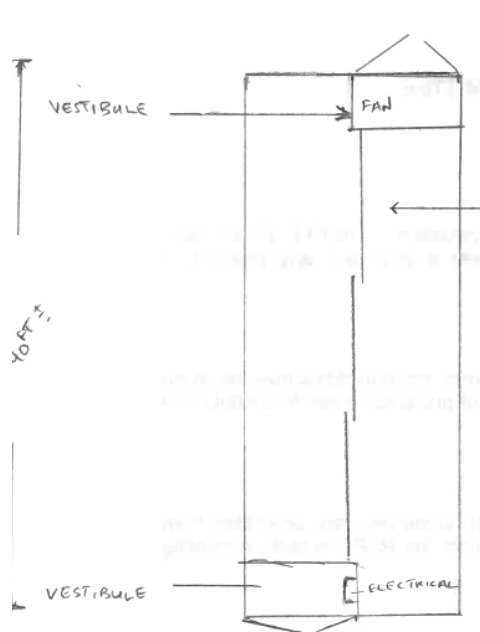
Sketch 1:

Shows the bottom of a bulkhead containing a door which is typical at two locations on the ground floor. The bulkheads create the vestibules shown in Sketch 1.
