## Wetland Vulnerability Study: Shubenacadie Watershed, Nova Scotia

### PREPARED FOR

Nova Scotia Department of Public Works  
1672 Granville Street  
Halifax, NS  
B3J 2N2

### PREPARED BY

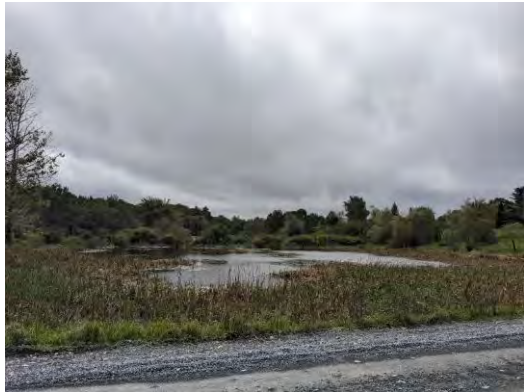
| Stressor | Occurrences | Frequently Occurring Indicators | Photo |
|---|---|---|---|
| Hydrologic Modification | 82 | <ul style="list-style-type: none"> <li>• Roadbed/railroad</li> <li>• ATV trails</li> <li>• Stormwater input</li> </ul> | |

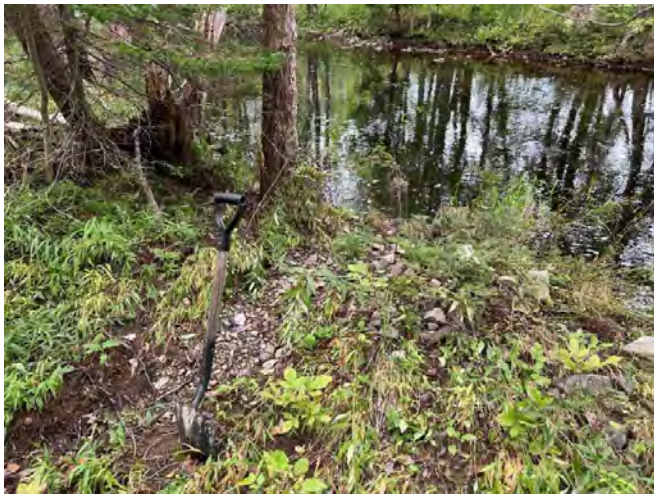
| Description | Photo |
|---|---|
| <p><b>1. <u>Inflow</u></b></p> <ul style="list-style-type: none"> <li>Scoured channel where water from Bennery Brook inflows into the floodplain during periods of high flow.</li> </ul> <p><u>Wetland Management Considerations</u></p> <ul style="list-style-type: none"> <li>Create stable, permanent inflow feature.</li> </ul> <p><b>2.</b> Set elevation of inflow feature based on desired outcomes.</p> | |

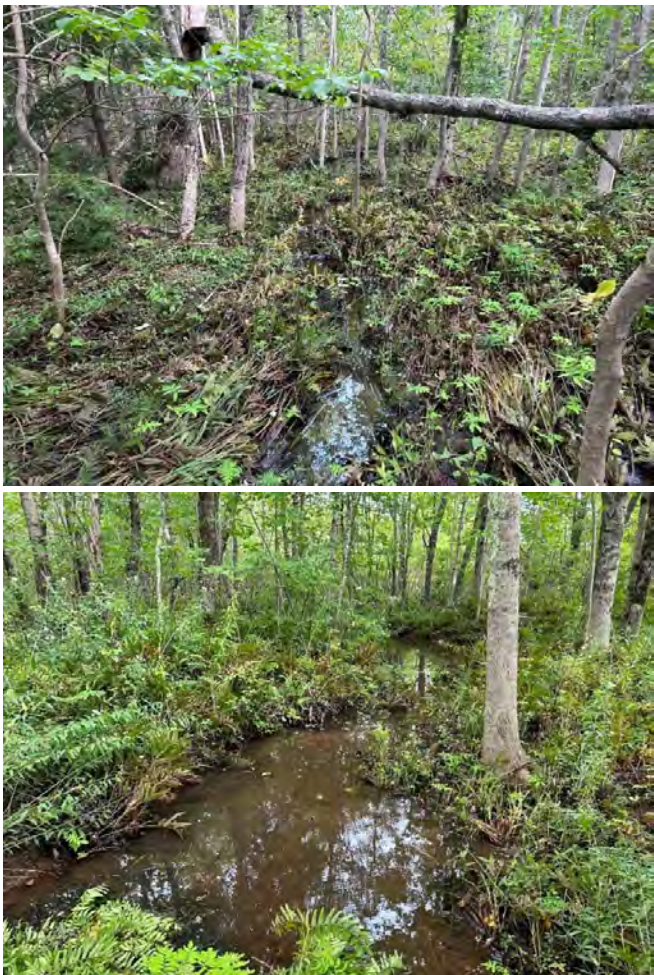
| Description | Photo |
|---|---|
| <p><b>3. <u>Drainage Route</u></b></p> <ul style="list-style-type: none"> <li>A drainage channel has been formed along the eastern area of Site 1 (adjacent to Hwy 102).</li> </ul> <p><u>Wetland Management Considerations</u></p> <ul style="list-style-type: none"> <li>Install natural barriers to current flow path (e.g., earthen berms, pools) to slow flow and retain water in Site 1.</li> <li>Create side channels/re-direct flow to other flow retention features (i.e., new ponds, areas 3 and 5).</li> </ul> | |

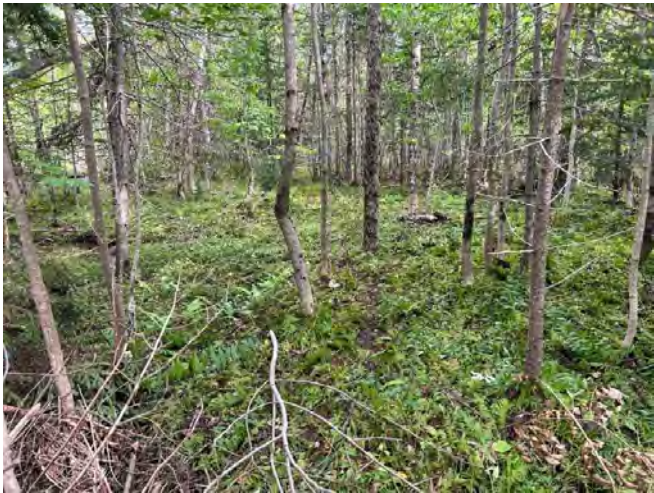
| Description | Photo |
|---|---|
| <p><b>4. <u>Intermittent Flood Area</u></b></p> <ul style="list-style-type: none"> <li>Highest and driest area within Site 1. Evidence of intermittent flooding (compressed vegetation).</li> </ul> <p><u>Wetland Management Considerations</u></p> <ul style="list-style-type: none"> <li>Redirect water to these areas more frequently.</li> <li>Potential creation of ponds and connection with existing channelized drainage.</li> </ul> | |

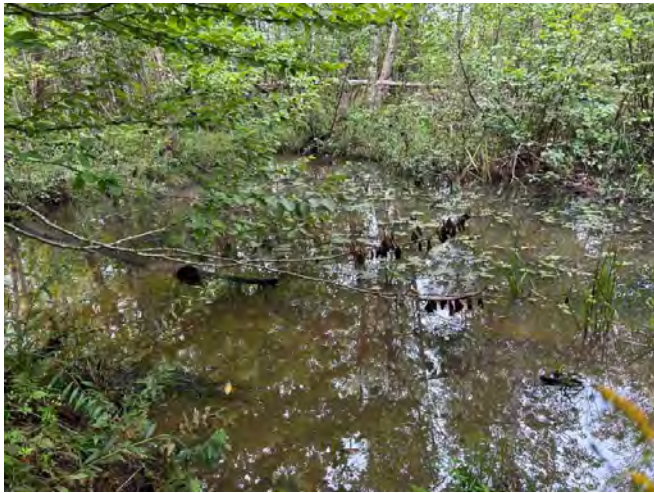
| Description | Photo |
|---|---|
| <p><b>5. <u>Vernal Pool</u></b></p> <ul style="list-style-type: none"> <li>Shallow (~0.5 m) vernal pond.</li> </ul> <p><u>Wetland Management Considerations</u></p> <ul style="list-style-type: none"> <li>Potential to increase depth and water storage ability.</li> <li>Create additional, similar ponds within Site 1 to help retain water in high flows.</li> </ul> | |

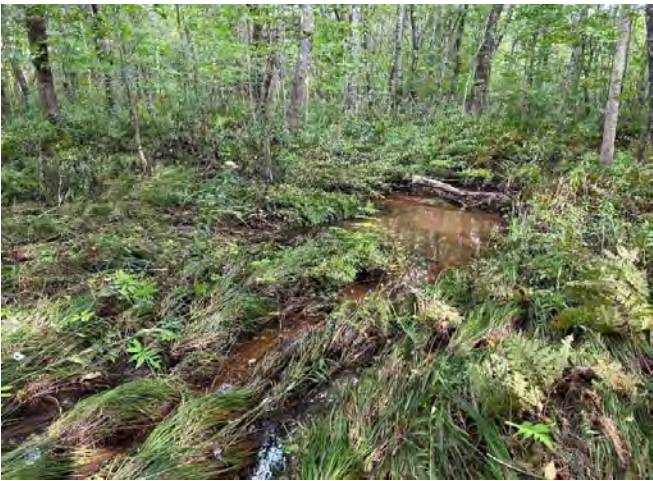
| Description | Photo |
|---|---|
| <p><b>6. <u>Surface Flow Drainage</u></b></p> <ul style="list-style-type: none"> <li>• Lower lying land, discharge from pond.</li> <li>• Evidence of sheet flow through vegetation.</li> </ul> <p><u>Wetland Management Considerations</u></p> <ul style="list-style-type: none"> <li>• Install natural barriers (e.g., earthen berms, pools) to slow flow and retain water in Site 1.</li> <li>• Create side channels/re-direct flow to other flow retention features (i.e., new ponds).</li> </ul> | |

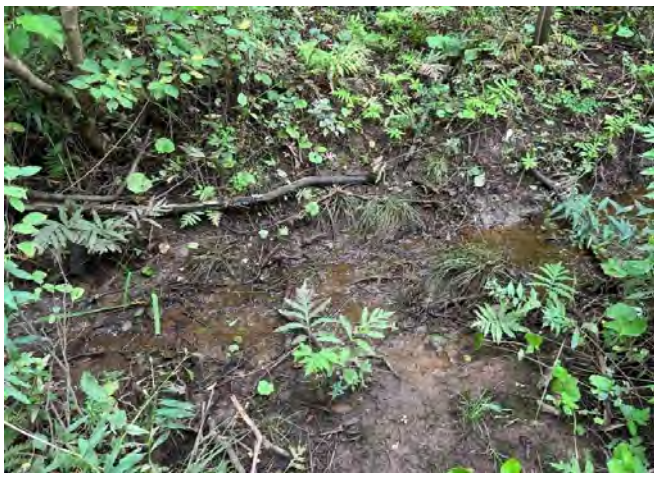
| Description | Photo |
|---|---|
| <p><b>7. <u>Channelized Drainage/Outflow</u></b></p> <ul style="list-style-type: none"> <li>• Defined drainage/outflow channel has been formed.</li> <li>• Two, narrow (~0.5m) scoured outflows to Bennery Brook.</li> </ul> <p><u>Wetland Management Considerations</u></p> <ul style="list-style-type: none"> <li>• Construct stabilized, permanent outflow.</li> <li>• Consider desired elevation for spillway and fish access through system.</li> <li>• Set elevation of outflow feature based on desired outcomes.</li> </ul> | |

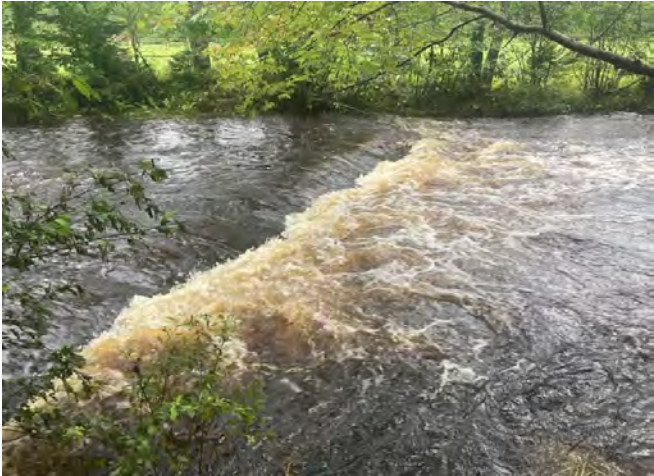
| Description | Photo |
|---|---|
| <p>Installed digger log in Bennery Brook, August 27, 2023, under bankfull conditions (photo from SWEPS).</p> | |

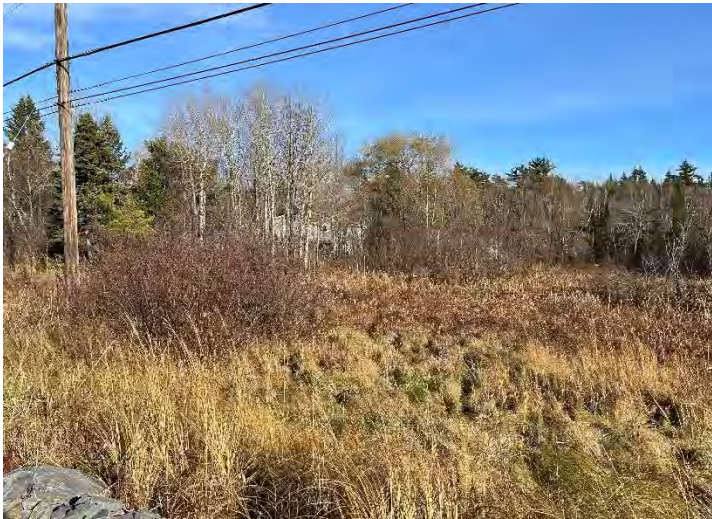
| Description | Photo |
|---|---|
| <p><b>1. <u>Marsh Area</u></b></p> <ul style="list-style-type: none"> <li>• Lowest area within Site 2.</li> <li>• Water table at surface at time of assessment.</li> <li>• Evidence of flooding.</li> </ul> <p><u>Wetland Management Considerations</u></p> <ul style="list-style-type: none"> <li>• Service road is within ~1 m of marsh surface elevation.</li> <li>• Use of blast rock on road may indicate potential flooding.</li> </ul> <p>Opportunity to consider road use and elevation in design.</p> | |

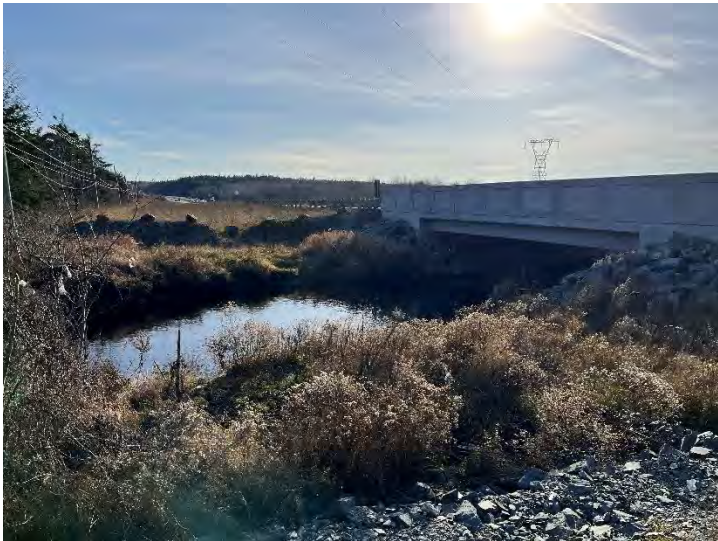
| Description | Photo |
|---|---|
| <p><b>2. <u>Hwy 102 Crossing</u></b></p> <ul style="list-style-type: none"> <li>• Leveling and stabilizing material likely left over from temporary crossing.</li> <li>• Berm running along edge of brook at this location may indicate potential to over top banks.</li> </ul> <p><u>Wetland Management Considerations</u></p> <ul style="list-style-type: none"> <li>• Potential to expand flood plain (area 3) and create additional ponds within Site 2 to help retain water in high flows and moderate channel flow.</li> </ul> | |

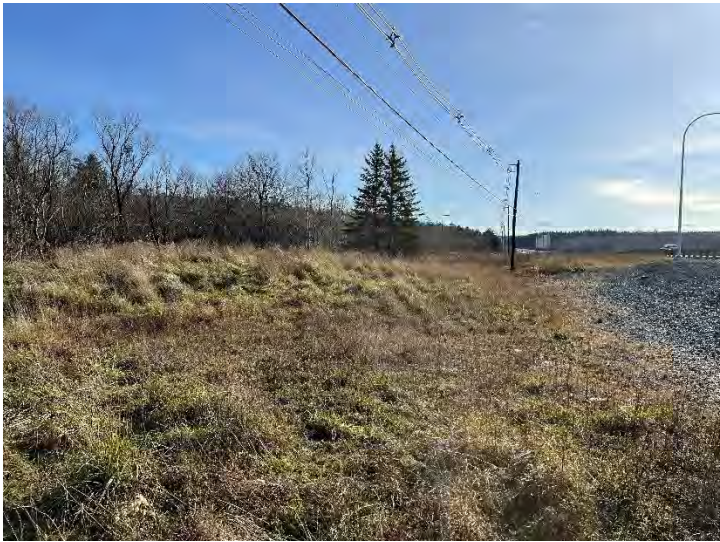
| Description | Photo |
|---|---|
| <p><b>3. <u>Service Road and Fill Area</u></b></p> <ul style="list-style-type: none"> <li>• Realignment fill area and current service road.</li> <li>• Potential spoil material deposit in the floodplain.</li> </ul> <p><u>Wetland Management Considerations</u></p> <ul style="list-style-type: none"> <li>• Alignment likely reduced the natural wetland size and functions.</li> <li>• Potential to expand wetland into this area.</li> </ul> | |

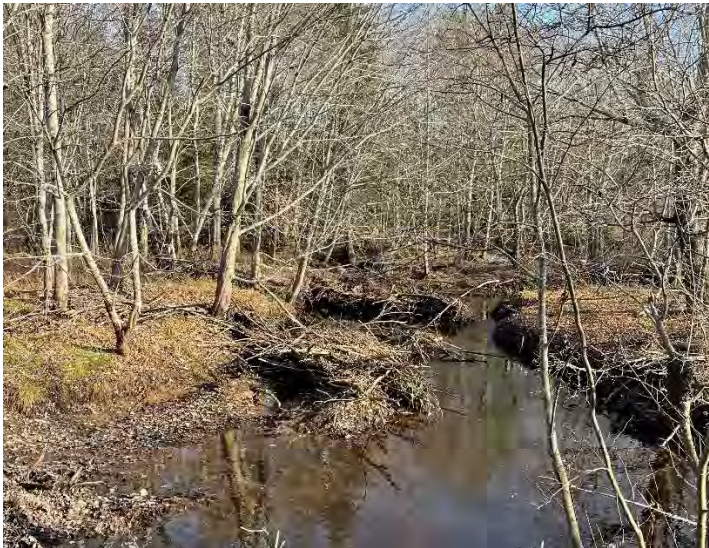
| Description | Photo |
|---|---|
| <p><b>4. <u>Treed Swamp Floodplain</u></b></p> <ul style="list-style-type: none"> <li>• Higher/drier area within Site 2. Evidence of intermittent flooding.</li> <li>• Entrenched brook through treed swamp. Low flow at time of assessment.</li> <li>• Evidence of beaver activity and lodges</li> </ul> <p><u>Wetland Management Considerations</u></p> <ul style="list-style-type: none"> <li>• Evidence of notable water level fluctuations</li> <li>• Potential to enhance floodplain and create additional ponds and flow retention features within Site 2 to help retain water in high flows and moderate channel flow.</li> </ul> | |

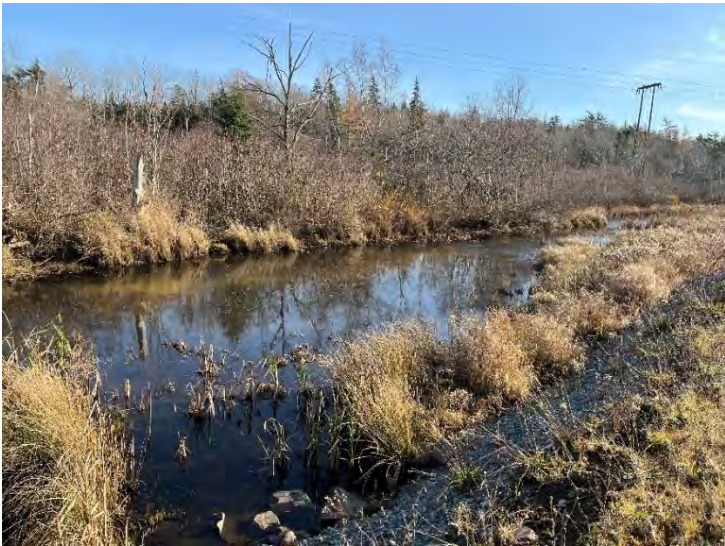
| Description | Photo |
|---|---|
| <p><b>5. <u>Man-Made Pond</u></b></p> <ul style="list-style-type: none"> <li>• &gt;1 m deep pool (at measurable point)</li> <li>• Potentially a result of highway construction (e.g. burrow pit)</li> </ul> <p><u>Wetland Management Considerations</u></p> <ul style="list-style-type: none"> <li>• Potential to increase depth and water storage ability.</li> <li>• Create additional, similar ponds within Site 2 to help retain water in high flows (e.g., area 6).</li> <li>• Stabilized permanent inflow and outflow. Consider desired elevation for spillway and fish access through system.</li> </ul> | |

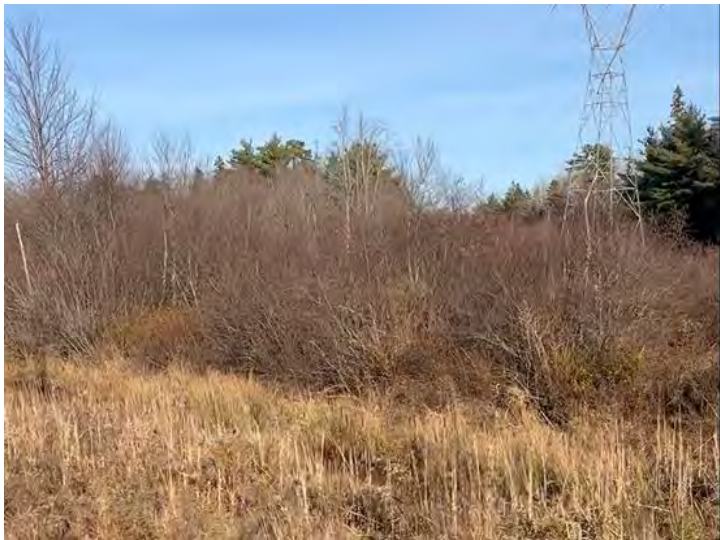
| Description | Photo |
|---|---|
| <p><b>6. <u>Shrub Dominated Floodplain</u></b></p> <ul style="list-style-type: none"> <li>• Moderate moisture regime</li> <li>• Some observed natural vernal pools or flow retention features.</li> </ul> <p><u>Wetland Management Considerations</u></p> <ul style="list-style-type: none"> <li>• Create additional side channels or other flow retention features (i.e., new ponds) to re-direct, store and slow flow.</li> <li>• Consider desired elevation for spillways and fish access through system.</li> </ul> | |

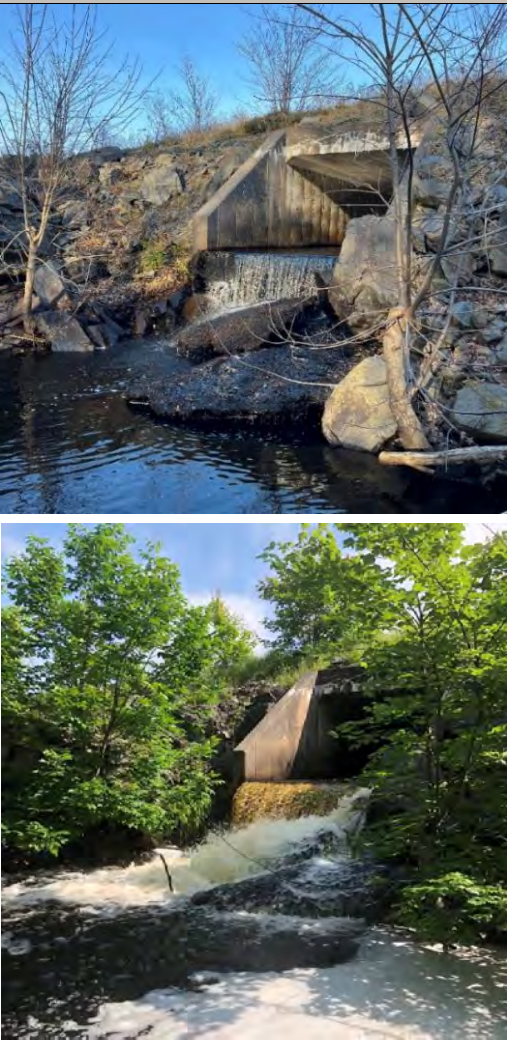
| Description | Photo |
|---|---|
| <p><b>1. <u>Sandy Cole Brook Crossing at Hwy 102</u></b></p> <ul style="list-style-type: none"> <li>Downstream perched culvert outlet.</li> <li>Top photo: Low flow (&lt;5 cm) in culvert at time of assessment (top photo).</li> <li>Bottom photo: High flow on July 6, 2023 (photo from SWEPS).</li> <li>Upstream inlet not assessed.</li> </ul> <p><u>Management Considerations</u></p> <ul style="list-style-type: none"> <li>Retrofit outlet with improved fish access/passage.</li> <li>Consider low-flow improvements. Note perch even under high flow conditions.</li> </ul> <p>Assess connectivity and quality of upstream habitat.</p> | |

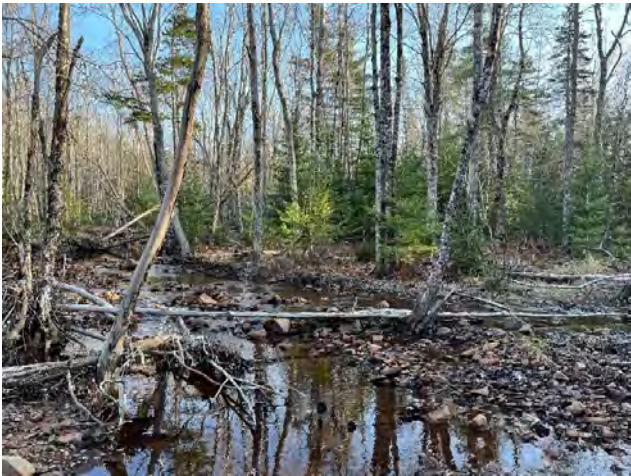
| Description | Photo |
|---|---|
| <p><b>2. <u>Floodplain at Confluence</u></b></p> <ul style="list-style-type: none"> <li>• Beaver activity and built pools.</li> <li>• Evidence of routine high flows, flooding and scouring.</li> </ul> <p><u>Management Considerations</u></p> <ul style="list-style-type: none"> <li>• Assess beaver-made features, consider construction of additional berms/pools to retain and slow flow to downstream reaches.</li> <li>• Set outflow elevations for desired outcomes and in consideration of fish passage.</li> </ul> | |

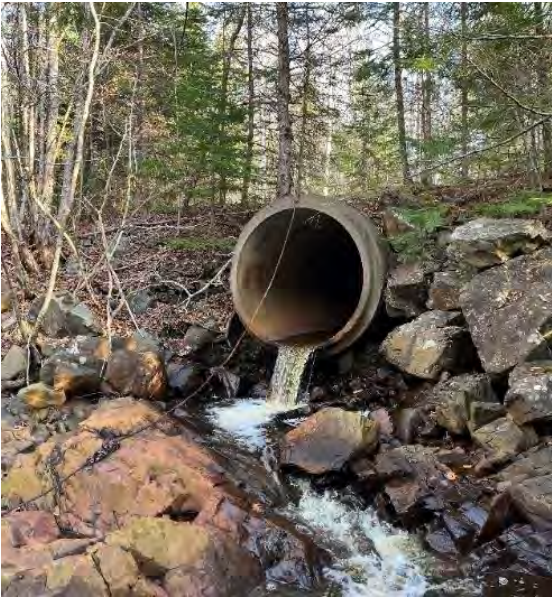
| Description | Photo |
|---|---|
| <p><b>3. <u>Bennery Brook Crossing a Old Trail</u></b></p> <ul style="list-style-type: none"> <li>• Downstream perched culvert outlet.</li> <li>• Flow partially obstructed at inlet.</li> <li>• No baffles or fish passage infrastructure.</li> </ul> <p><u>Management Considerations</u></p> <ul style="list-style-type: none"> <li>• Replace or retrofit culvert with improved fish passage.</li> <li>• Consider low-flow improvements.</li> <li>• Assess connectivity and quality of upstream habitat.</li> </ul> | |

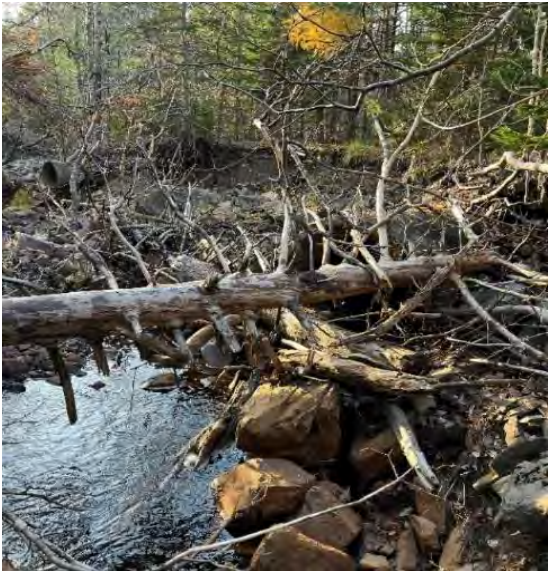
| Description | Photo |
|---|---|
| <p><b>4. <u>Bennery Brook Crossing at Old Trail</u></b></p> <ul style="list-style-type: none"> <li>Partially blocked inlet to perched culvert.</li> <li>Obstructs flow and fish passage.</li> <li>Culvert size and blockage like resulted in channel diversion and trail washout.</li> </ul> <p><u>Management Considerations</u></p> <ul style="list-style-type: none"> <li>Remove culvert obstructions.</li> <li>Further assess inlet elevations. Consider if low-flow retrofits are required.</li> </ul> | |

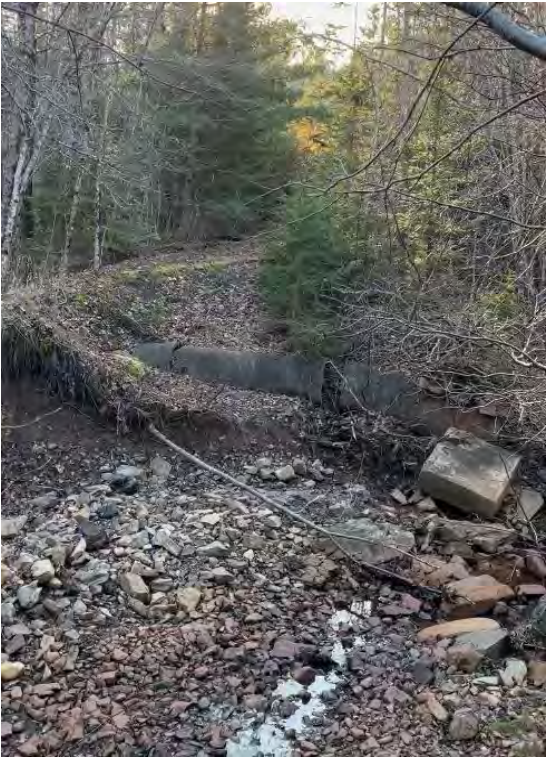
| Description | Photo |
|---|---|
| <p><b>5. <u>Washed Out Trail at Bennery Brook Crossing</u></b></p> <ul style="list-style-type: none"> <li>Washed out trail at channel diversion, west of mail stream.</li> <li>Scouring and erosion issues.</li> <li>Debris from broken culvert(s).</li> </ul> <p><u>Management Considerations</u></p> <ul style="list-style-type: none"> <li>Repair trail and reinstall appropriately sized culvert(s).</li> <li>Considerations for fish passage. Potential location to install a fish passage bypass around the main culvert, if flow could be maintained under low flow conditions.</li> <li>Install erosion and sediment controls to prevent further washouts and improved downstream water quality.</li> </ul> | |

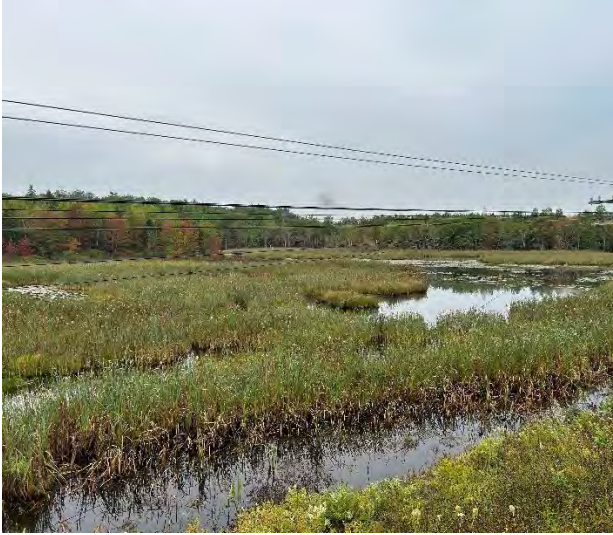
**Figure 15 Site 4 up-gradient wetland area south of the rail line.**

Site 4 is a wetland bisected by a rail line east of Halls Road in Enfield, Nova Scotia (Figure 15). MEL (Andy Walter) visited this site on August 29, 2023. Site 4 lies entirely within private land but can be viewed from the rail line right-of-way. Current site conditions are shown in in-text Figure 15 and 16.

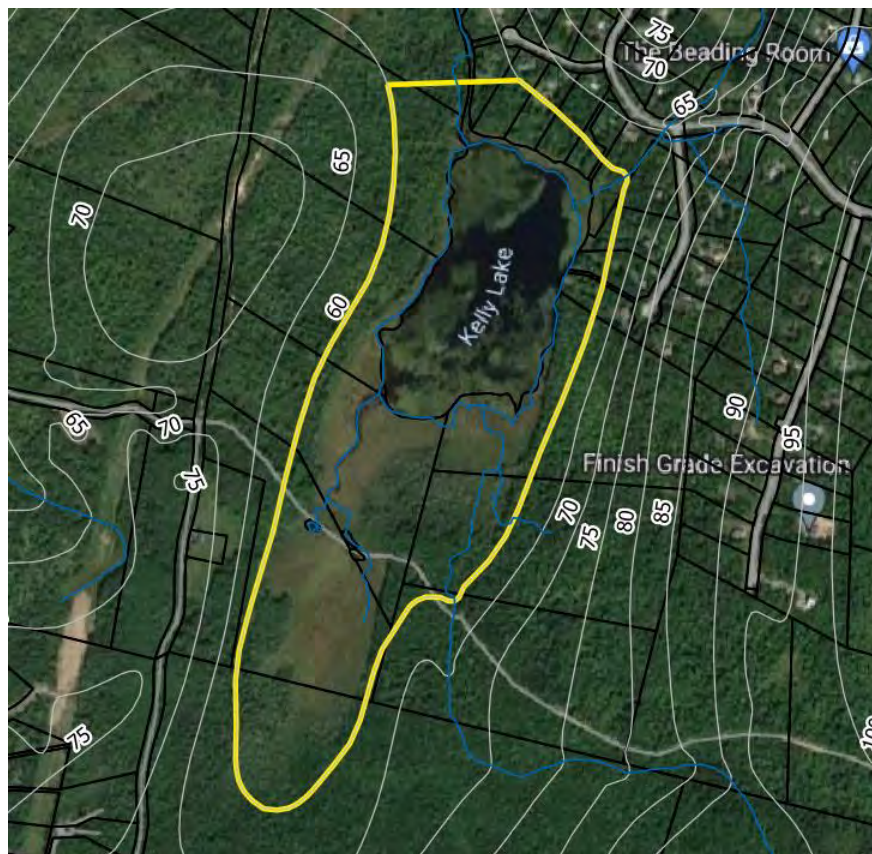
**Figure 19 Site 6 Current Conditions** (shown in yellow)

the hydrology of the wetland and is frequently inundated. Should future development be planned for these properties, it is recommended that adequate setbacks, inline with municipal and provincial regulations, be maintained to preserve the function and integrity of the riparian wetland, and ultimately Kelly Lake, which discharges to Grand Lake. Impacts to upgradient wetlands which may have direct or indirect hydrological connectivity should also be considered. Future development has the potential to impact wetland function, largely through changes to hydrology (e.g., water storage and flow paths) and water quality (e.g., nutrient and sediment runoff). Wetland hydrology may be particularly impacted where roads run perpendicular to the natural flow path and have a greater risk of causing upgradient impoundment if proper cross drainage is not installed.
